TECHNICAL PUBLICATION SJ 85-4

BURRELL DAM SAFETY EVALUATION

Wayne Ingram
Engineer

May 1985

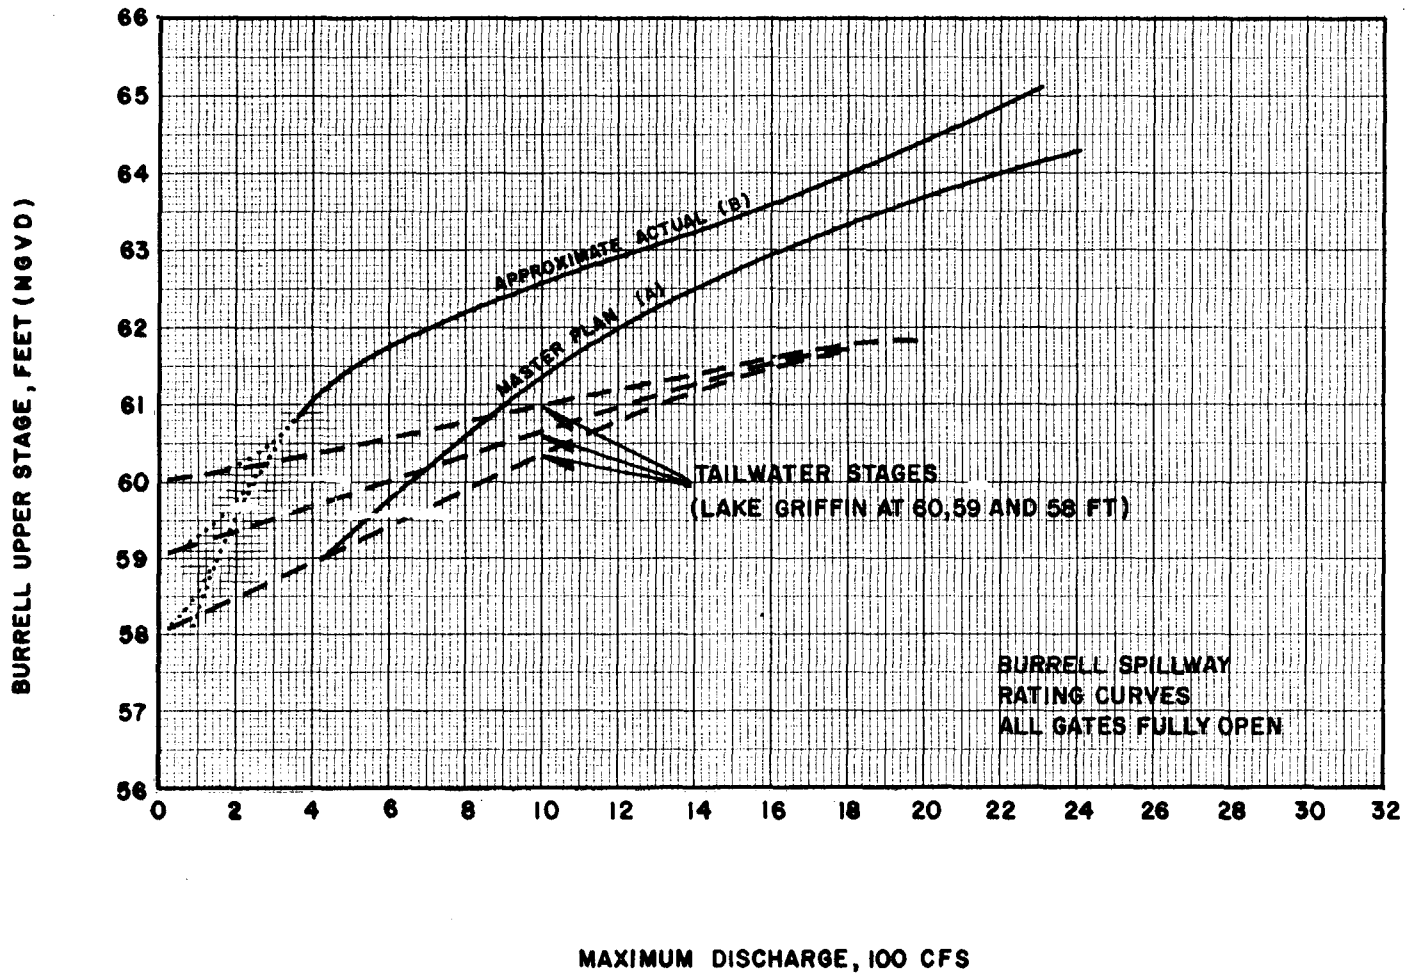
FIGURE 9 Burrell Spillway Rating Curves

Some uncertainty exists as to the design discharge capacity of the Burrell spillway. The Master Plan (3) for the existing dam provides the rating curve seen in Figure 9 (Curve A) which is the same as included in the Phase I Inspection Report. A second curve, produced later, which considers backwater in the downstream channel, gives a significantly lower discharge capacity (Curve B). Discharge measurements made in 1982 and 1983 indicate that Curve B is approximately correct, at least in the range of elevations up to about 63 feet.

It is believed that additional measurements and analysis are necessary to establish a more reliable rating curve. In the absence of this information, however, curve B is assumed to be the best available information. Three tailwater rating curves are also given in Figure 9. Each curve applies to a given Lake Griffin stage.

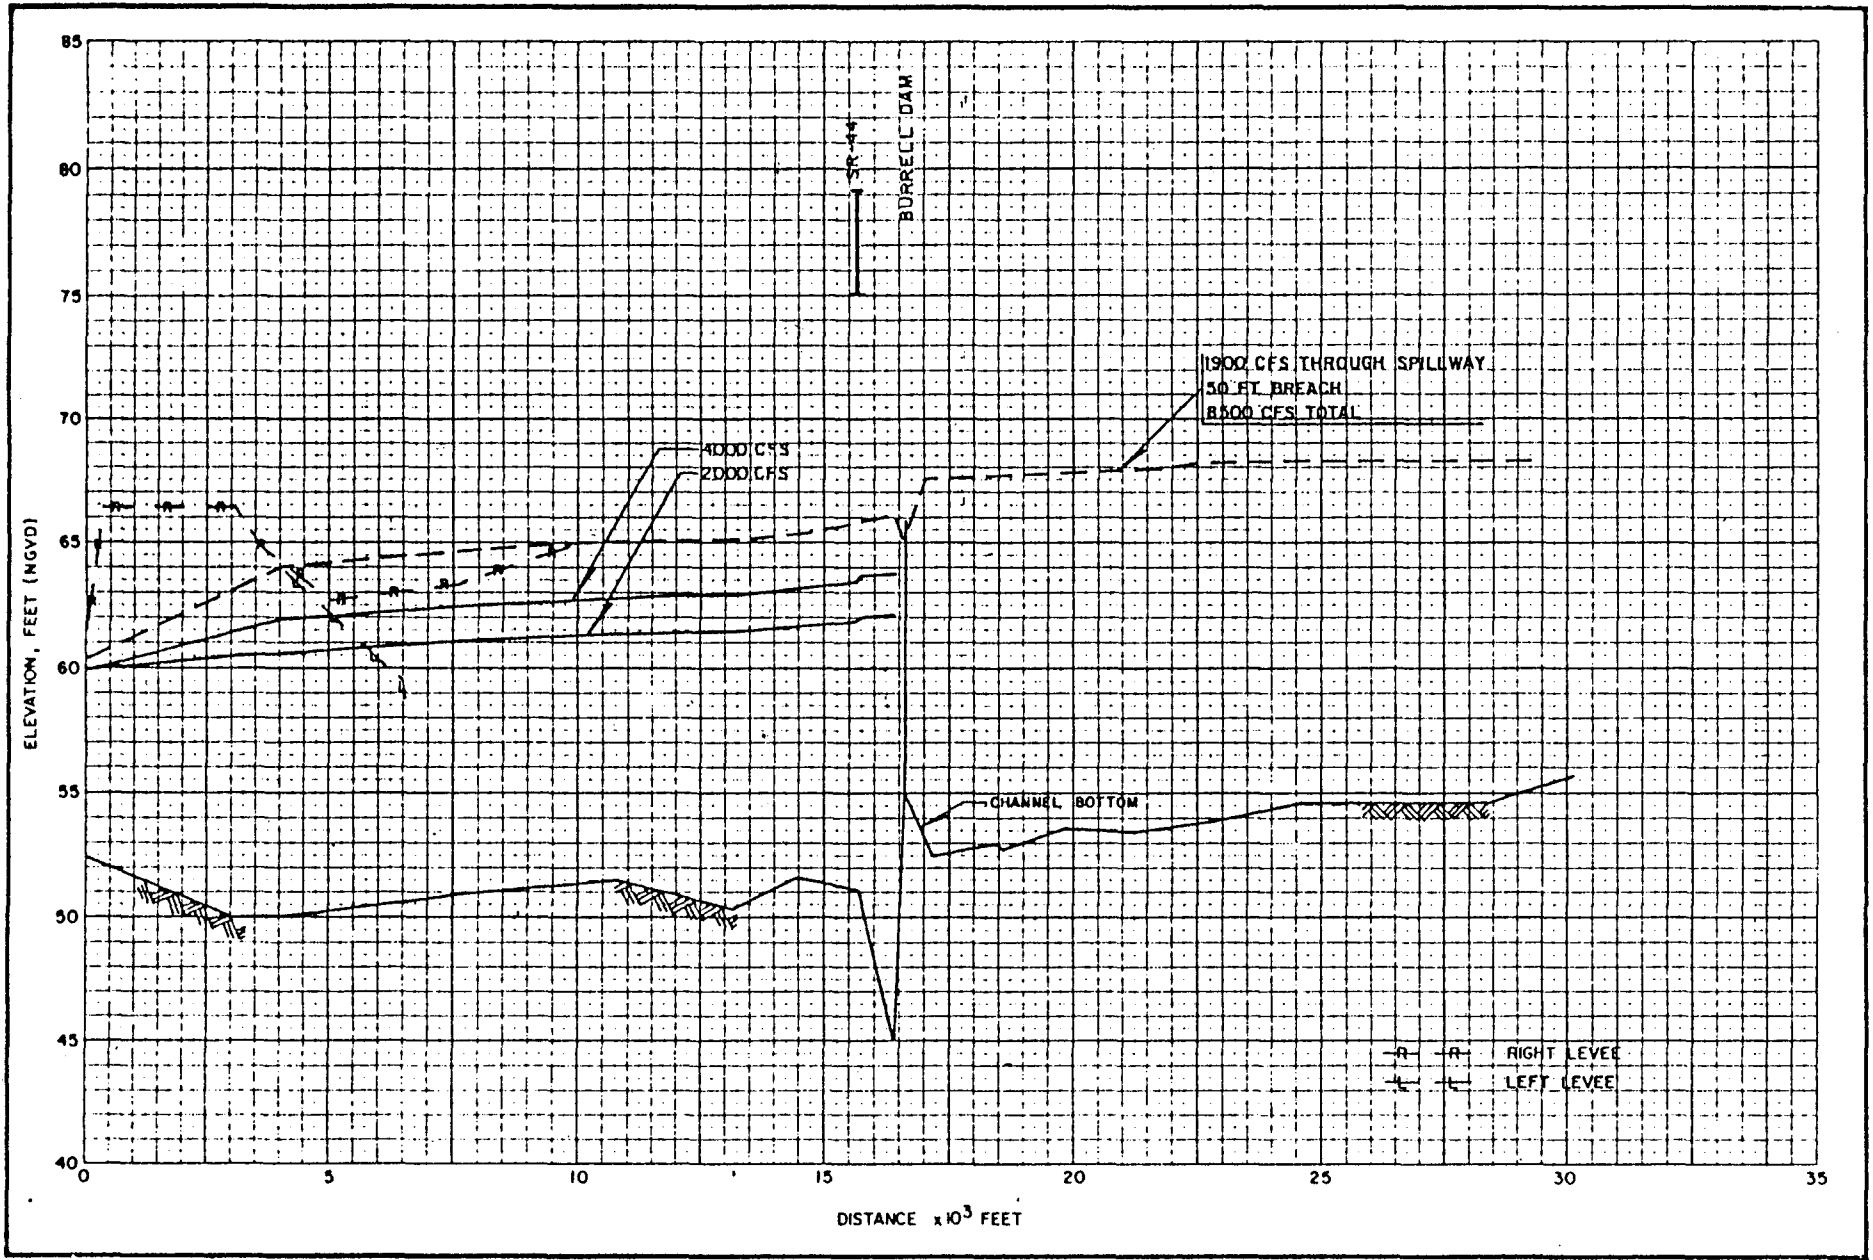
FIGURE II
HAINES CREEK WATER SURFACE PROFILES

Figure 11 is a water surface profile for given steady flow conditions. Levee crest elevations are plotted on this figure, also. It is observed that discharges exceeding about 5000 cfs would overtop the levees on both sides of Haines Creek even with no freeboard allowance. This would in all likelihood result in failure of these levees. The impact of levee failure at the lowest point along the levee on upstream water levels is indicated in Figure 12. The profiles are plotted assuming Burrell Dam did not exist. It was assumed that water levels in Haines Creek at the point of levee failure were at critical depth after failure. It is observed that levee failure at the location indicated has little impact on water levels downstream of Burrell Dam.

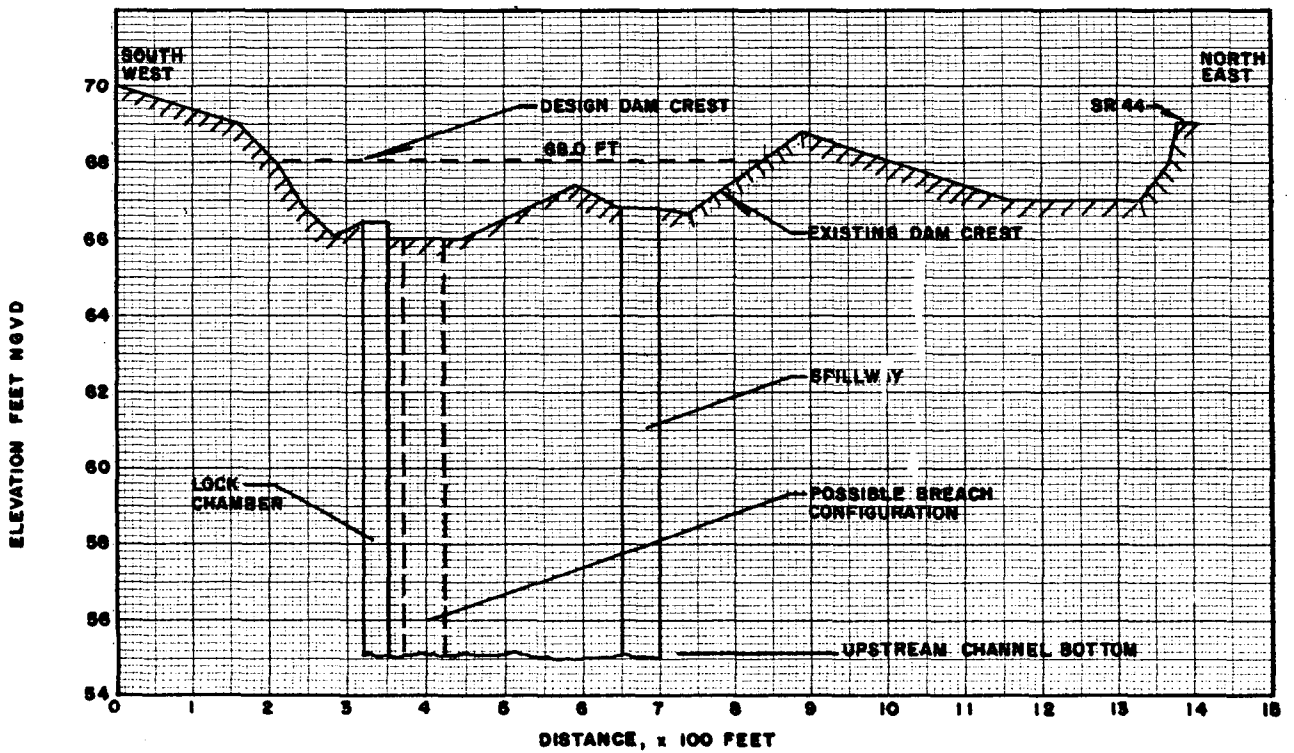
FIGURE 14 Top of Dam Profile

Assuming the dam is overtopped and does fail, the breach is expected to grow to a bottom width of about 50 feet maximum. Figure 14 is a profile showing the dam crest elevation looking downstream, the lock and spillway location and a possible breach location are also indicated.

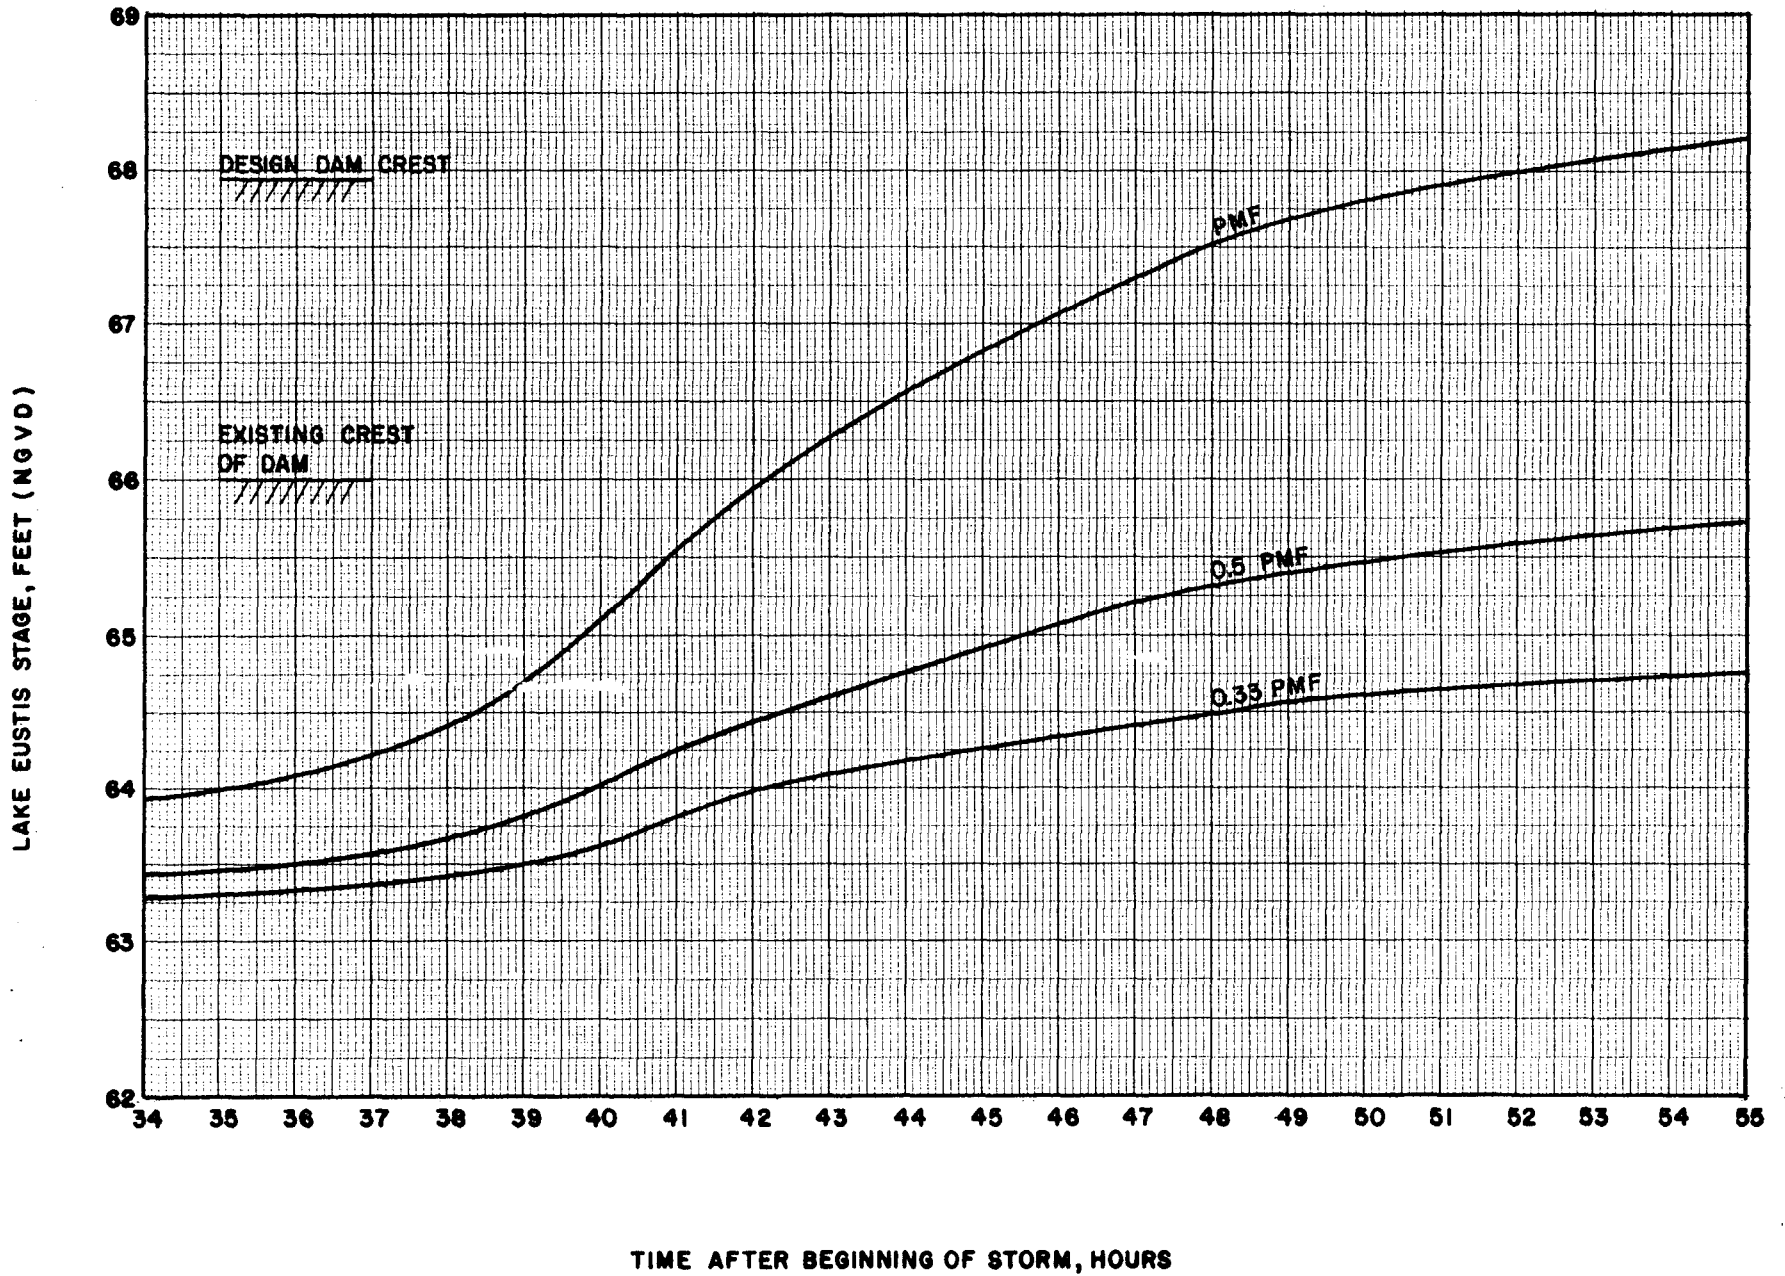
FIGURE 16 Lake Eustis Stage Hydrographs

It is observed that the peak stage is not very sensitive to outflow conditions. This is true because the outflow via Haines Creek, even with no obstructions (e.g. Burrell Dam), is small relative to inflow and storage increases in the upstream lakes. The peak stage of 69.1 feet resulting from the no failure assumption and the full PMF results very late in the simulation due to

Since it is observed that the peak stages are not sensitive to estimates at discharge of Burrell, it is concluded that the Burrell Dam would be overtopped by more than 2 feet during a PMF and lake stages would rise to the crest of the dam as a result of the 0.5 PMF. These conditions result even with what is believed to be an optimistic assumption of discharge capacity of the existing spillway of 1900 cfs.

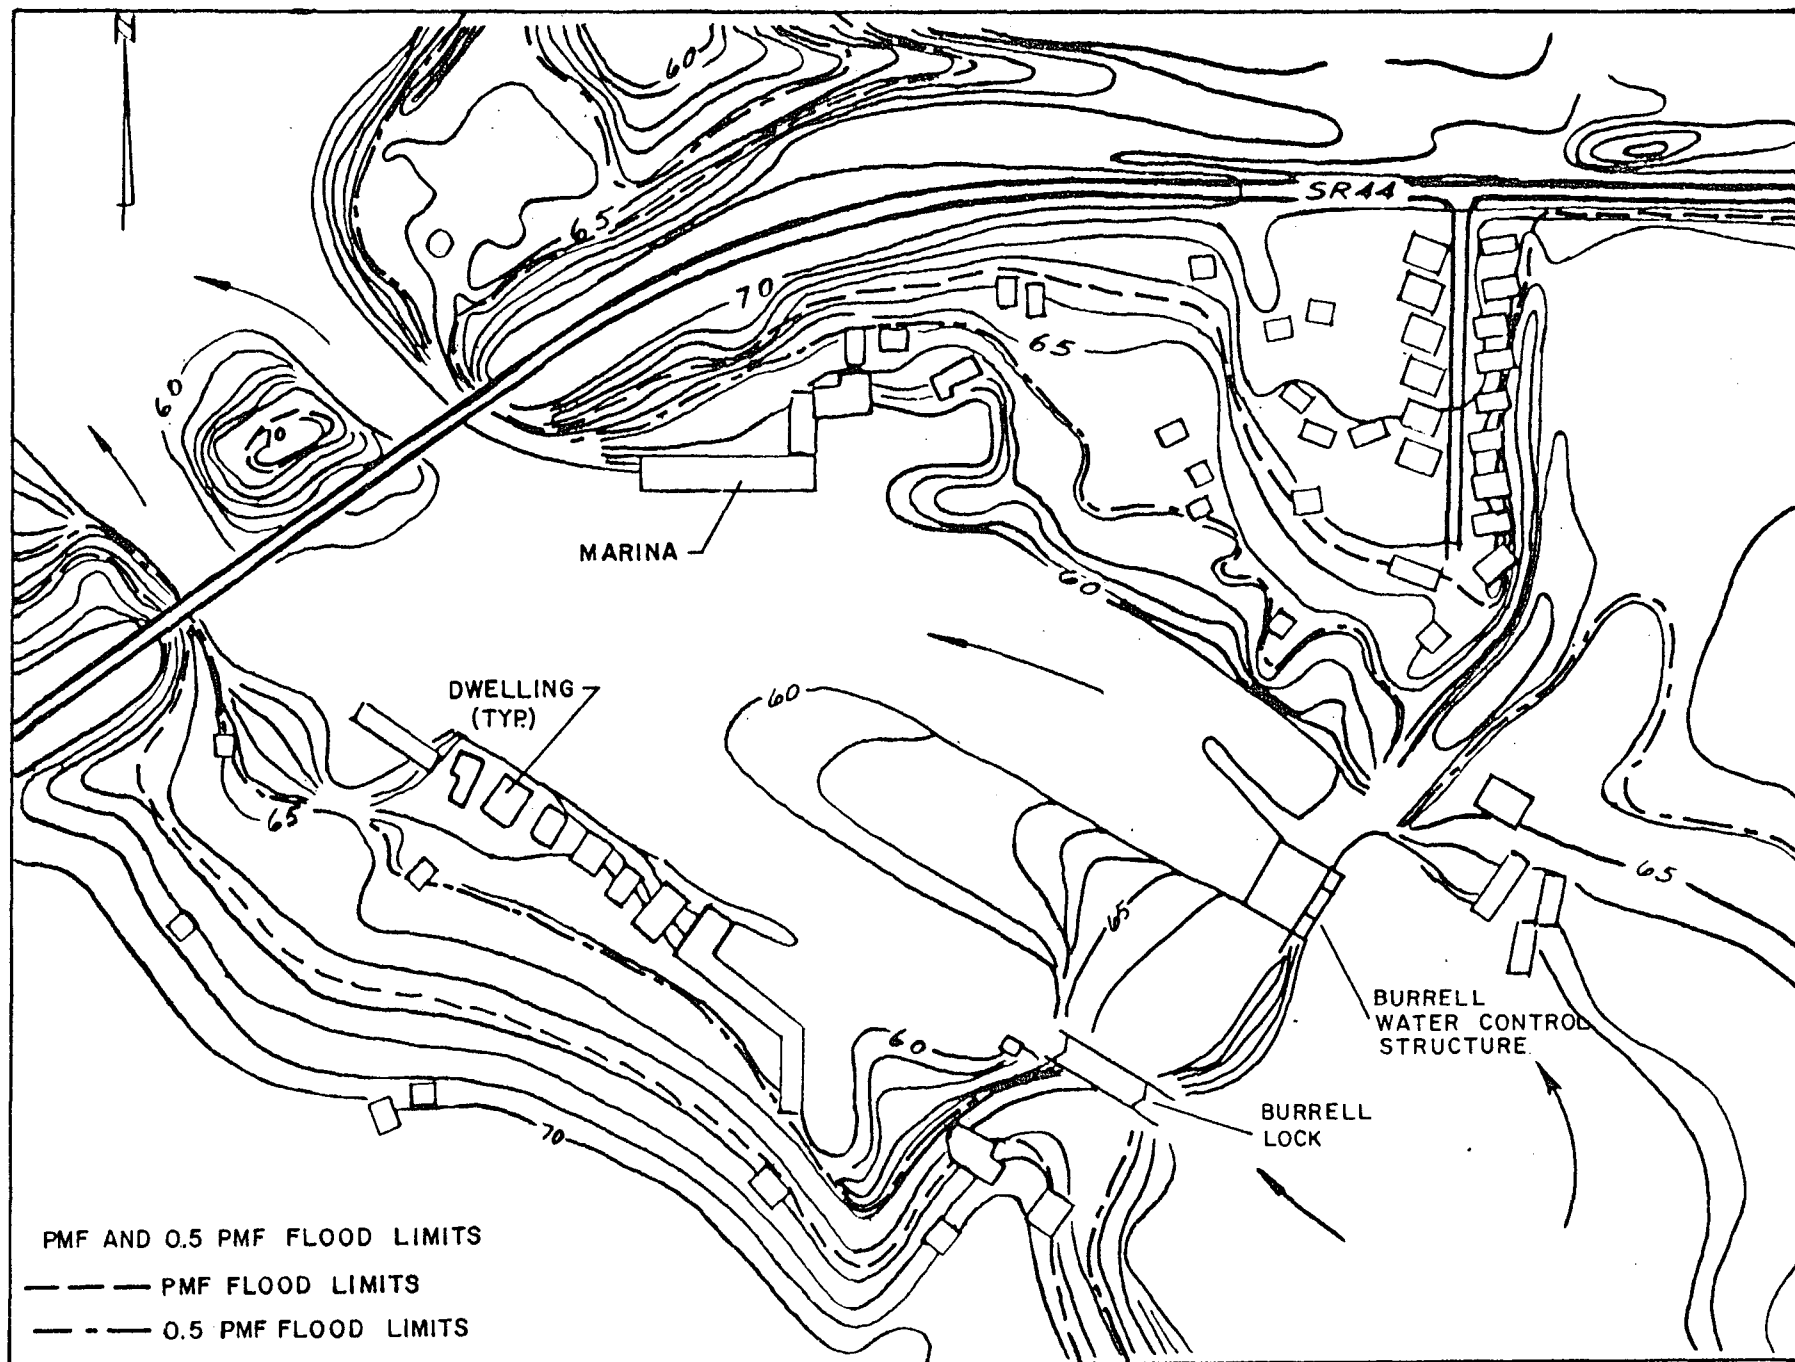
FIGURE 19. Burrell Tailwater Flood Limits

There are approximately 50 residences and a marina immediately downstream of Burrell Dam. The locations and surrounding ground elevations of most of these are seen on Figure 19. The peak flood stages for the area from the Total Failure case are indicated on the figure. More than one half of these structures are susceptible to flooding for the PMF. The six residences immediately adjacent to the south side of the channel would appear to be the most seriously impacted. Water depths there could be as much as five feet and accompanied by strong currents exceeding 5 ft./sec. These structures could be swept from their foundations or have the bank eroded out from below them by these currents. Other structures would be subjected to lesser depths of inundations and are also more protected from swift currents. Figure 20 shows flood extents for lower Haines

Based on this information it is concluded that the danger of loss of life extends to approximately six residences. This is believed to be sufficiently hazardous to classify the dam as unsafe. It is also believed, however, that a reasonable emergency action plan and warning system could be quickly implemented at minimal cost which would remove this risk of loss of life so that the dam could be classified as safe.

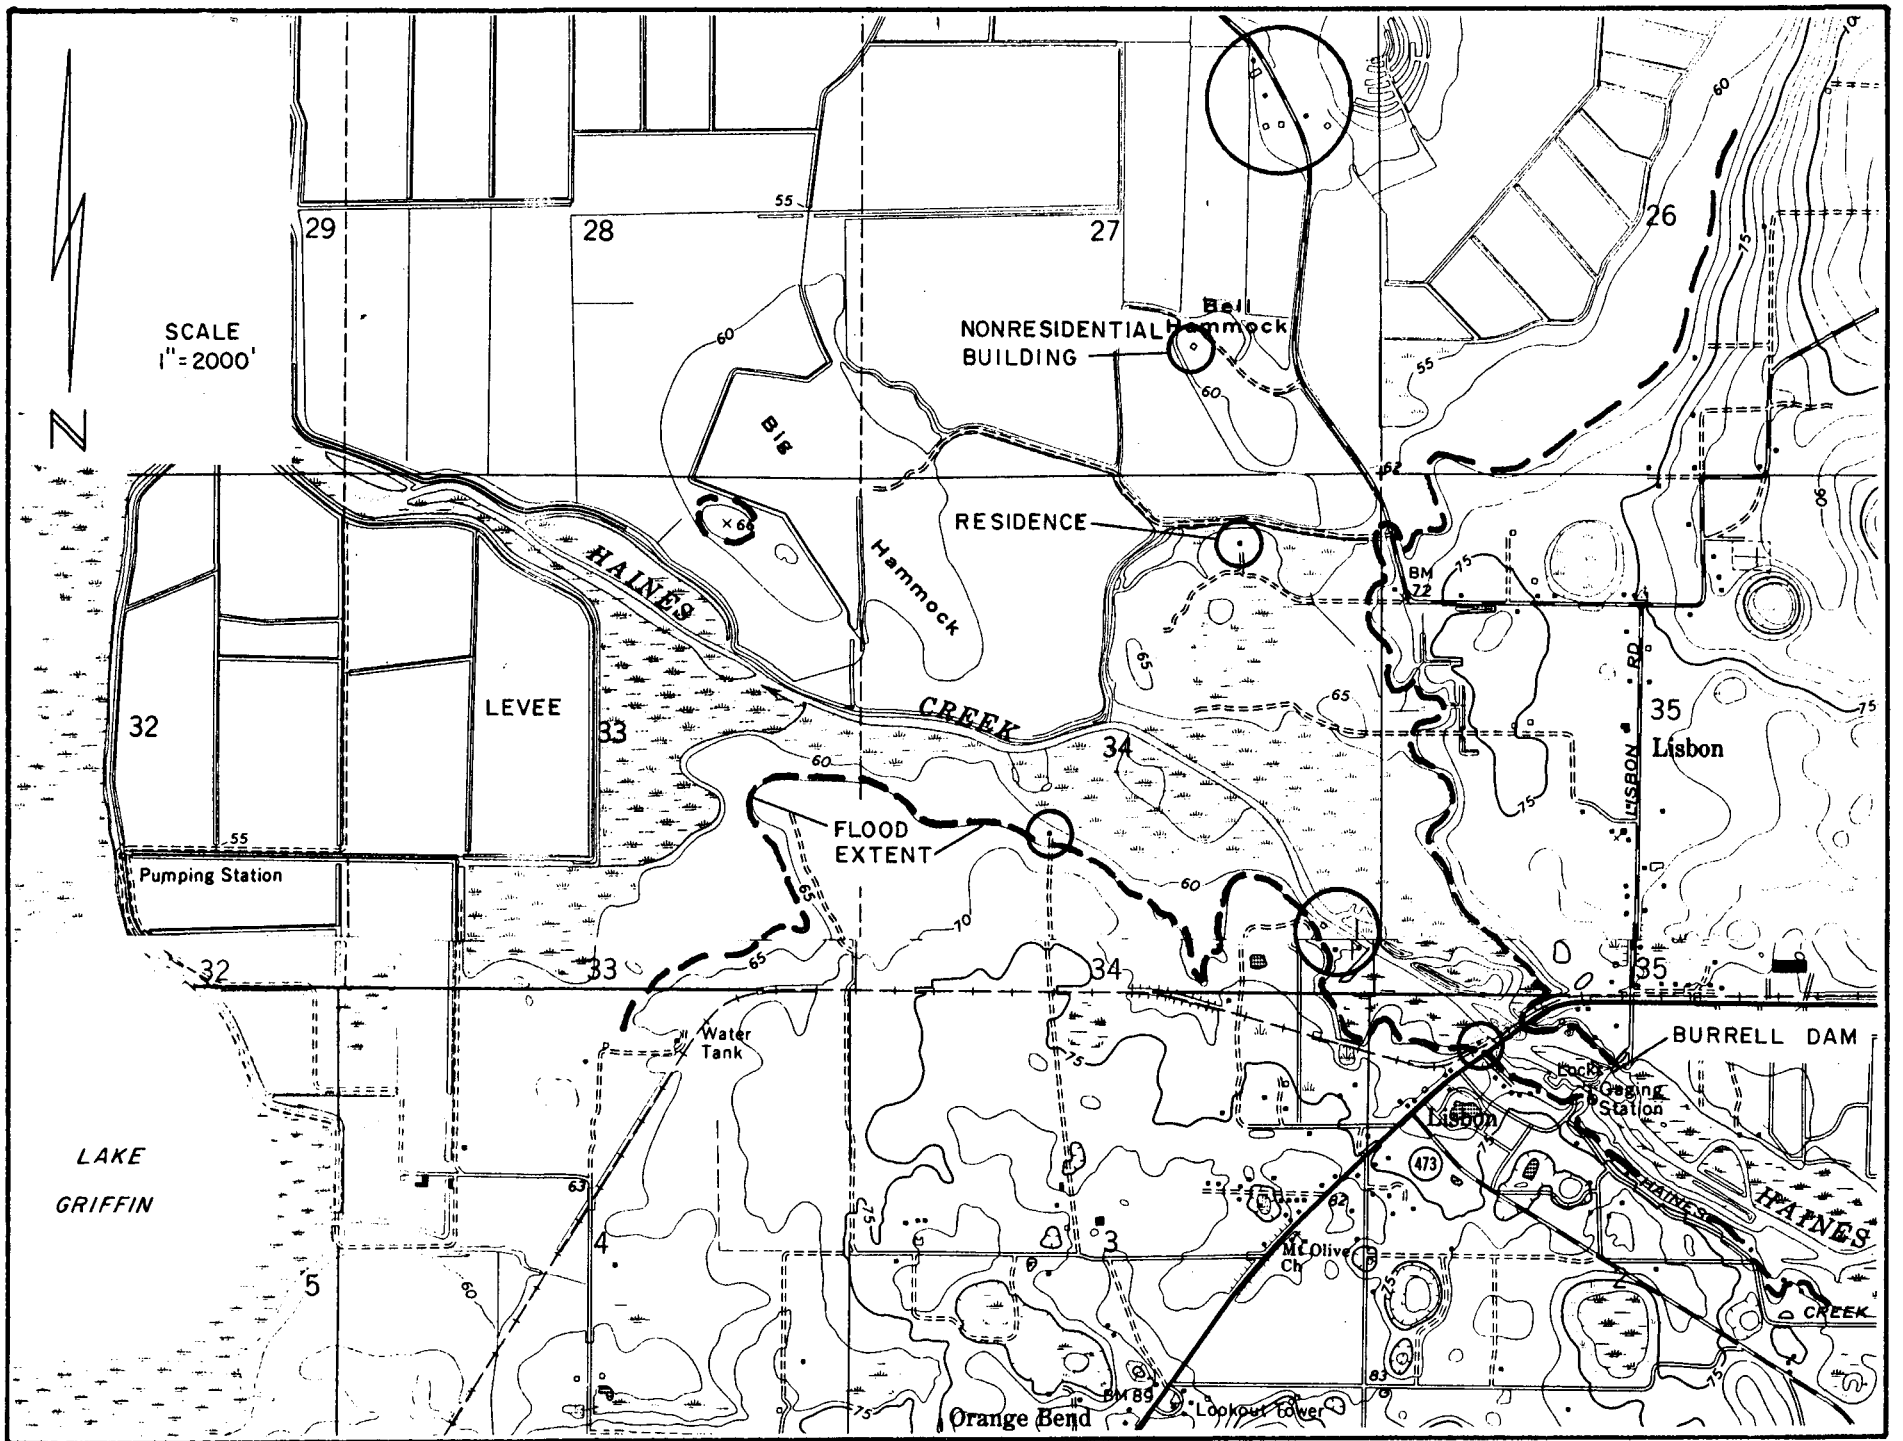
FIGURE 20.

Creek in its entirety. Locations of existing residences and agricultural structures potentially impacted by a PMP related failure are also indicated on Figure 20.

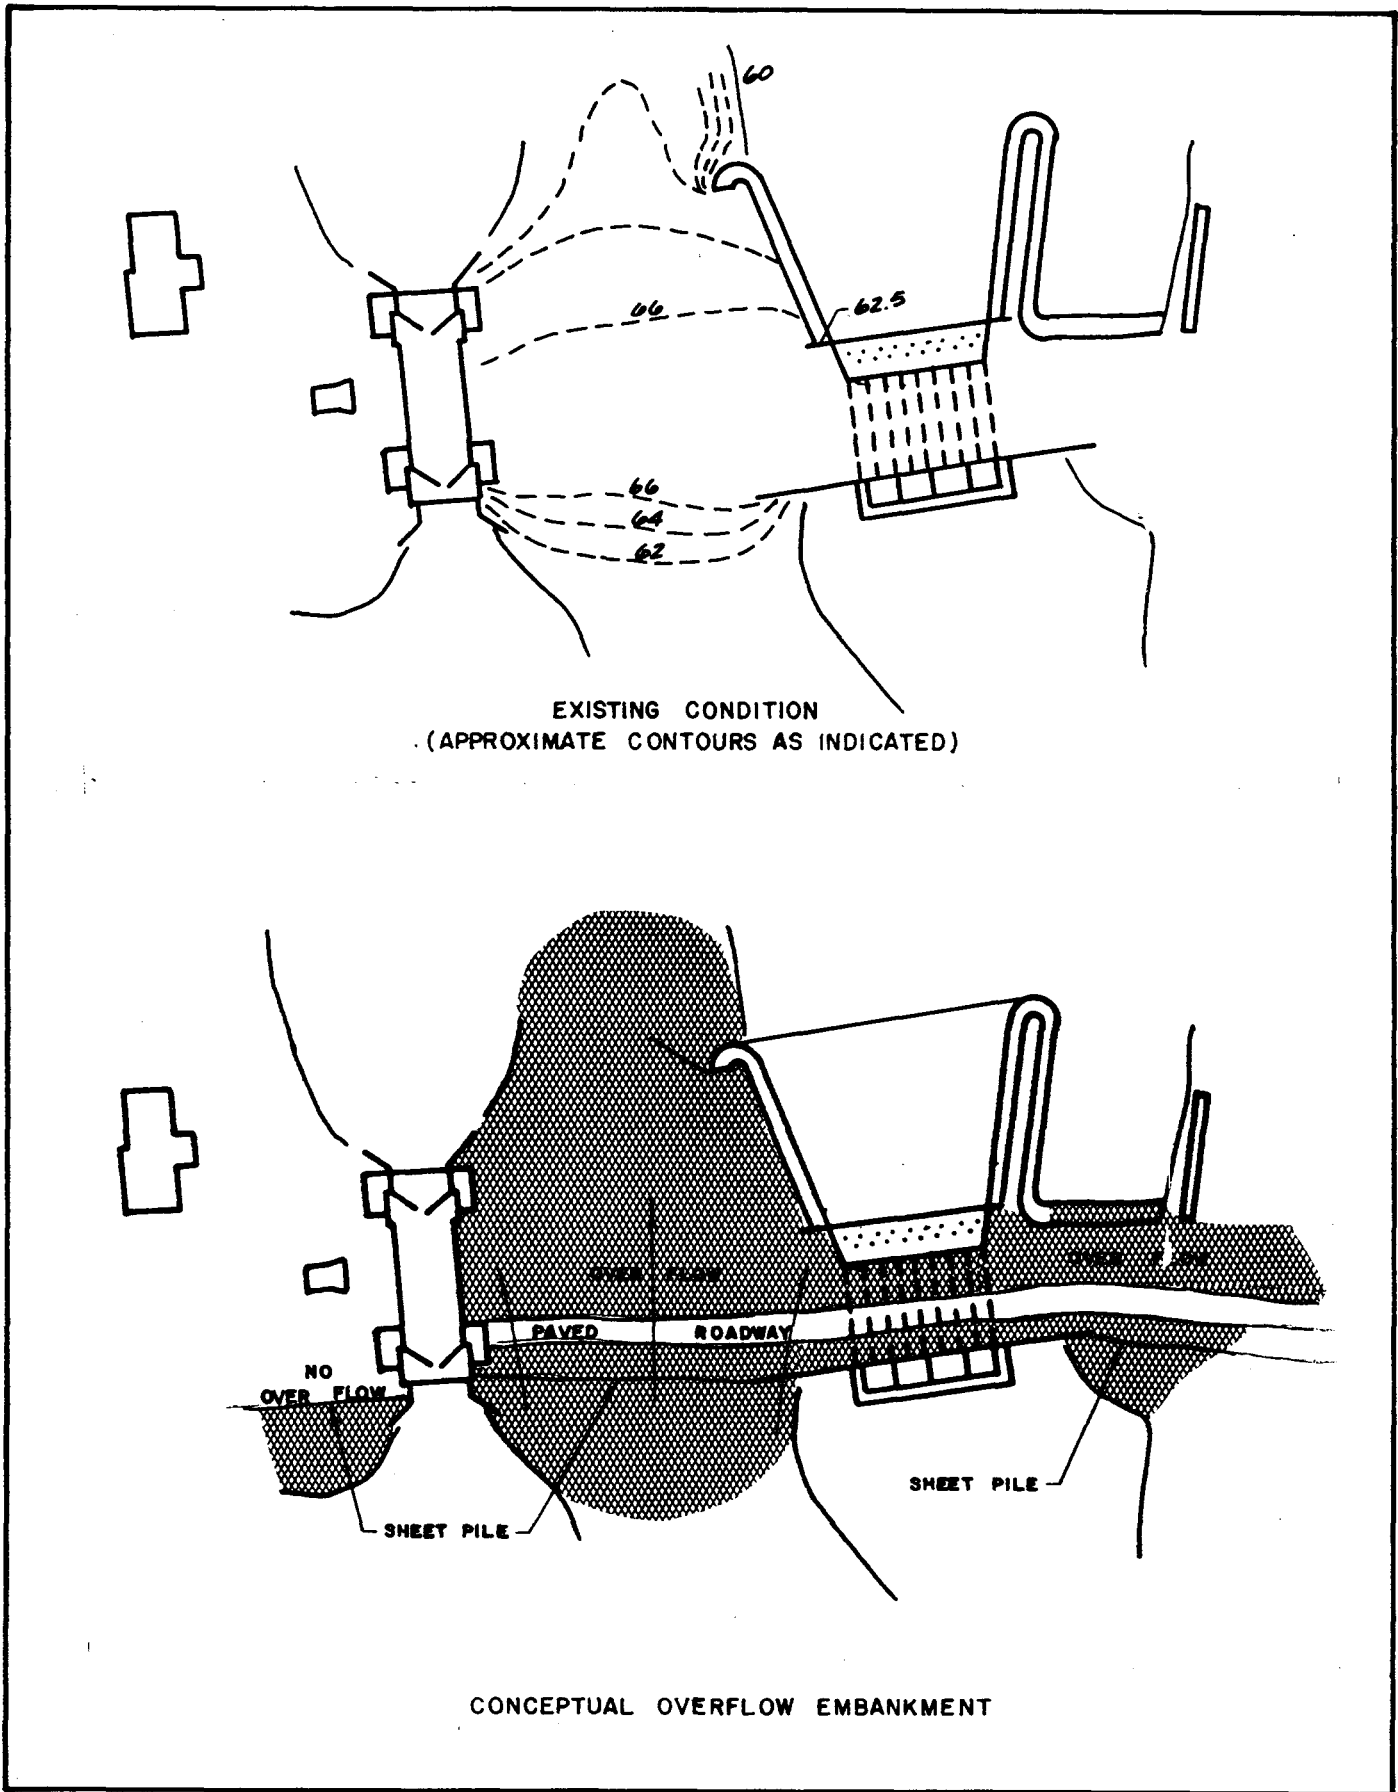
Figure 21 Conceptual Drawing of Burrell Overflow Embankment Rehabilitative Alternative

The earth dam is assumed to fail due to surface erosion by the flow over the crest. If the existing dam could, with minor modifications, be made resistant to erosion then failure could be eliminated (subject to verification of other factors such as stability against sliding, uplift, etc.). This alternative is actually a special case of increasing the spillway capacity, since the existing dam would act as an emergency spillway. There are several different configurations which could technically satisfy the requirement. Emergency overflows have in some cases been constructed as grassed earthen channels of flat enough slope to keep flow velocities below erosive limits. Other possibilities include replacing the earth embankment with non-erodible material such as protective riprap or gabions (wire containers filled with rock) as seen in Figure 21. Another alternative would be to drive steel or concrete sheet piling along the length of the dam which could withstand the small water level differences if the earth embankment were completely eroded.

A rigid non-erosive shell or paving of the existing embankment is an alternative, but adequate prevention of internal erosion during overflow and detection of cavities beneath the covering created by seepage or other causes are important concerns.

Based on data available at this time and engineering judgment, a flexible protective covering such as riprap or gabions and the sheet pile wall alternatives would appear to be the most feasible alternatives. These would maintain flood damages at the current conditions, presumably resulting in no increased
