**RESIDENTIAL IRRIGATION
EFFICIENCY ASSESSMENT
FINAL REPORT**

Residential Irrigation Efficiency Assessment

Final Report

Submitted to
St. Johns River Water Management District

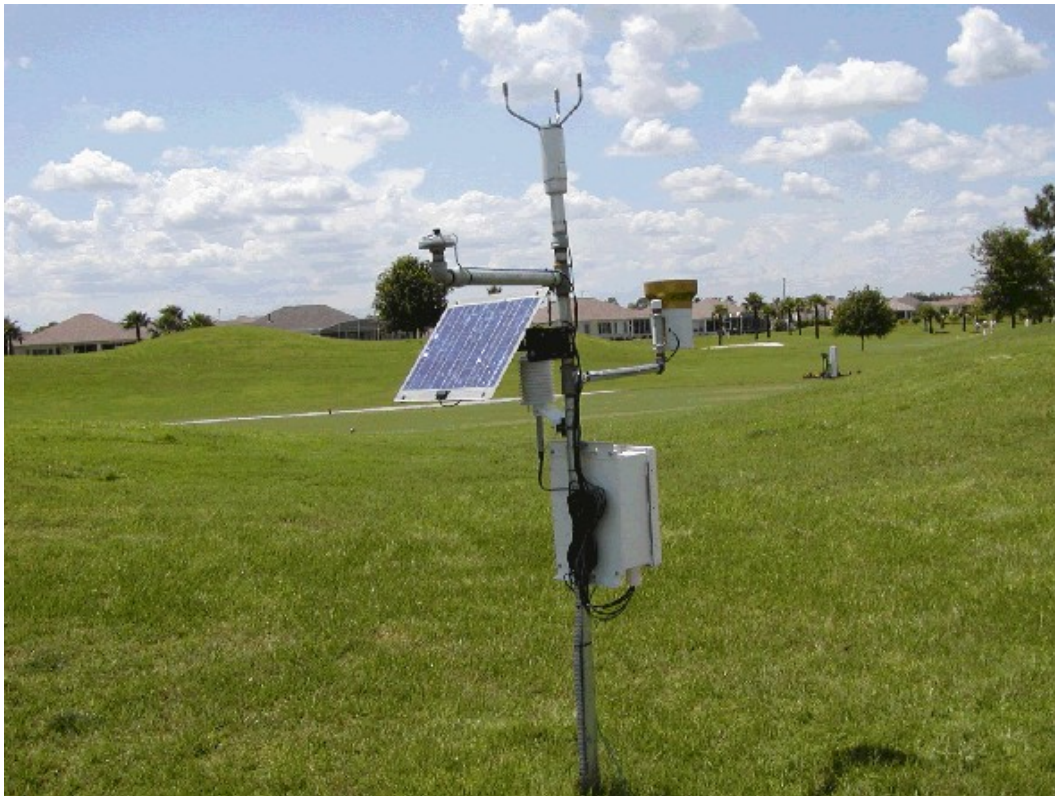
Figure 2. Reference ET weather station.

Weather stations were installed in late February 2002, in Marion and Lake Counties to enable calculation of reference evapotranspiration (Fig. 1). The third weather station was installed May 2003, in Orange County. The weather stations were located in flat-grassed areas so that the nearest obstruction was at least 61 m (200 ft) away from the station (Fig. 2). Irrigated areas were chosen when possible; however, this resulted in one of the stations collecting irrigation water in the precipitation bucket. A separate rain bucket and data logger (Davis Instruments Corp., Hayward, CA and Onset Computer Corp., Bourne, MA) was installed in a nonirrigated area to separate precipitation events from irrigation events. The residential home sites were located within 1 km of the weather stations. Date, time, relative humidity and temperature (model HMP45C, Vaisala, Inc., Woburn, MA), soil heat flux (model HFT3, Radiation Energy Balance Systems, Bellevue, WA), solar radiation (model LI200X, Li-Cor, Inc., Lincoln, NE), wind speed and direction (model WAS425, Vaisala, Inc., Sunnyvale, CA) and, precipitation (model TE525WS, Texas Electronics, Inc., Dallas, TX), were recorded in 15 minute intervals via a CR10X data logger (Campbell Scientific, Inc., Logan UT).

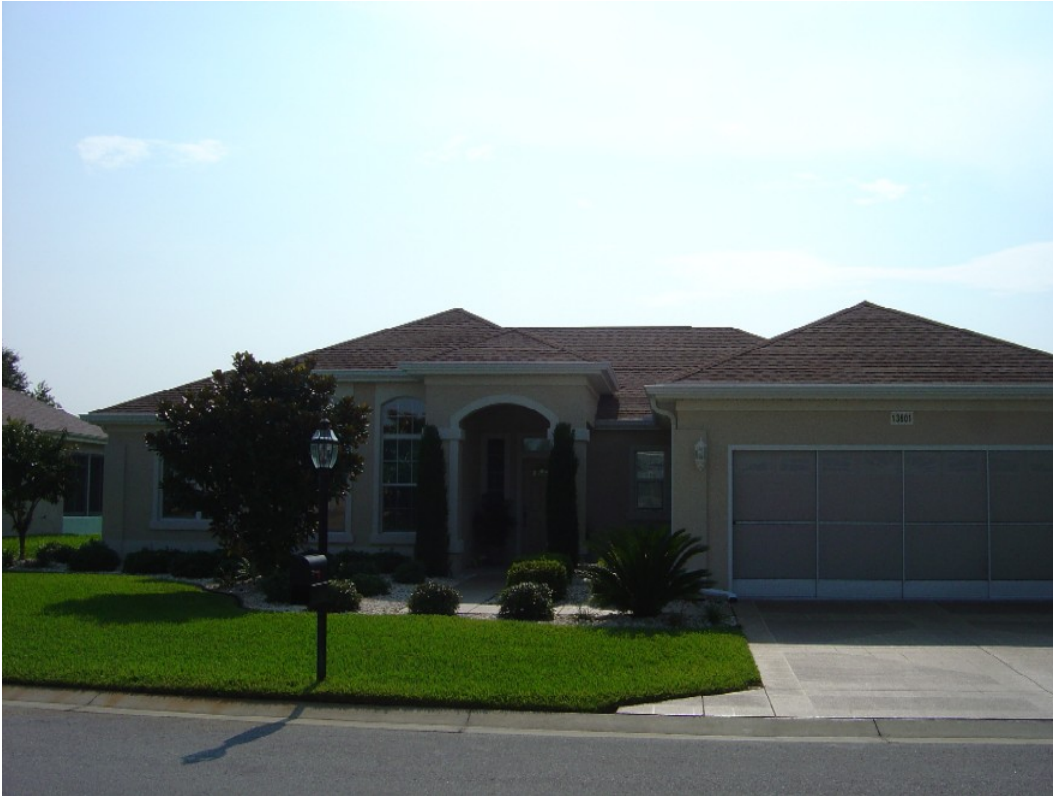
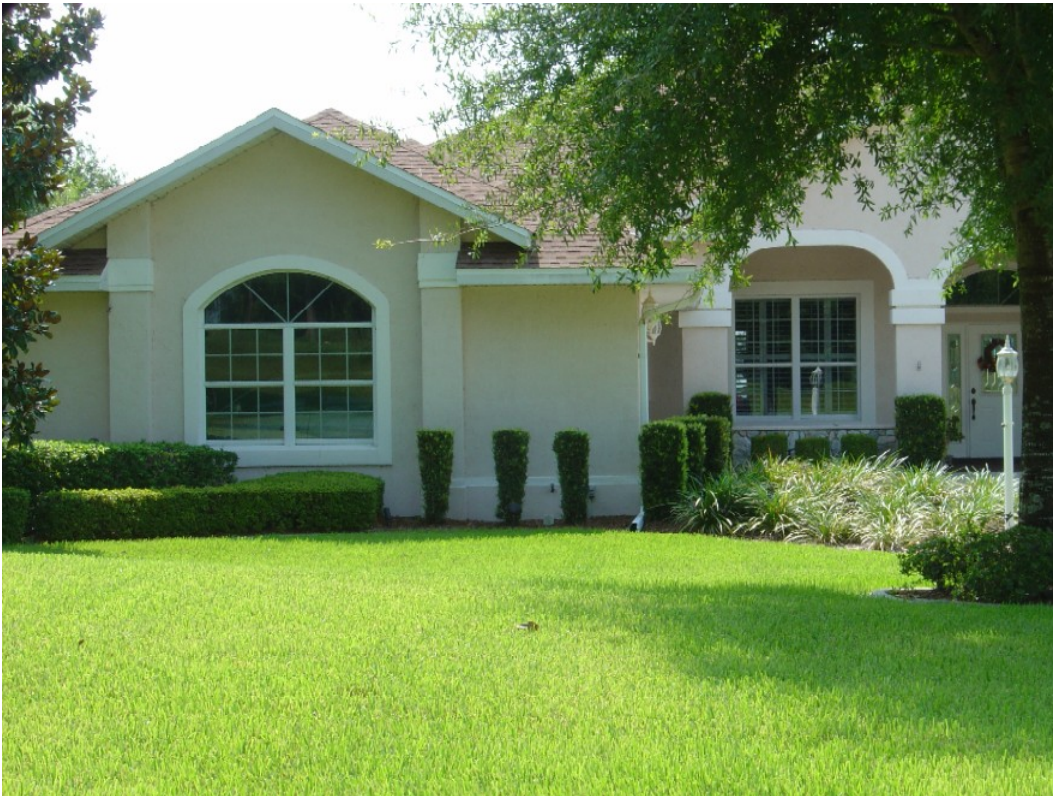
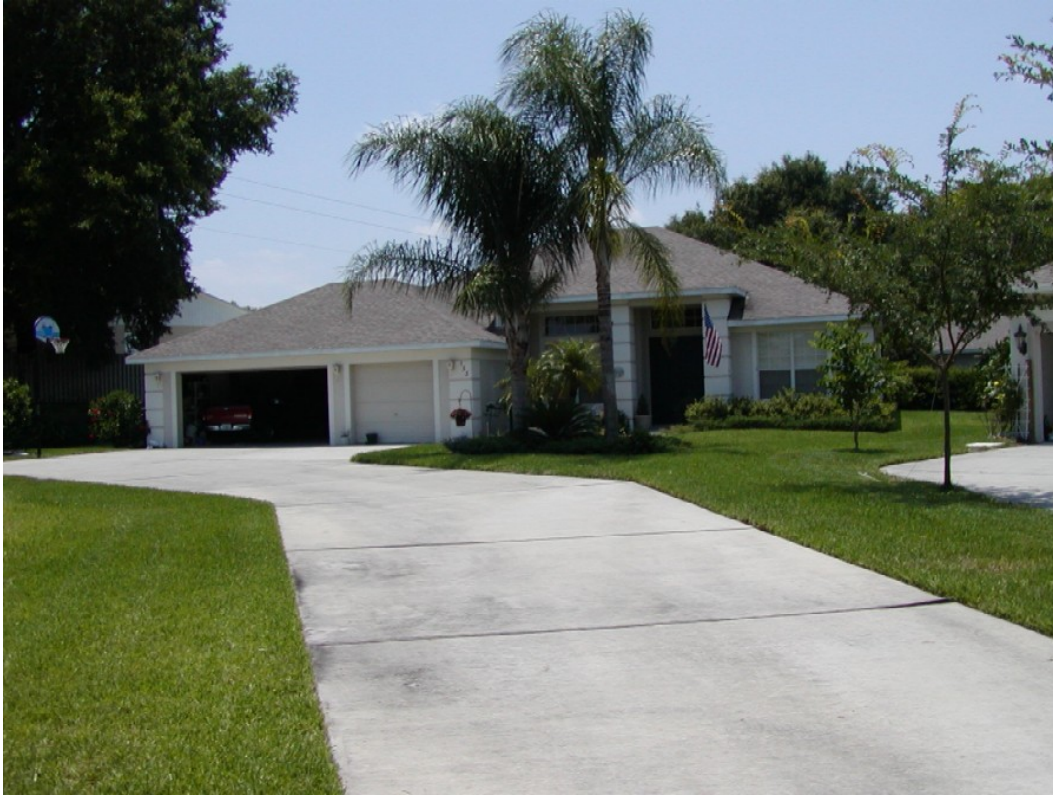
Figure 3. Example cooperator home, Marion County, T1.

Figure 4. Example cooperator home, Lake County, T1.

Figure 5. Example cooperator home, Orange County, T1.

T1 consisted of existing irrigation systems and typical landscape plantings, where the homeowner controlled the irrigation scheduling (Figs. 3-5). Existing irrigation was rotary sprinklers and spray heads installed to irrigate both landscape and turfgrass during the same irrigation cycle (Fig. 6). T2 homes initially were to consist of an irrigation system designed for as high efficiency as practically possible and a typical landscape on new homes. Cooperator

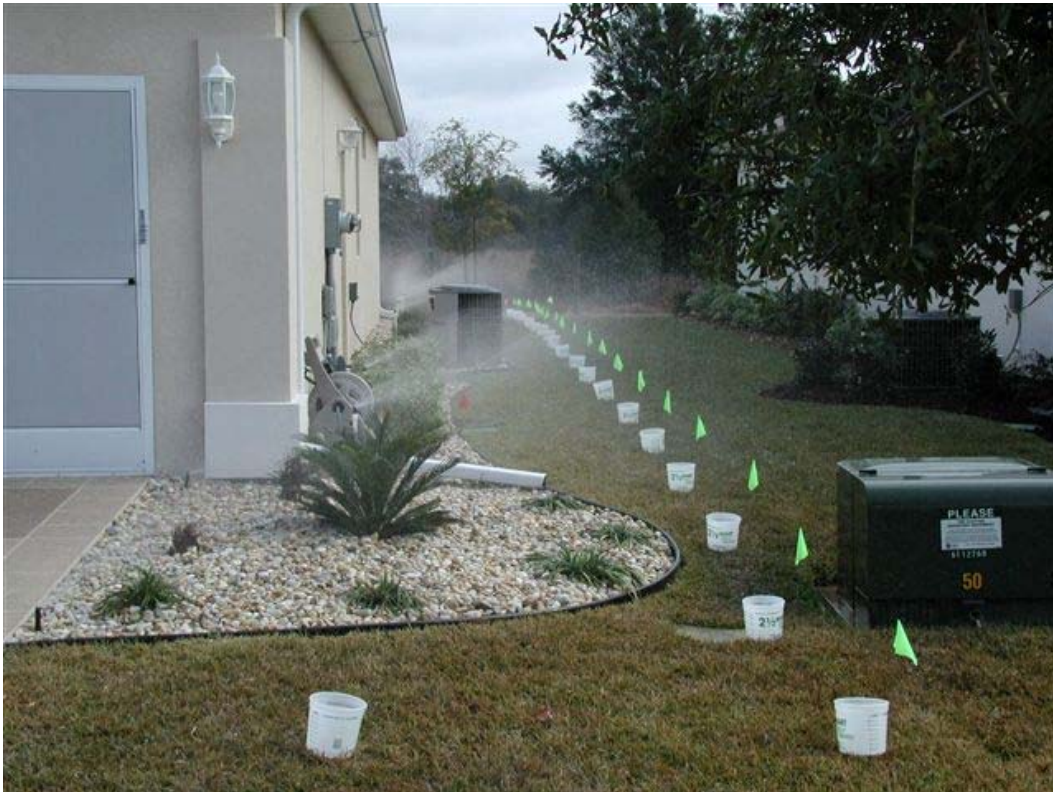
Figure 6. Landscape and turfgrass in the same irrigation zone.

The average T1 or T2 irrigated landscape was comprised of approximately 75% turfgrass (60-88% range) where turfgrass and landscape plants were irrigated on the same irrigation zones. The turfgrass portion of the T3 homes averaged 31% (5-66% range). The remaining landscaped area was established with Florida native plant material and irrigated with microirrigation or in one case not irrigated after establishment.

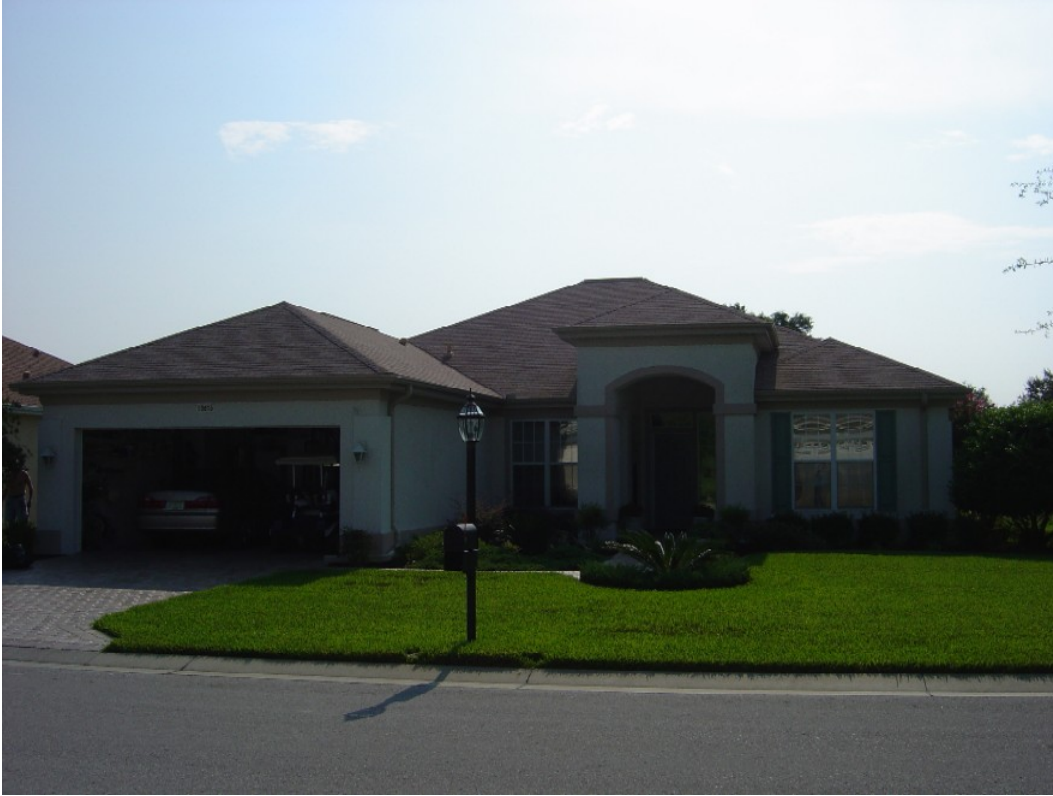
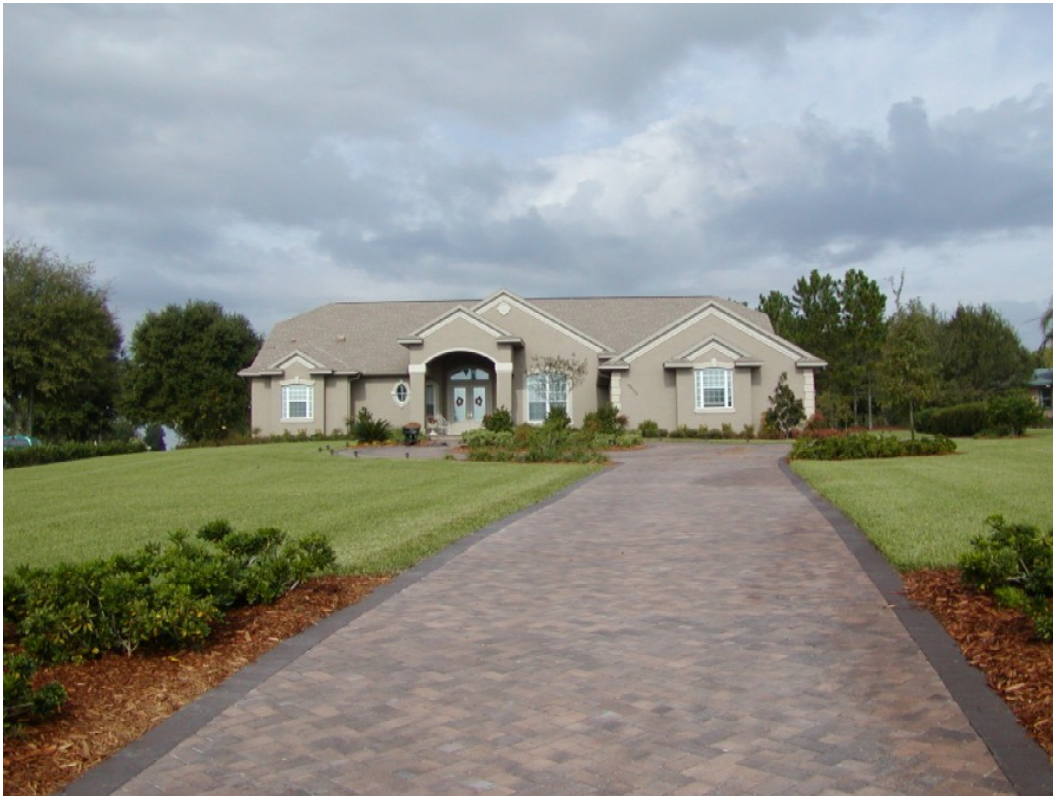
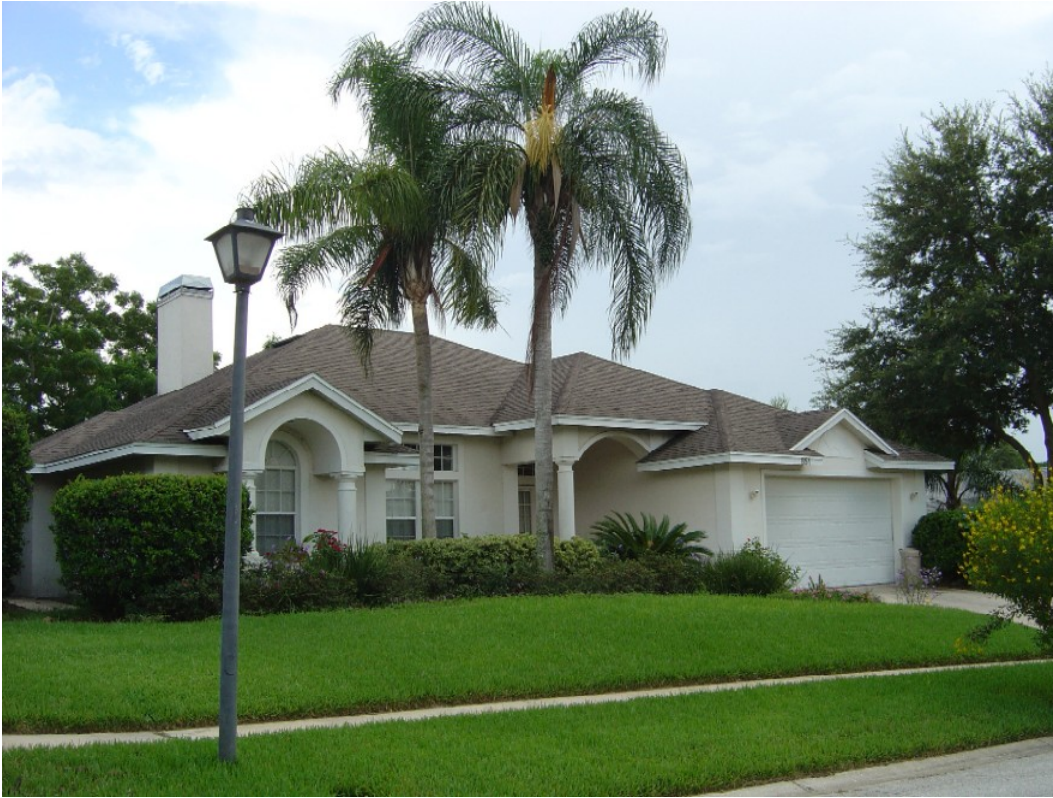
Figure 7. Example cooperator home, Marion County, T2.

Figure 8. Example cooperator home, Lake County, T2.

Figure 9. Example cooperator home, Orange County, T2.

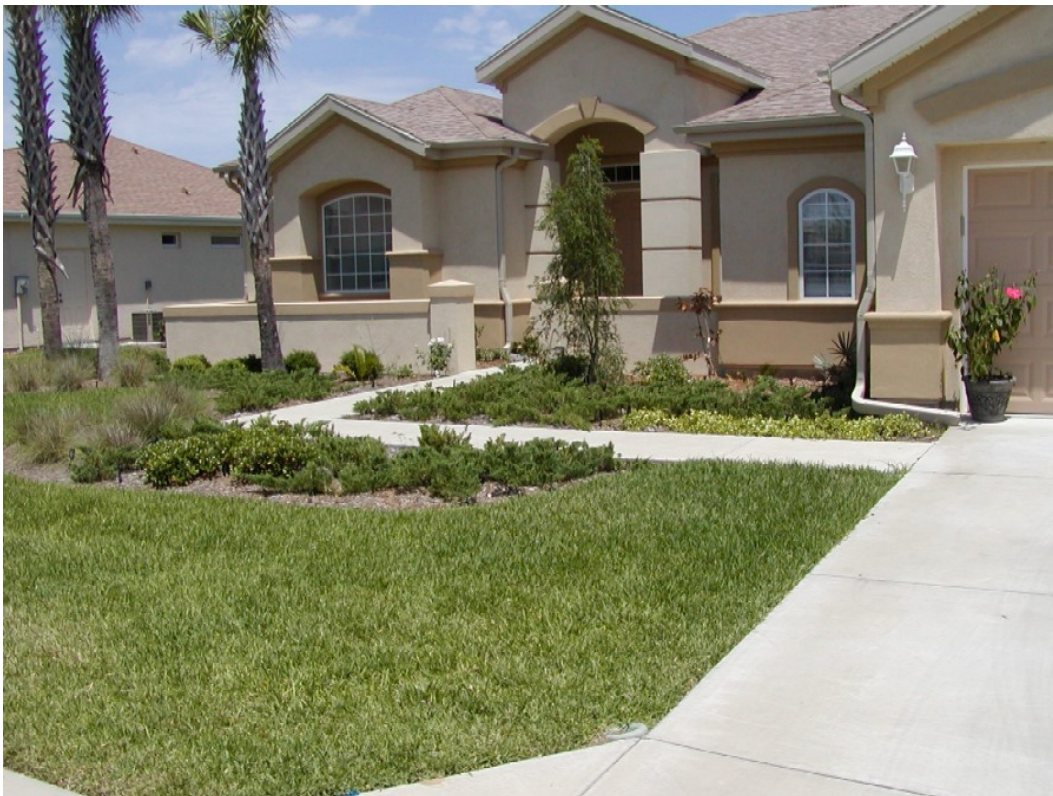
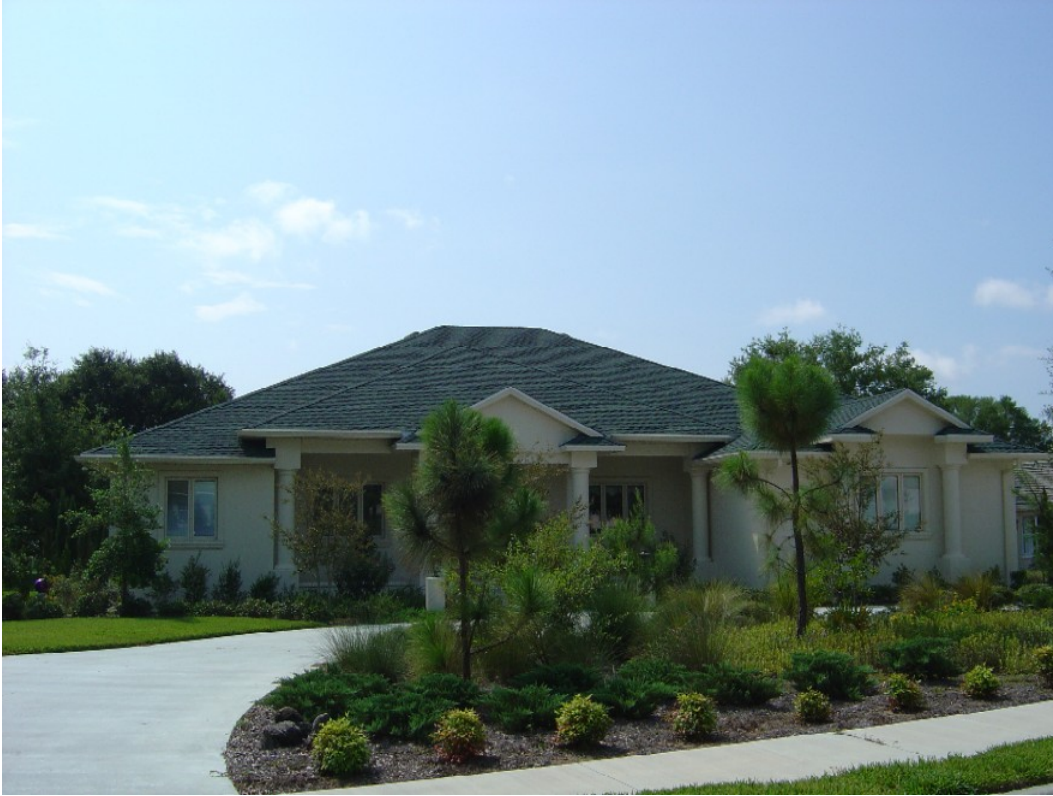
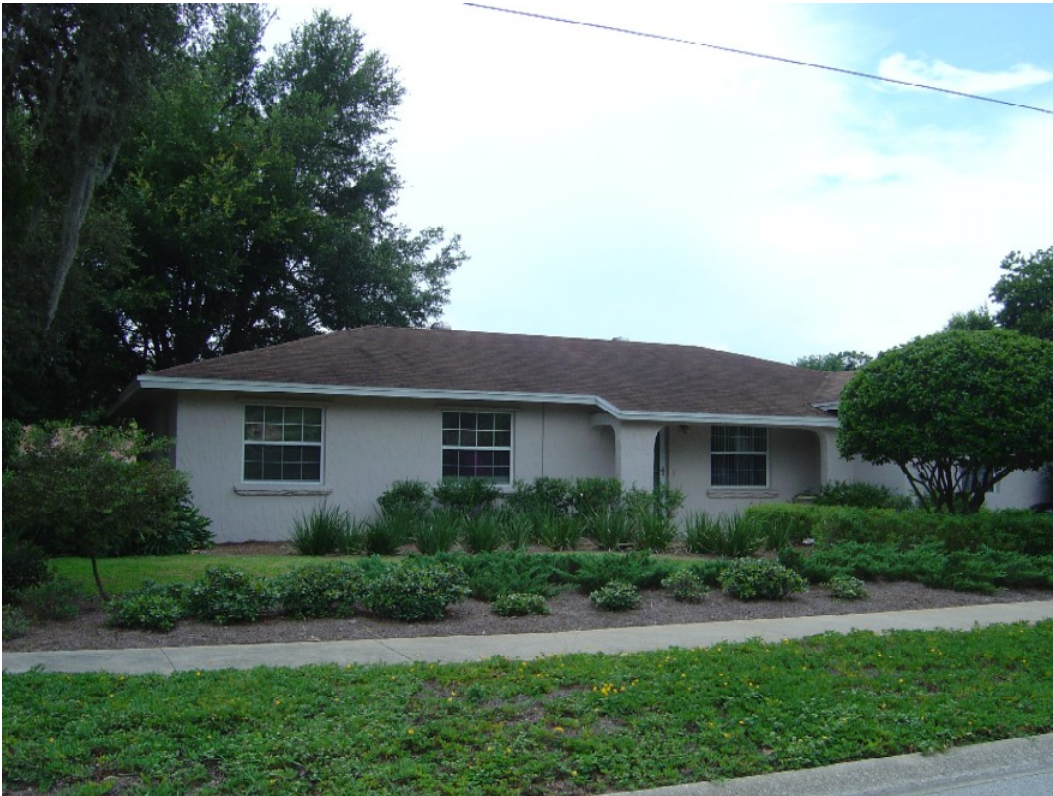
Figure 10. Example cooperator home, Marion County, T3.

Figure 11. Example cooperator home, Lake County, T3.

Figure 12. Example cooperator home, Orange County, T3.

recruitment began and a sufficient number of homes were recruited for both T1 and T2. Uniformity testing of these homes and several T3 homes, which did have well designed irrigation systems, resulted in no uniformity differences between the two groups. It was decided in consultation with SJRWMD staff to adjust the time clocks of T2 cooperators on a seasonal basis to replace 60% of historical ET according to guidelines established by Dukes and Haman (2001). Accordingly, T2 homes consisted of existing irrigation systems and typical landscape plantings similar to T1 (Figs. 7-9). T3 consisted of an irrigation system designed according to specifications for optimal efficiency, including a landscape design that minimized turfgrass and maximized the use of native drought tolerant plants. Ornamental landscape plants were irrigated by microirrigation as opposed to standard spray and rotor heads to achieve further water savings (Figs. 10-12).

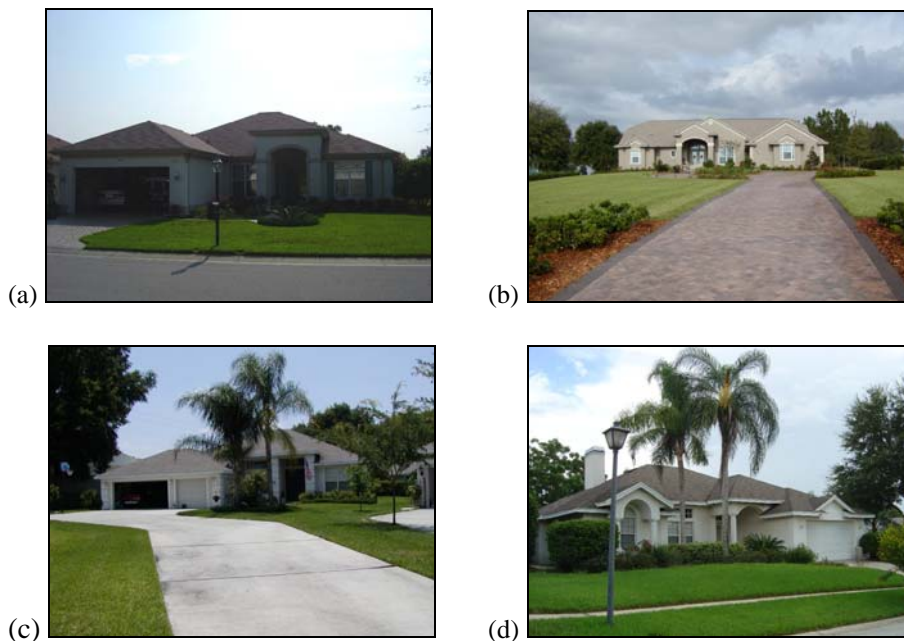
Figure 1. Examples of typical landscapes, where the turfgrass area is greater than the bedded area, T1 and T2.

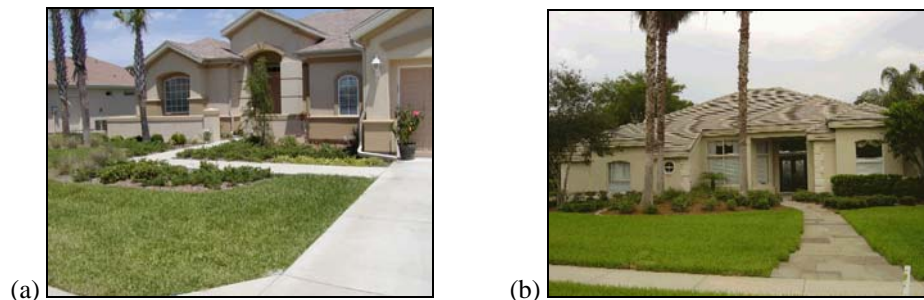
Figure 2. Examples of T3 landscapes, where the turfgrass area was minimized and the bedded area irrigated by microirrigation.

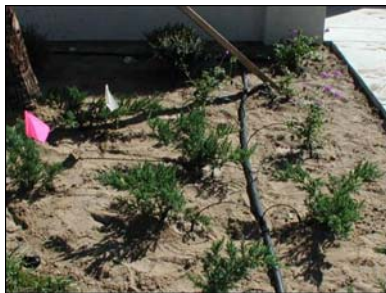
Figure 3. Sample of drip tubing in a plant bed.

The T3 irrigation designs included microirrigation in the bedded areas. Microirrigation components utilized included micro-spray heads and drip tubing. The benefit of microirrigation is the low volume water output, which allows for the irrigated area to be concentrated around the root zone.

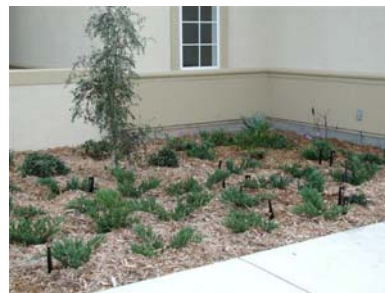
Figure 4. Microspray or microjets
