Special Publication SJ 83-SP1

**ANALYSIS OF SELECTED WATER QUALITY FACTORS
IN THE
UPPER ST. JOHNS RIVER BASIN**

**Report to the
St. Johns River Water Management District, Palatka**

**Department of Environmental Science and Engineering
Florida Institute of Technology
Melbourne, Florida 32901**

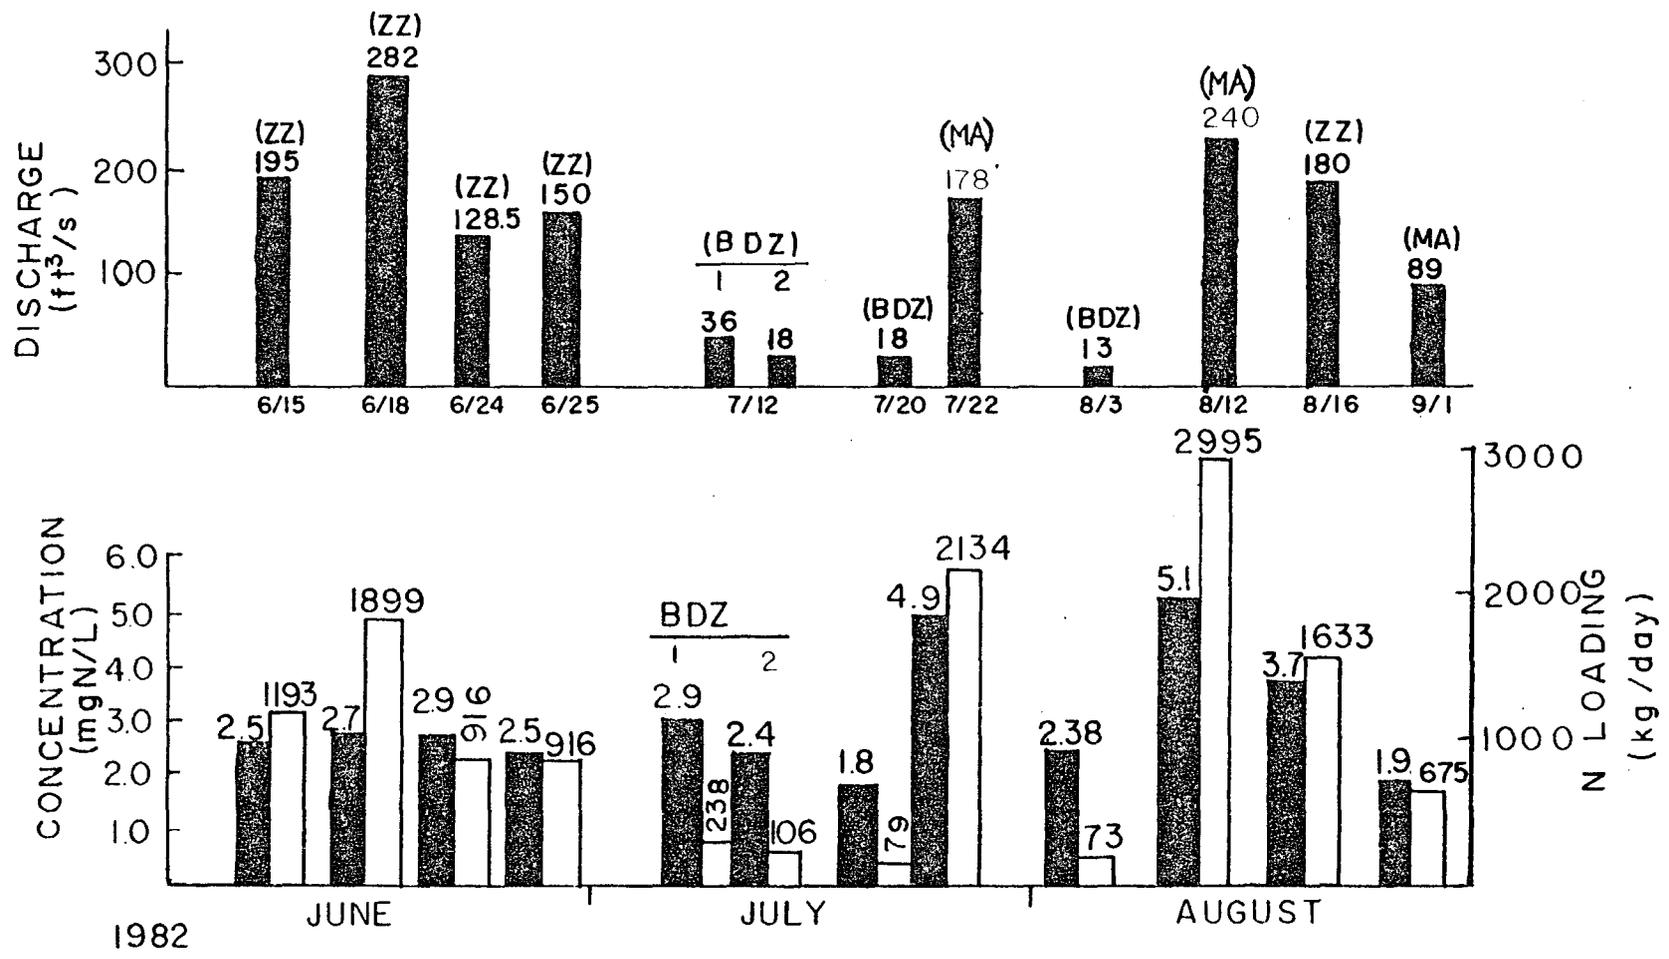
Fig. 23. Discharge and total nitrogen concentrations (■) and loading (□) from Zigzag Canal (Z.Z), Mary A Canal (M.S.) and Bulldozer Canal (BDZ) agricultural pumps.

Thirteen pump events were monitored during this study, in addition to periodic background sampling. Pump discharge rates and total nitrogen and total phosphorus concentrations and loading rates are presented in Tables 5 and 6 and Figure 23 and 24. The thirteen pump events were collectively analyzed in numerous ways to determine statistical relationships. Water quality parameters were regressed against rainfall and discharge, as well as against each other. Very significant relationships were found between discharge and ammonia ($r = .95$; $p < .01$), but no other significant relationships were found.

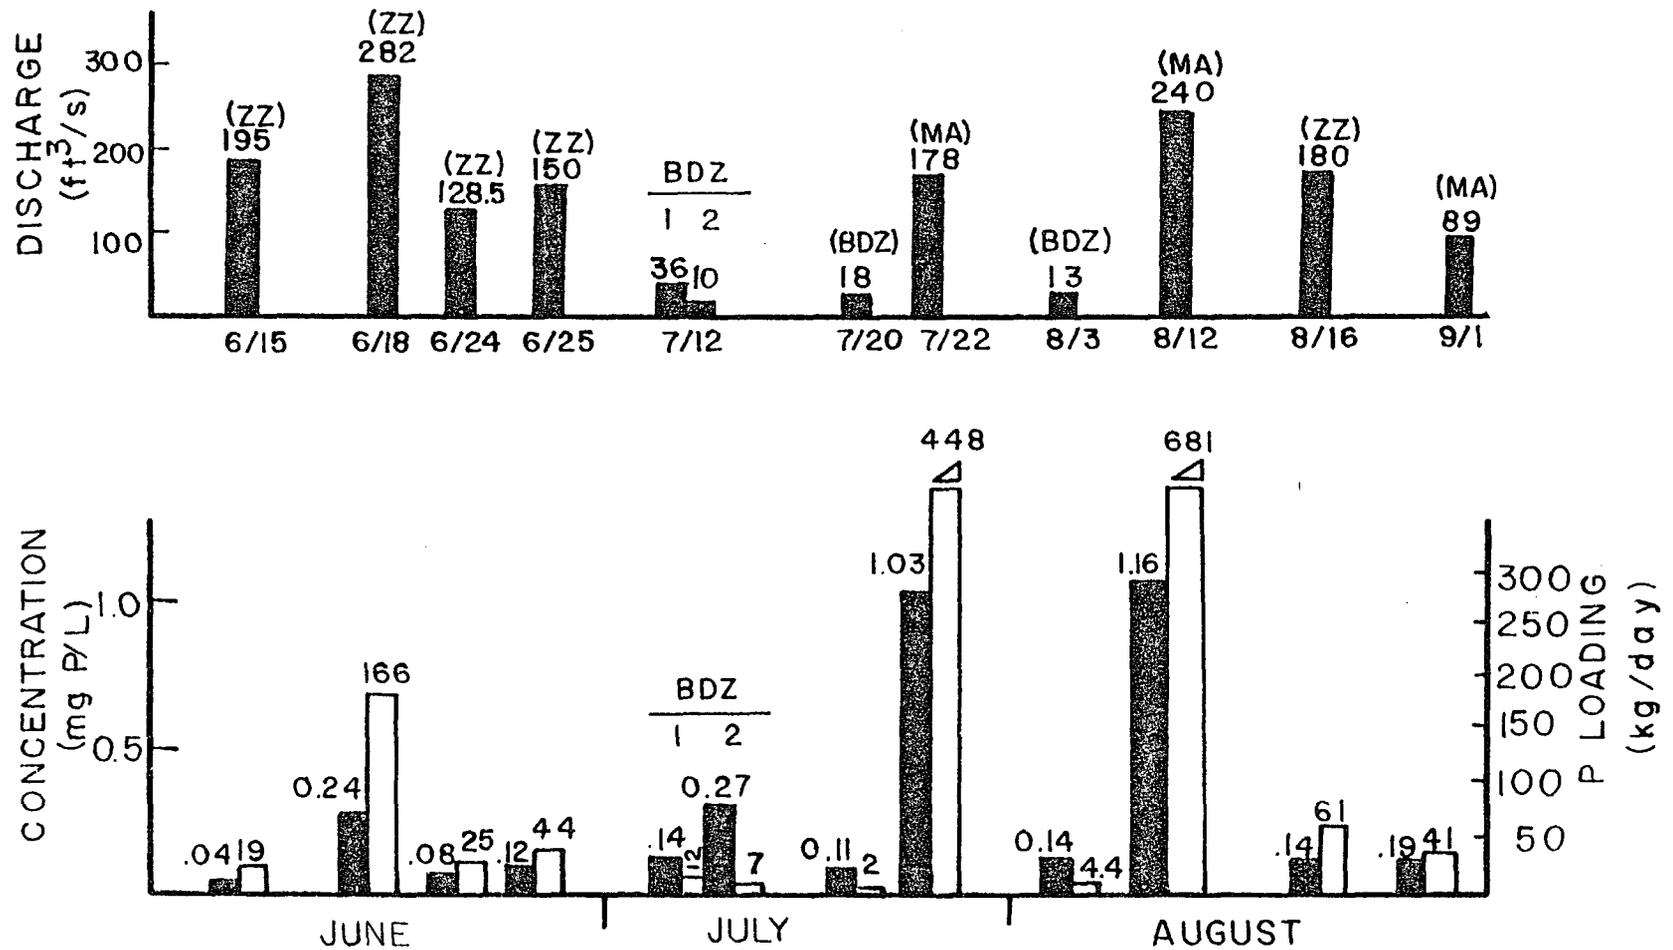
Fig. 24. Discharge and total phosphorus concentrations (■) and loading (□) from the Zigzag Canal (Z.Z.), Mary A Canal (M.A.) and Bulldozer Canal (BDZ) agricultural pumps.

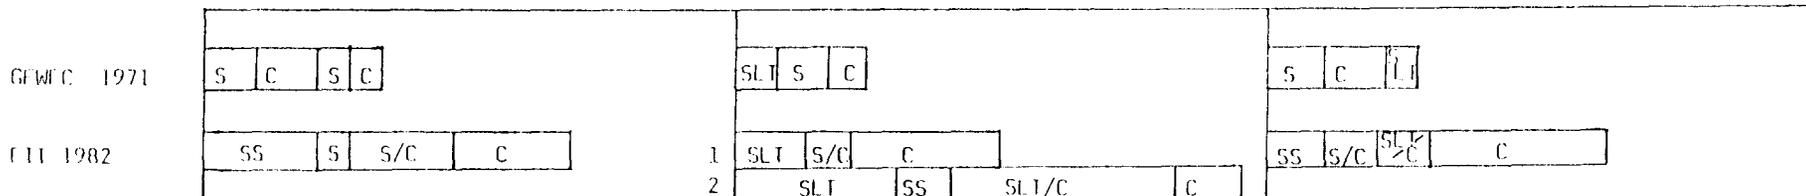
KEY: USPD = Unconsolidated silt and plant detritus S = Sand (1) = Clay found at 38"
 PD = Plant detritus SLT/C = Silt and clay [] = Depth of strata
 SLT = Silt C = Clay [] = Did not reach hardpan
 S/PD = Sand and plant detritus SS = Silty sand
 S/C = Sand and clay

FIGURE 25. West bank, Center and East Bank cores in lakes Hellen Blazes, Sawgrass and Washington

Core data indicate all the lakes generally have a layer of fine organic matter on the sediment surface with layers of sand and clay beneath the surface at various depths. The U.S. Fish and Wildlife Service (1951) described the sediments of Lake Washington as "hard sand and silty mud". We found that the lake is characterized by large amounts of fine organic matter on the surface (more than the other lakes), underlain by clay and some sand. We frequently encountered clay in Lake Washington at lower core depths. The sediment at the inlet to Lake Washington is primarily comprised of sand. Lakes Sawgrass and Hellen Blazes have very shallow layers of fine organic matter on the surface, but these southern lakes in the chain exhibited more fibrous or woody organic matter beneath the fine layer than other

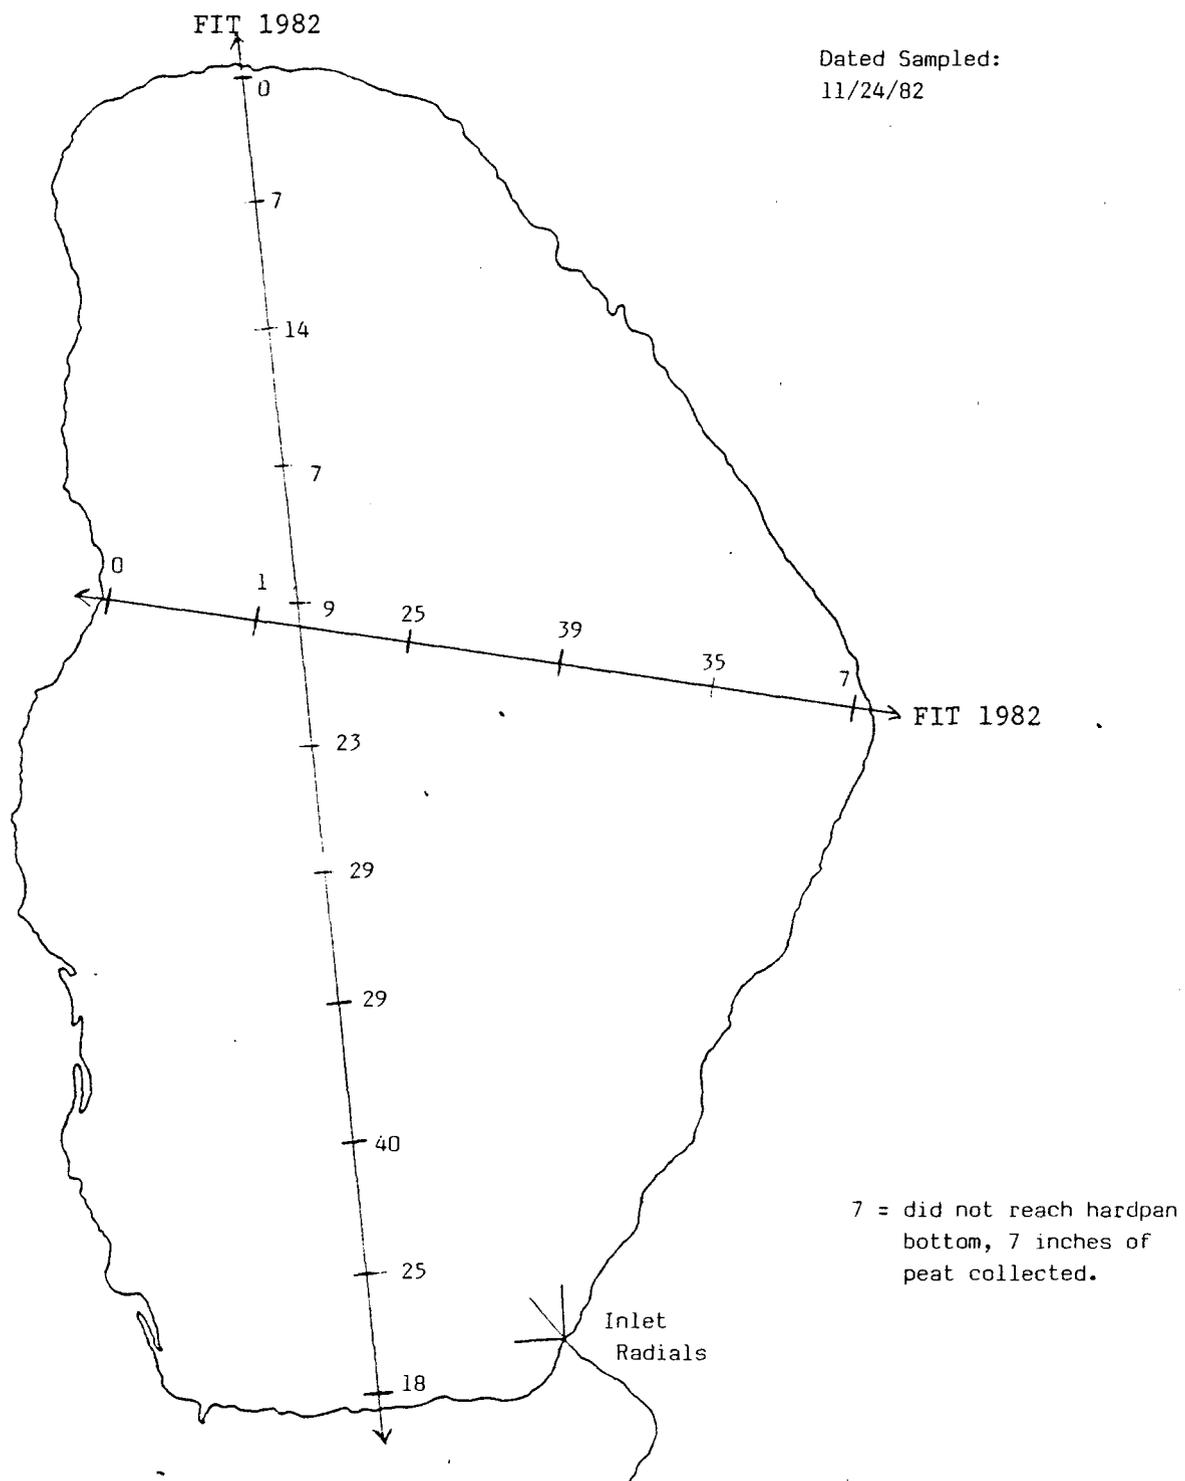
Fig. 28. Depth of organic sediment in Blue Cypress Lake (inches).

Blue Cypress, which is considered separately, had the greatest depth of organic matter of any lake, averaging 17.7 inches for the 17 longitudinal and transverse cores. Most of this organic matter appeared to be well decomposed material of algal origin. More peat was encountered in this lake than the others. In fact, all of the radial cores had a loose peat bottom, and sand or clay levels were never found.

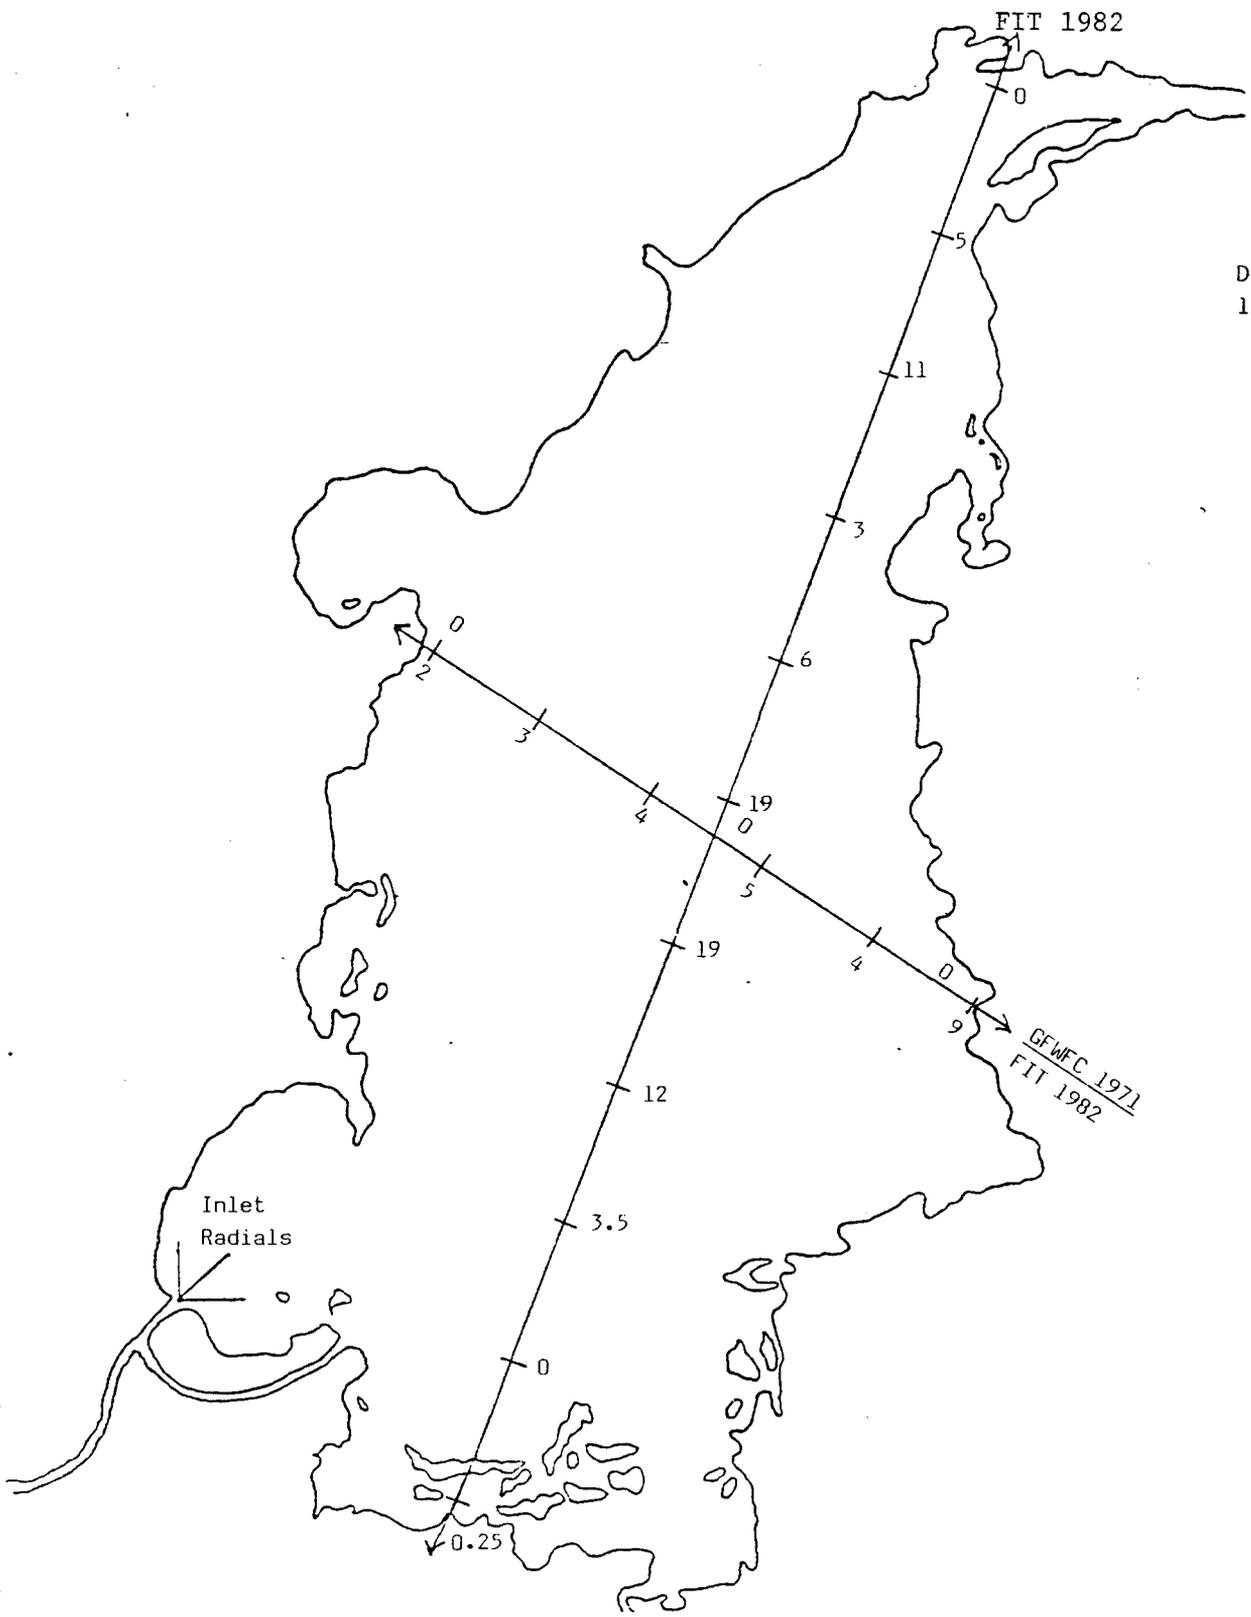
Fig. 33. Depth of organic sediment in Lake Poinsett (inches).

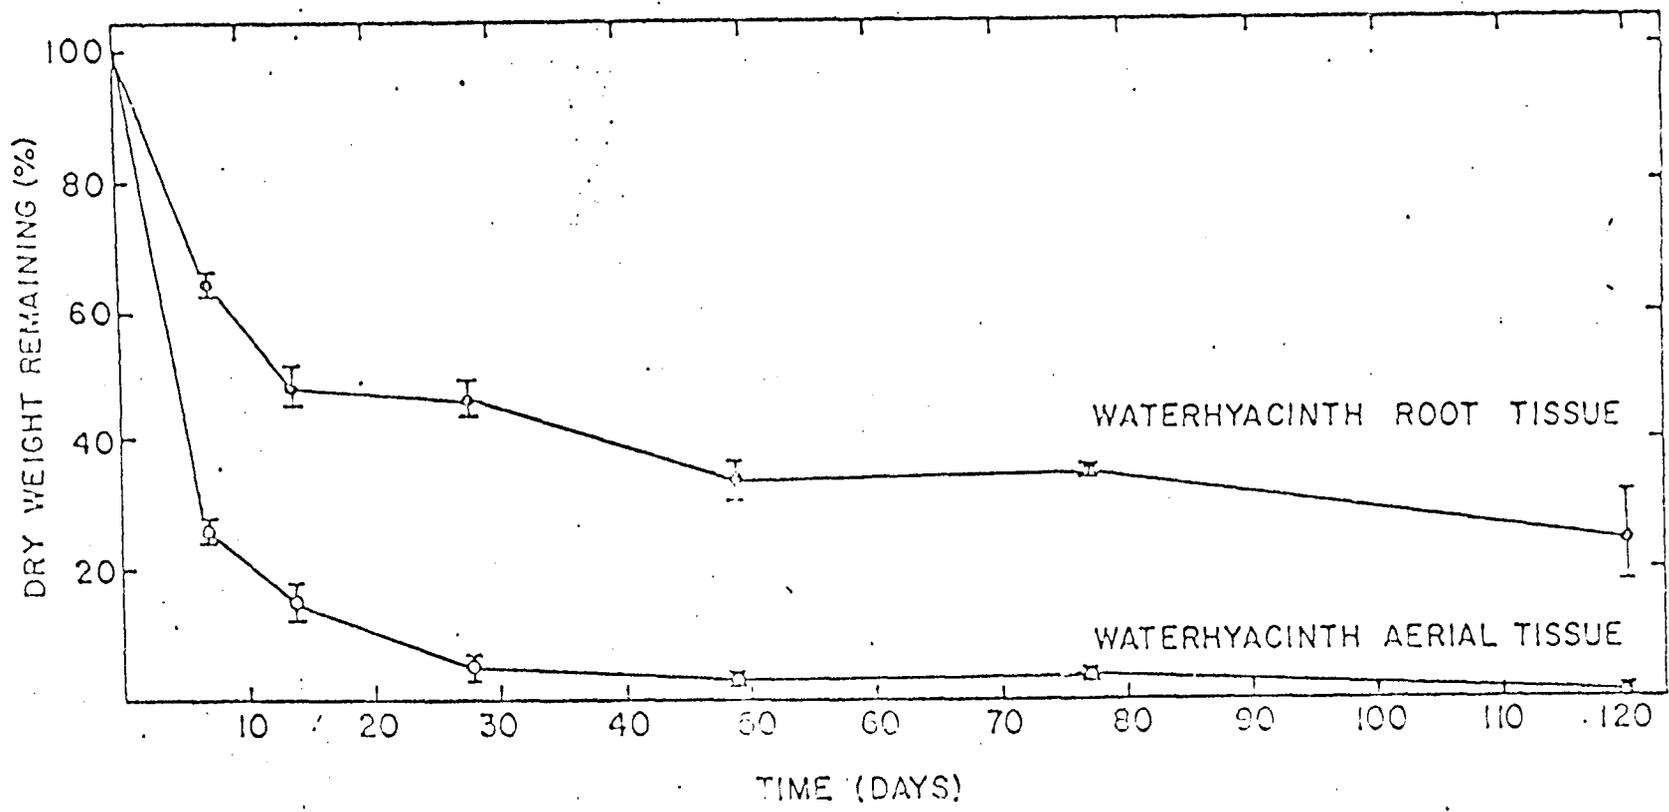
Fig. 34. Dry weight loss of waterhyacinth aerial and root tissues during decomposition at the Pompano Beach sewage lagoon from June 17 - October 14, 1982. Points and bars represent $\bar{x} \pm 1$ S-E., n = 4. (From Debusk, 1983).

Waterhyacinth aerial tissues submerged at the sewage lagoon decomposed more rapidly than roots (Fig. 34). The dry weight loss of aerial tissue in the first seven days was equal to ($p < .05$) the loss of root tissue during the entire 120 day incubation period. Also, decomposition of aerial and root tissues in the nitrogen rich wastewater facility were much greater than corresponding rates in the low nitrogen Lake Washington site. Aerial tissues comprised 88% of the standing crop biomass of plants collected at the Pompano Beach sewage lagoon and only 68% of the standing crop biomass of plants obtained from Lake Washington, where roots are more important to the total biomass.

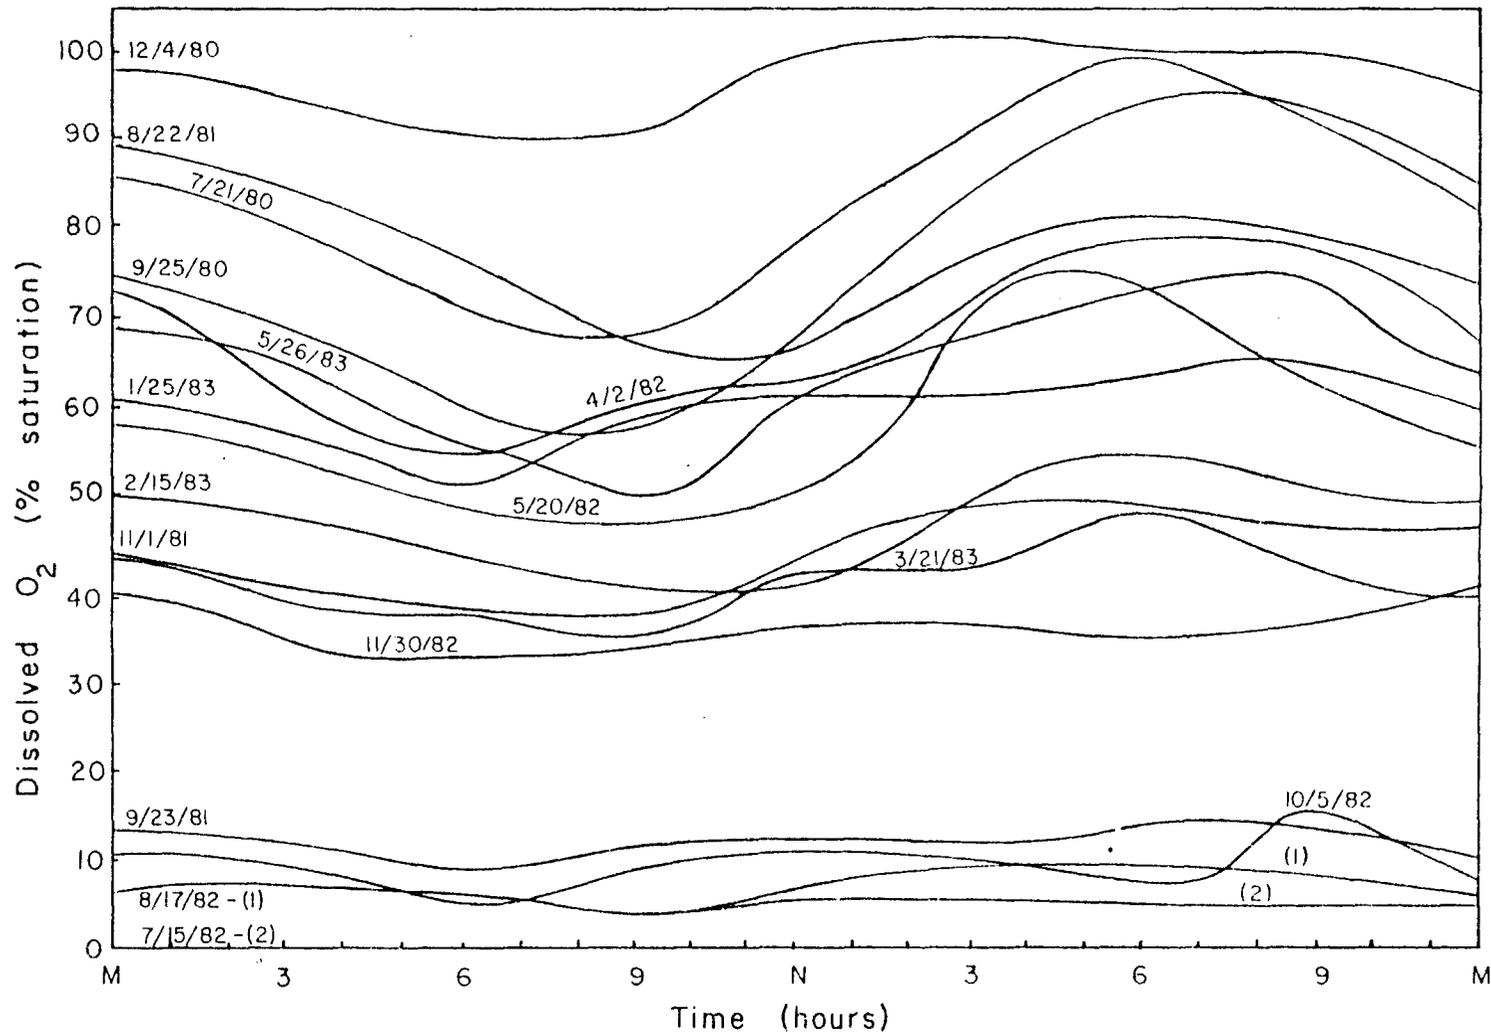
Figure 35. Diurnal oxygen curves (percent saturation) at Camp Holly, near the entrance to Lake Washington.

Sixteen diurnal oxygen curves (percent saturation) were constructed from 24 hours diurnal oxygen measurements made at the entrance to Lake Washington at U.S. 192. These data show very little fluctuation of oxygen in the system. Color, total iron, ferrous iron, and solar radiation data were collected during the diurnal sampling and it was found that low percent saturation curves correlate positively with high color and

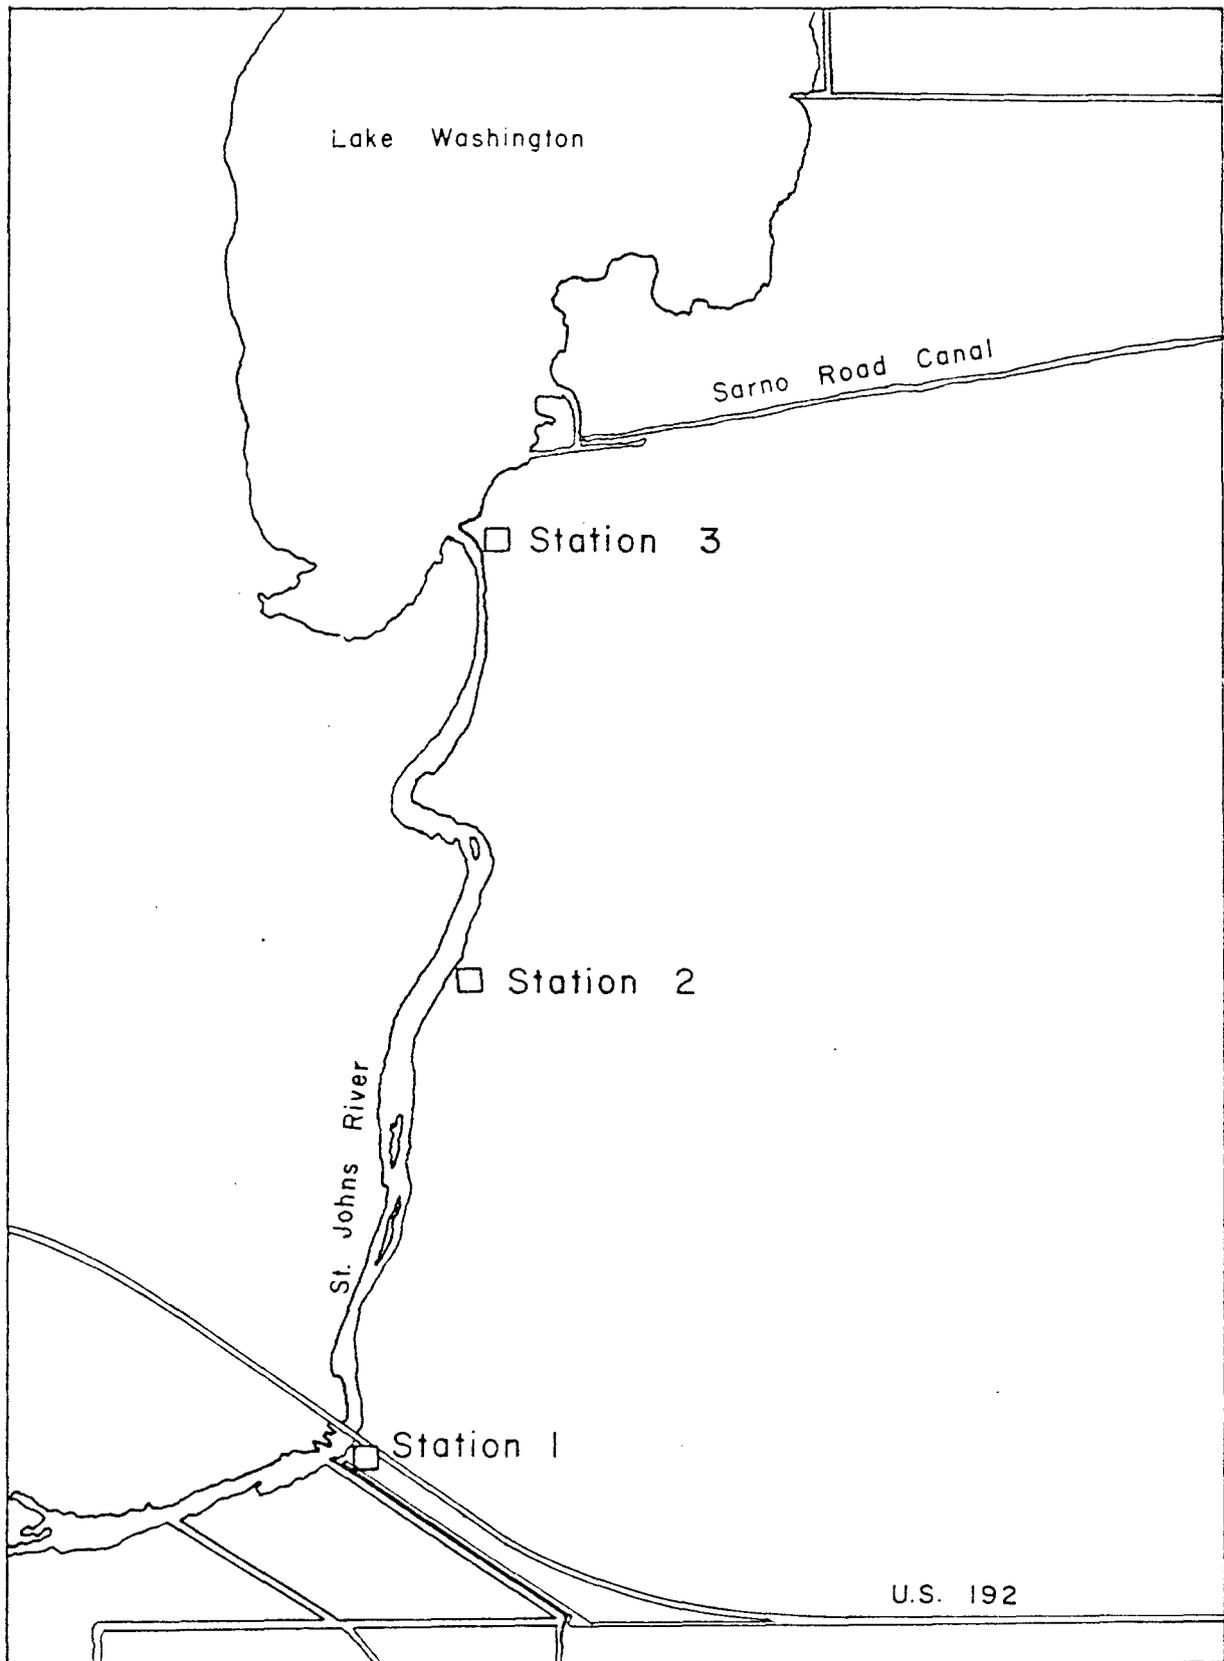
Figure 36 . Oxygen metabolism measurement stations.

7. Two station method; station 2 - 3, (Figure 36).

8. Two station method; station 1 - 3, (Figure 36).
