TECHNICAL PUBLICATION SJ 85-4

BURRELL DAM SAFETY EVALUATION

Wayne Ingram
Engineer

May 1985

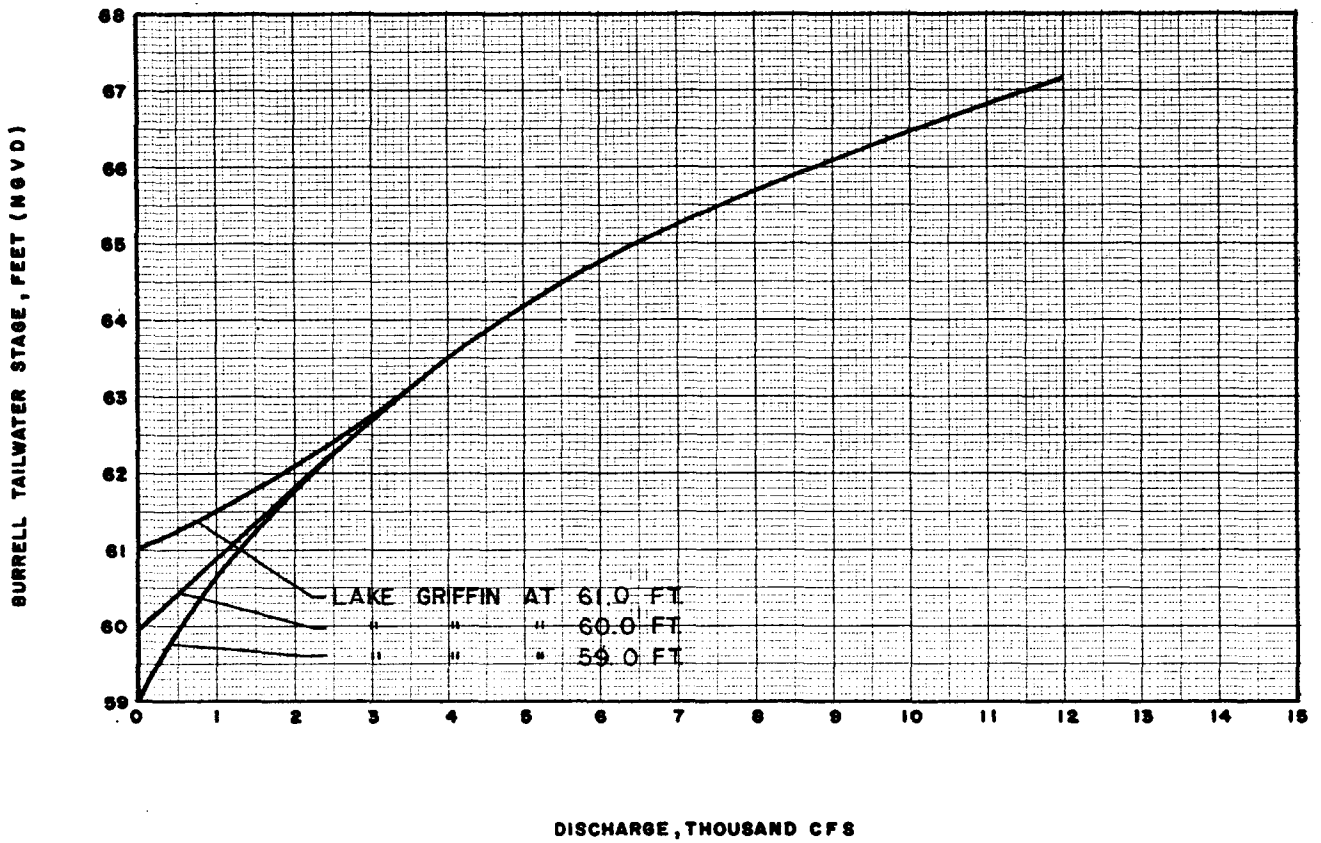
FIGURE 10b Haines Creek Rating Curve Below Dam

Figure 10b is a set of rating curves for Burrell tailwater, each curve corresponding to a given Lake Griffin stage. It is observed that for Lake Griffin stages below 61.0 feet and discharges greater than about 2,000 cfs, the Burrell tailwater is independent of Lake Griffin stage. In event of a failure of Burrell Dam the tailwater stages would therefore be expected to be independent of Lake Griffin stage, at least in the early hours following the failure. The hazard associated with a failure of the dam is primarily related to the rate of increase in water levels. The most critical condition then would exist when Lake Griffin stages were low prior to failure. This would result in a larger change in water level over the same time period. (An argument might also be made that the failure period would be shorter in this case due to a larger initial water drop across the dam.) A Lake Griffin stage of 60.0 feet was assumed for this

study. It is extremely unlikely that the combination of wet antecedent hydrologic conditions and a PMP event centered over the Haines Creek Chain of Lakes would coincide with Lake Griffin stages lower than 60.0 feet, or approximately a 5-year flood stage (7).

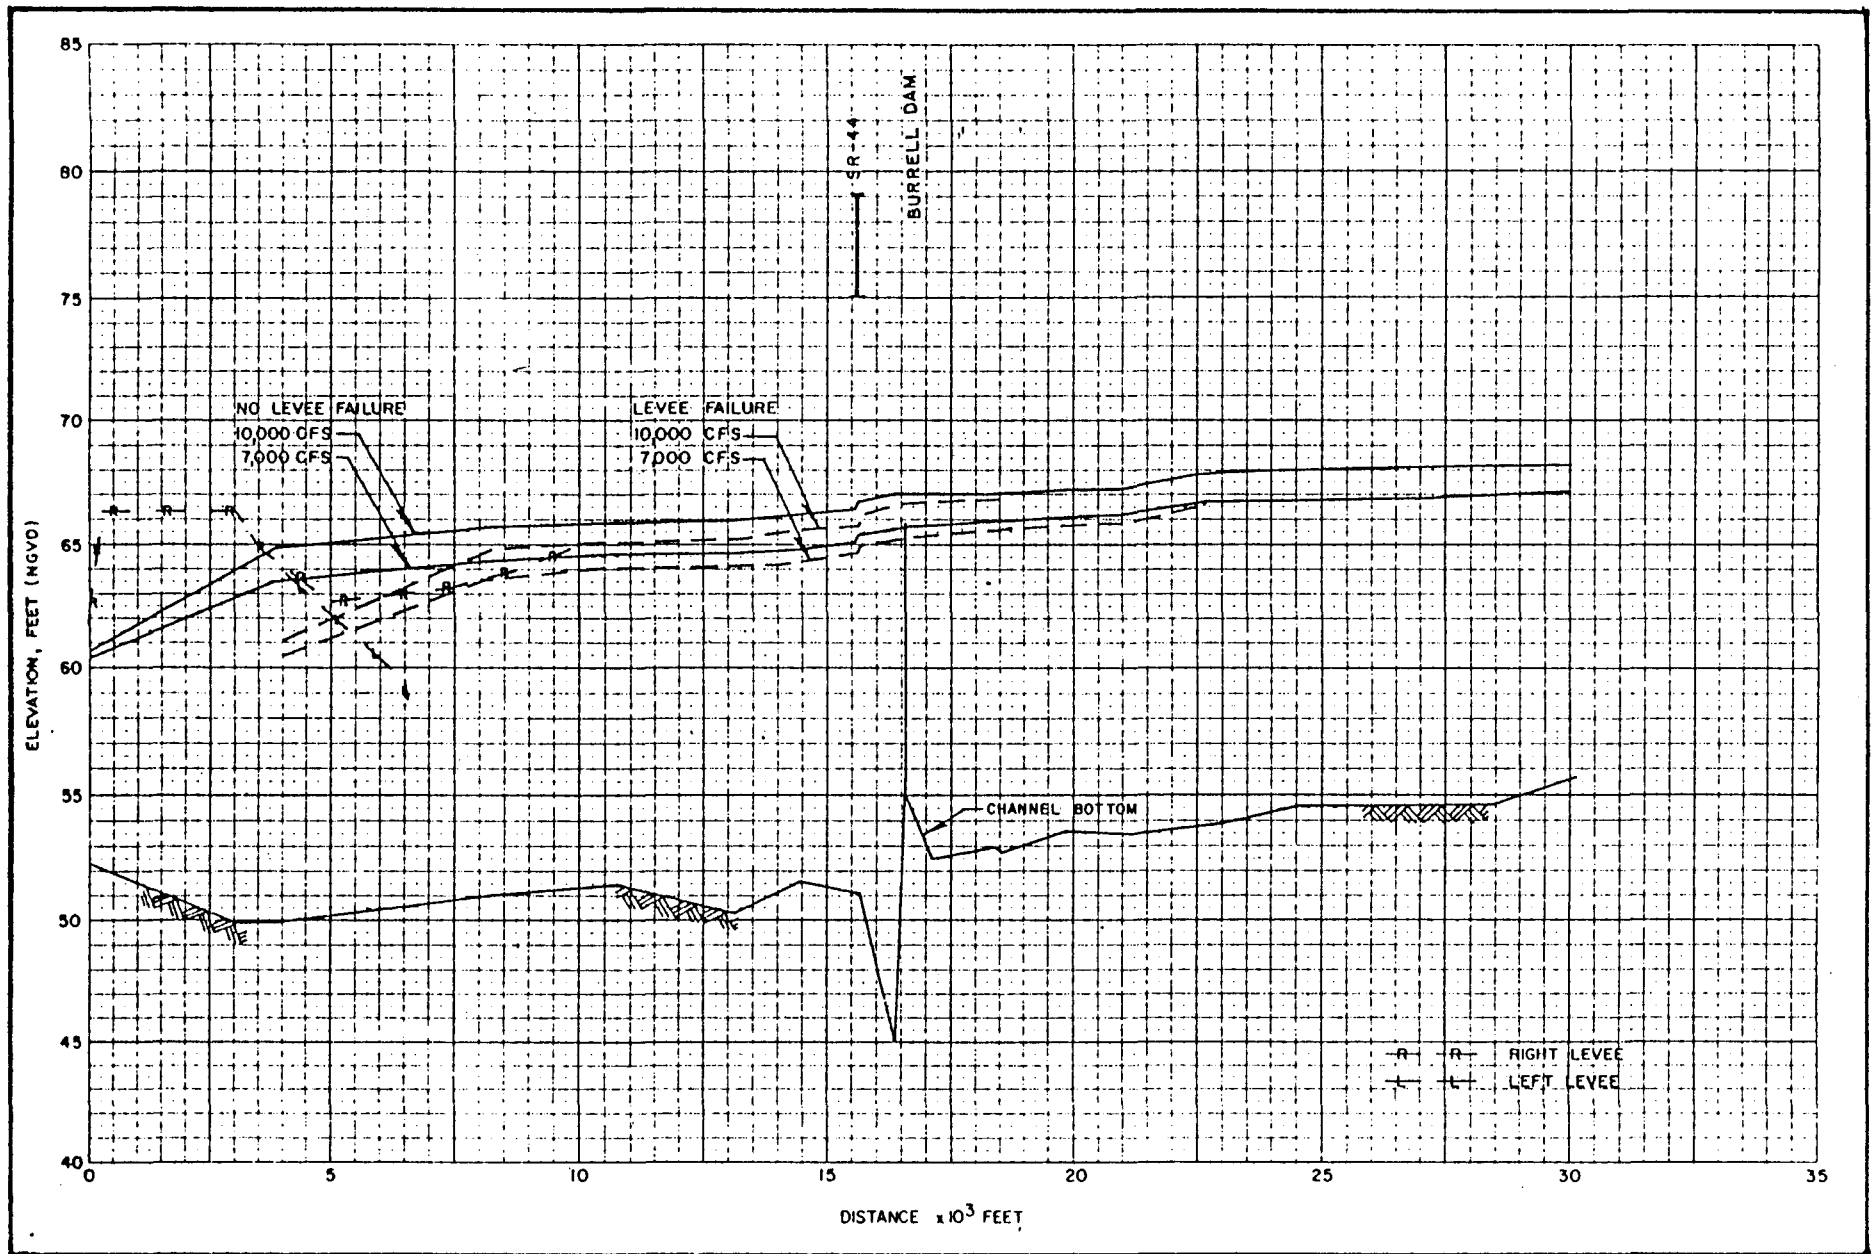
FIGURE 12

Haines Creek Water Surface Profiles with
Downstream Levee Failure

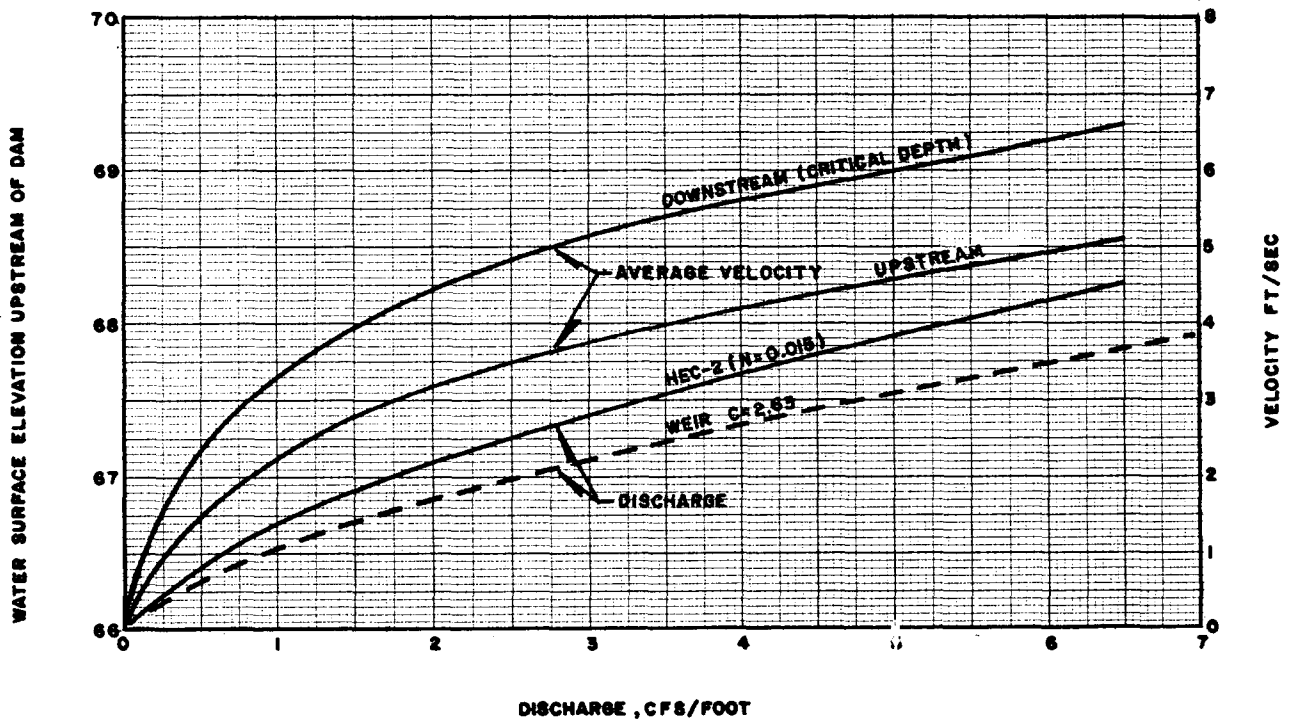
FIGURE 13 Dam Crest Rating Curve

Figure 13 shows discharge rate per foot of dam width as a function of head at the dam. This relation is based on water surface profile analysis using Mannings equation with $n=0.015$ (a conservatively low value) and assuming critical depth at the downstream edge of the 50 feet wide dam crest. A weir flow curve is also given with a broad crested weir coefficient of 2.63 (1). This comparison indicates that as long as the dam remains intact, the weir flow equation with a typical coefficient over predicts the discharge.

Average flow velocities as a function of flow are also given on Figure 13. The downstream velocities are for critical depth

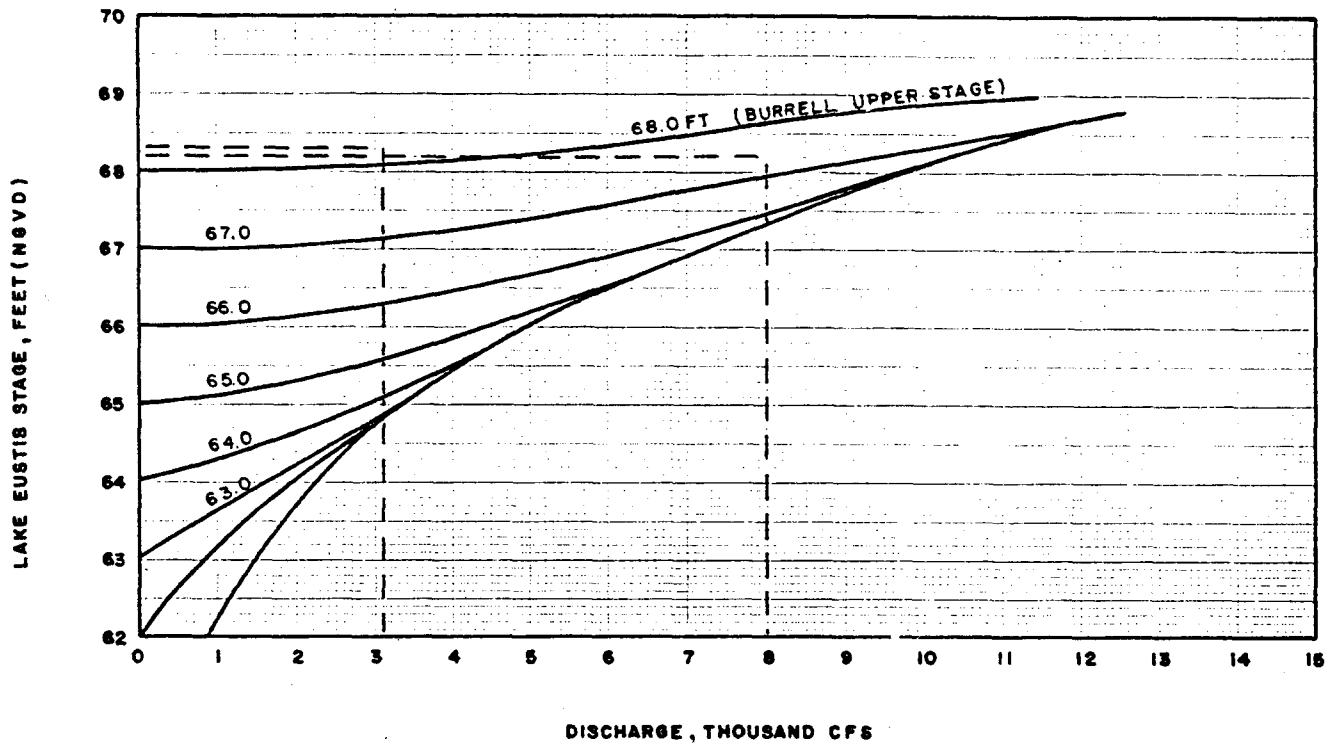
Figure 17a Haines Creek Rating Curves, Below Dam

Using these peak stage data, the peak flow below Burrell Dam can be estimated. Figures 17a and 17b are the same as Figures 10a and 10b except that two headwater rating curves have been added - one for flow over the dam without failure and one for steady flow with a 50 feet wide breach. For the PMF case with a Burrell upstream stage of 68.3 feet and a 50 feet wide breach the flow would be 9500 cfs. The stage immediately upstream of Burrell, however, would not be at 68.3 feet when Lake Eustis is at 68.3 feet due to the water level drop in the 2.5 miles of Upper Haines Creek. By trial and error use of Figures 17a and 17b it is found that the steady flow with Lake Eustis at 68.3 feet would be about 8000 cfs with the Burrell headwater stage of 67.3 feet. The tailwater stage would be 65.7 feet. A similar method is used to find that the discharge immediately before

failure is 3100 cfs with a headwater stage of 68.2 feet and a tailwater stage of 62.8 feet. The increase in discharge due to the failure is therefore 4900 cfs and the increase in tailwater stage is 2.9 feet. Table 6 summarizes the before and after failure conditions for given cases.
