# LEVY LAKE

*Flood Attenuation/  
Wetland Restoration Plan*

**LEVY LAKE**  
**Flood Attenuation/Wetland Restoration Plan**

February 2001

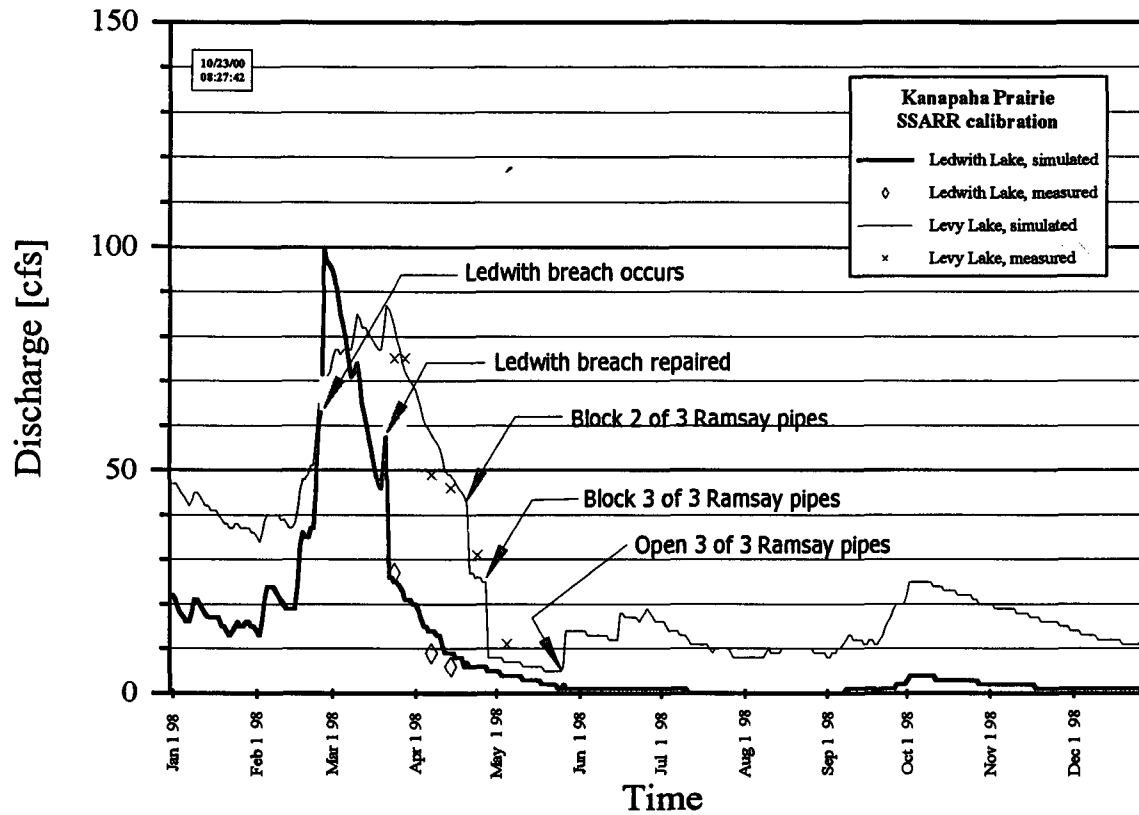
Figure 4

Discharge hydrographs for Kanapaha Prairie SSARR model re-calibration for 1998

The new data covered the period of time between about 15 May 1998 and 31 July 1999. This new data consisted of rainfall monitored at the Lake Wauberg site, Kanapaha Prairie gage data, and Levy Lake gage data. This new data improves the performance of the model at elevations below about 55 ft for Kanapaha Prairie and about 62 ft for Levy Lake (Figures 1 through 4).

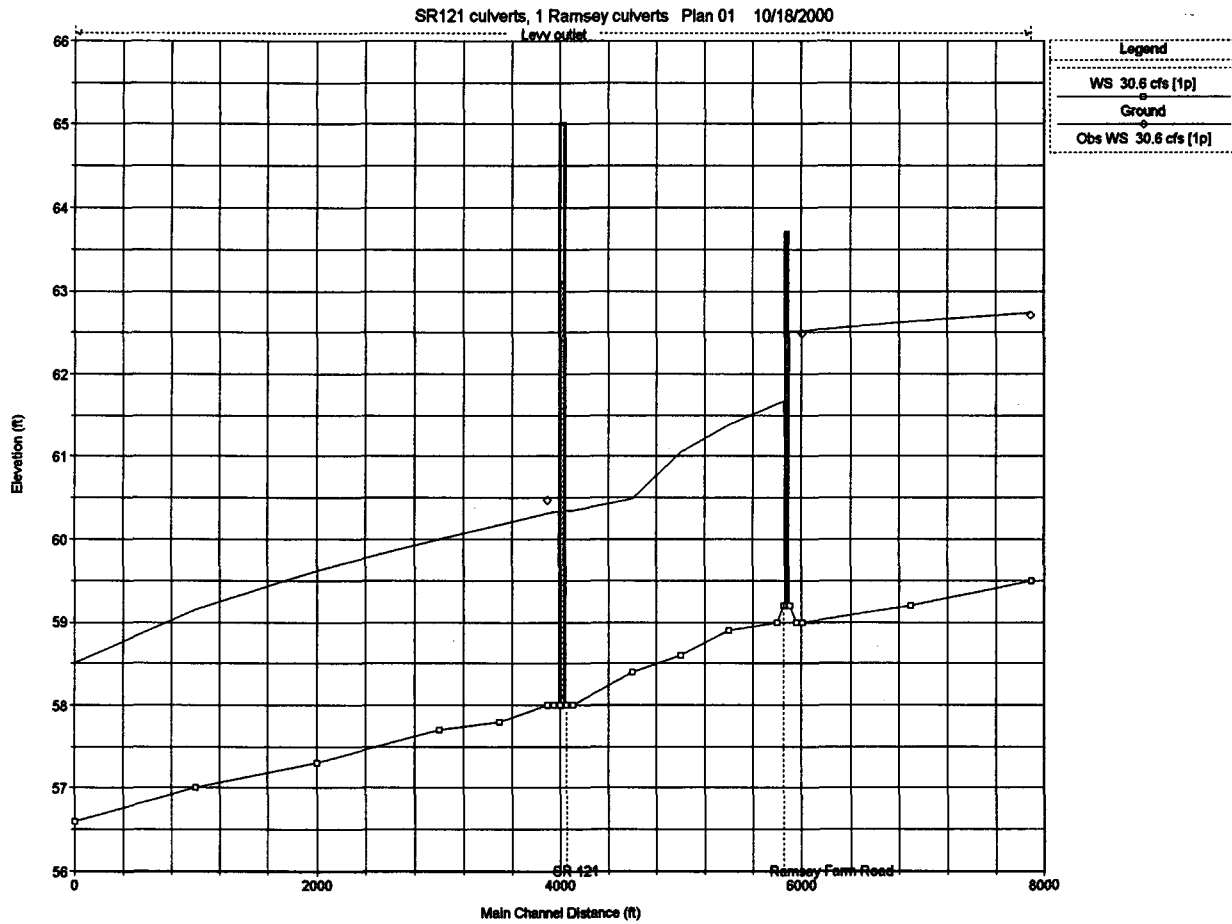
**Figure 7 Results of Ramsey Road HEC-RAS model calibration [2 of 3 pipes blocked off]**

Using the cross sections and  $n$ -values developed for the three-culvert configuration, the configuration for three blocked culverts was calibrated (Figure 6) with discharges measured on a single date. The seepage around the blockage was accounted for by replacing all three 42-inch CMPs with three 1.4-foot CMPs. Finally, using the same configuration but replacing one 1.4-foot CMP with a 42-inch CMP, the HEC–RAS model was essentially verified (Figure 7) with discharges measured on a single date.

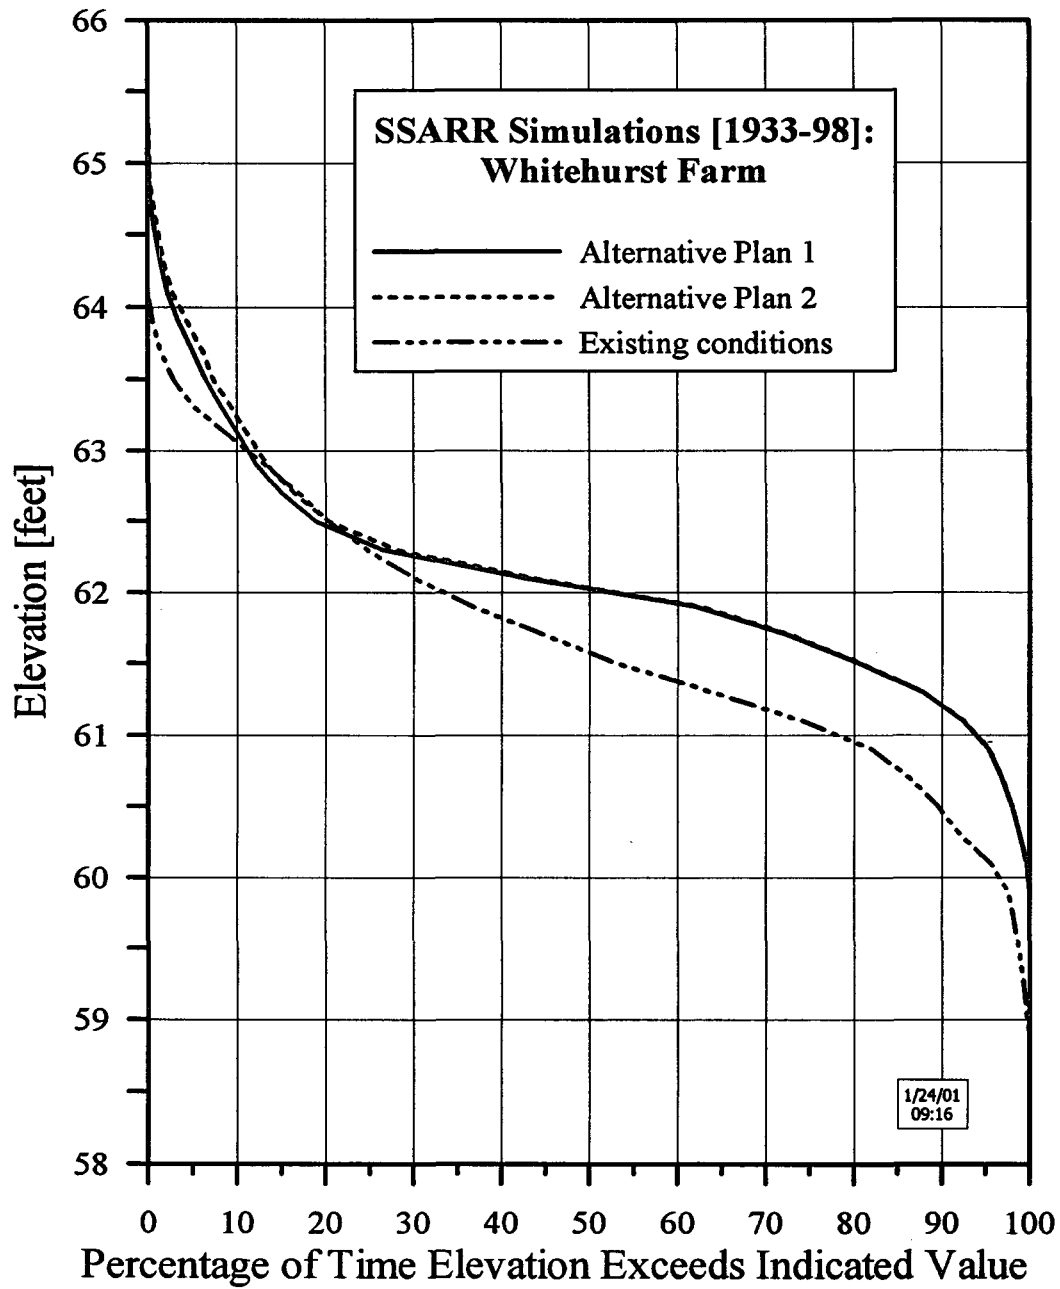
**Figure 10** Elevation duration curves for SSARR simulation of Whitehurst farm

Elevation duration curves provide information with respect to the hydroperiods of bodies of water. Figures 10 and 11 show elevation duration curves corresponding to the three alternatives for Whitehurst farm and Levy Lake, respectively.

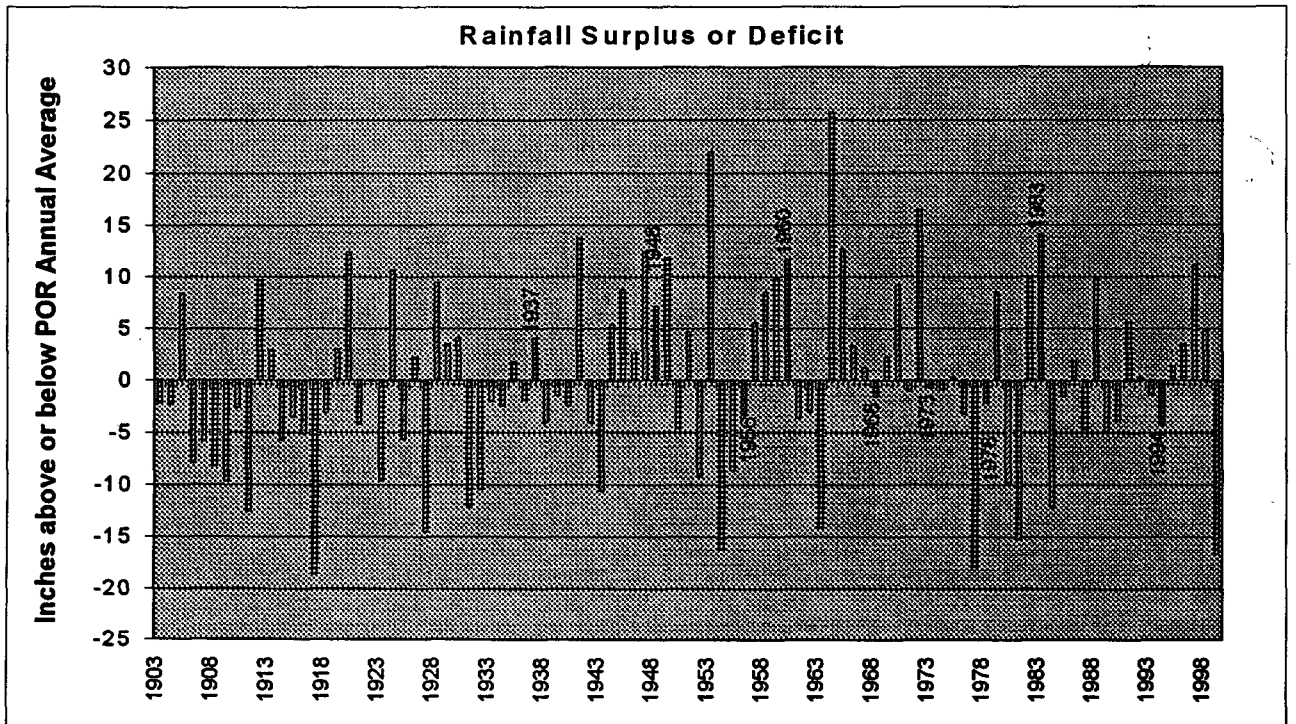
**FIGURE 2. Annual Rainfall Surplus or Deficit from POR Average Annual and Representative Water Year Dates of Imagery**

The hydrologic conditions for the dates of photography are illustrated in Figures 1 and 2 and described below.

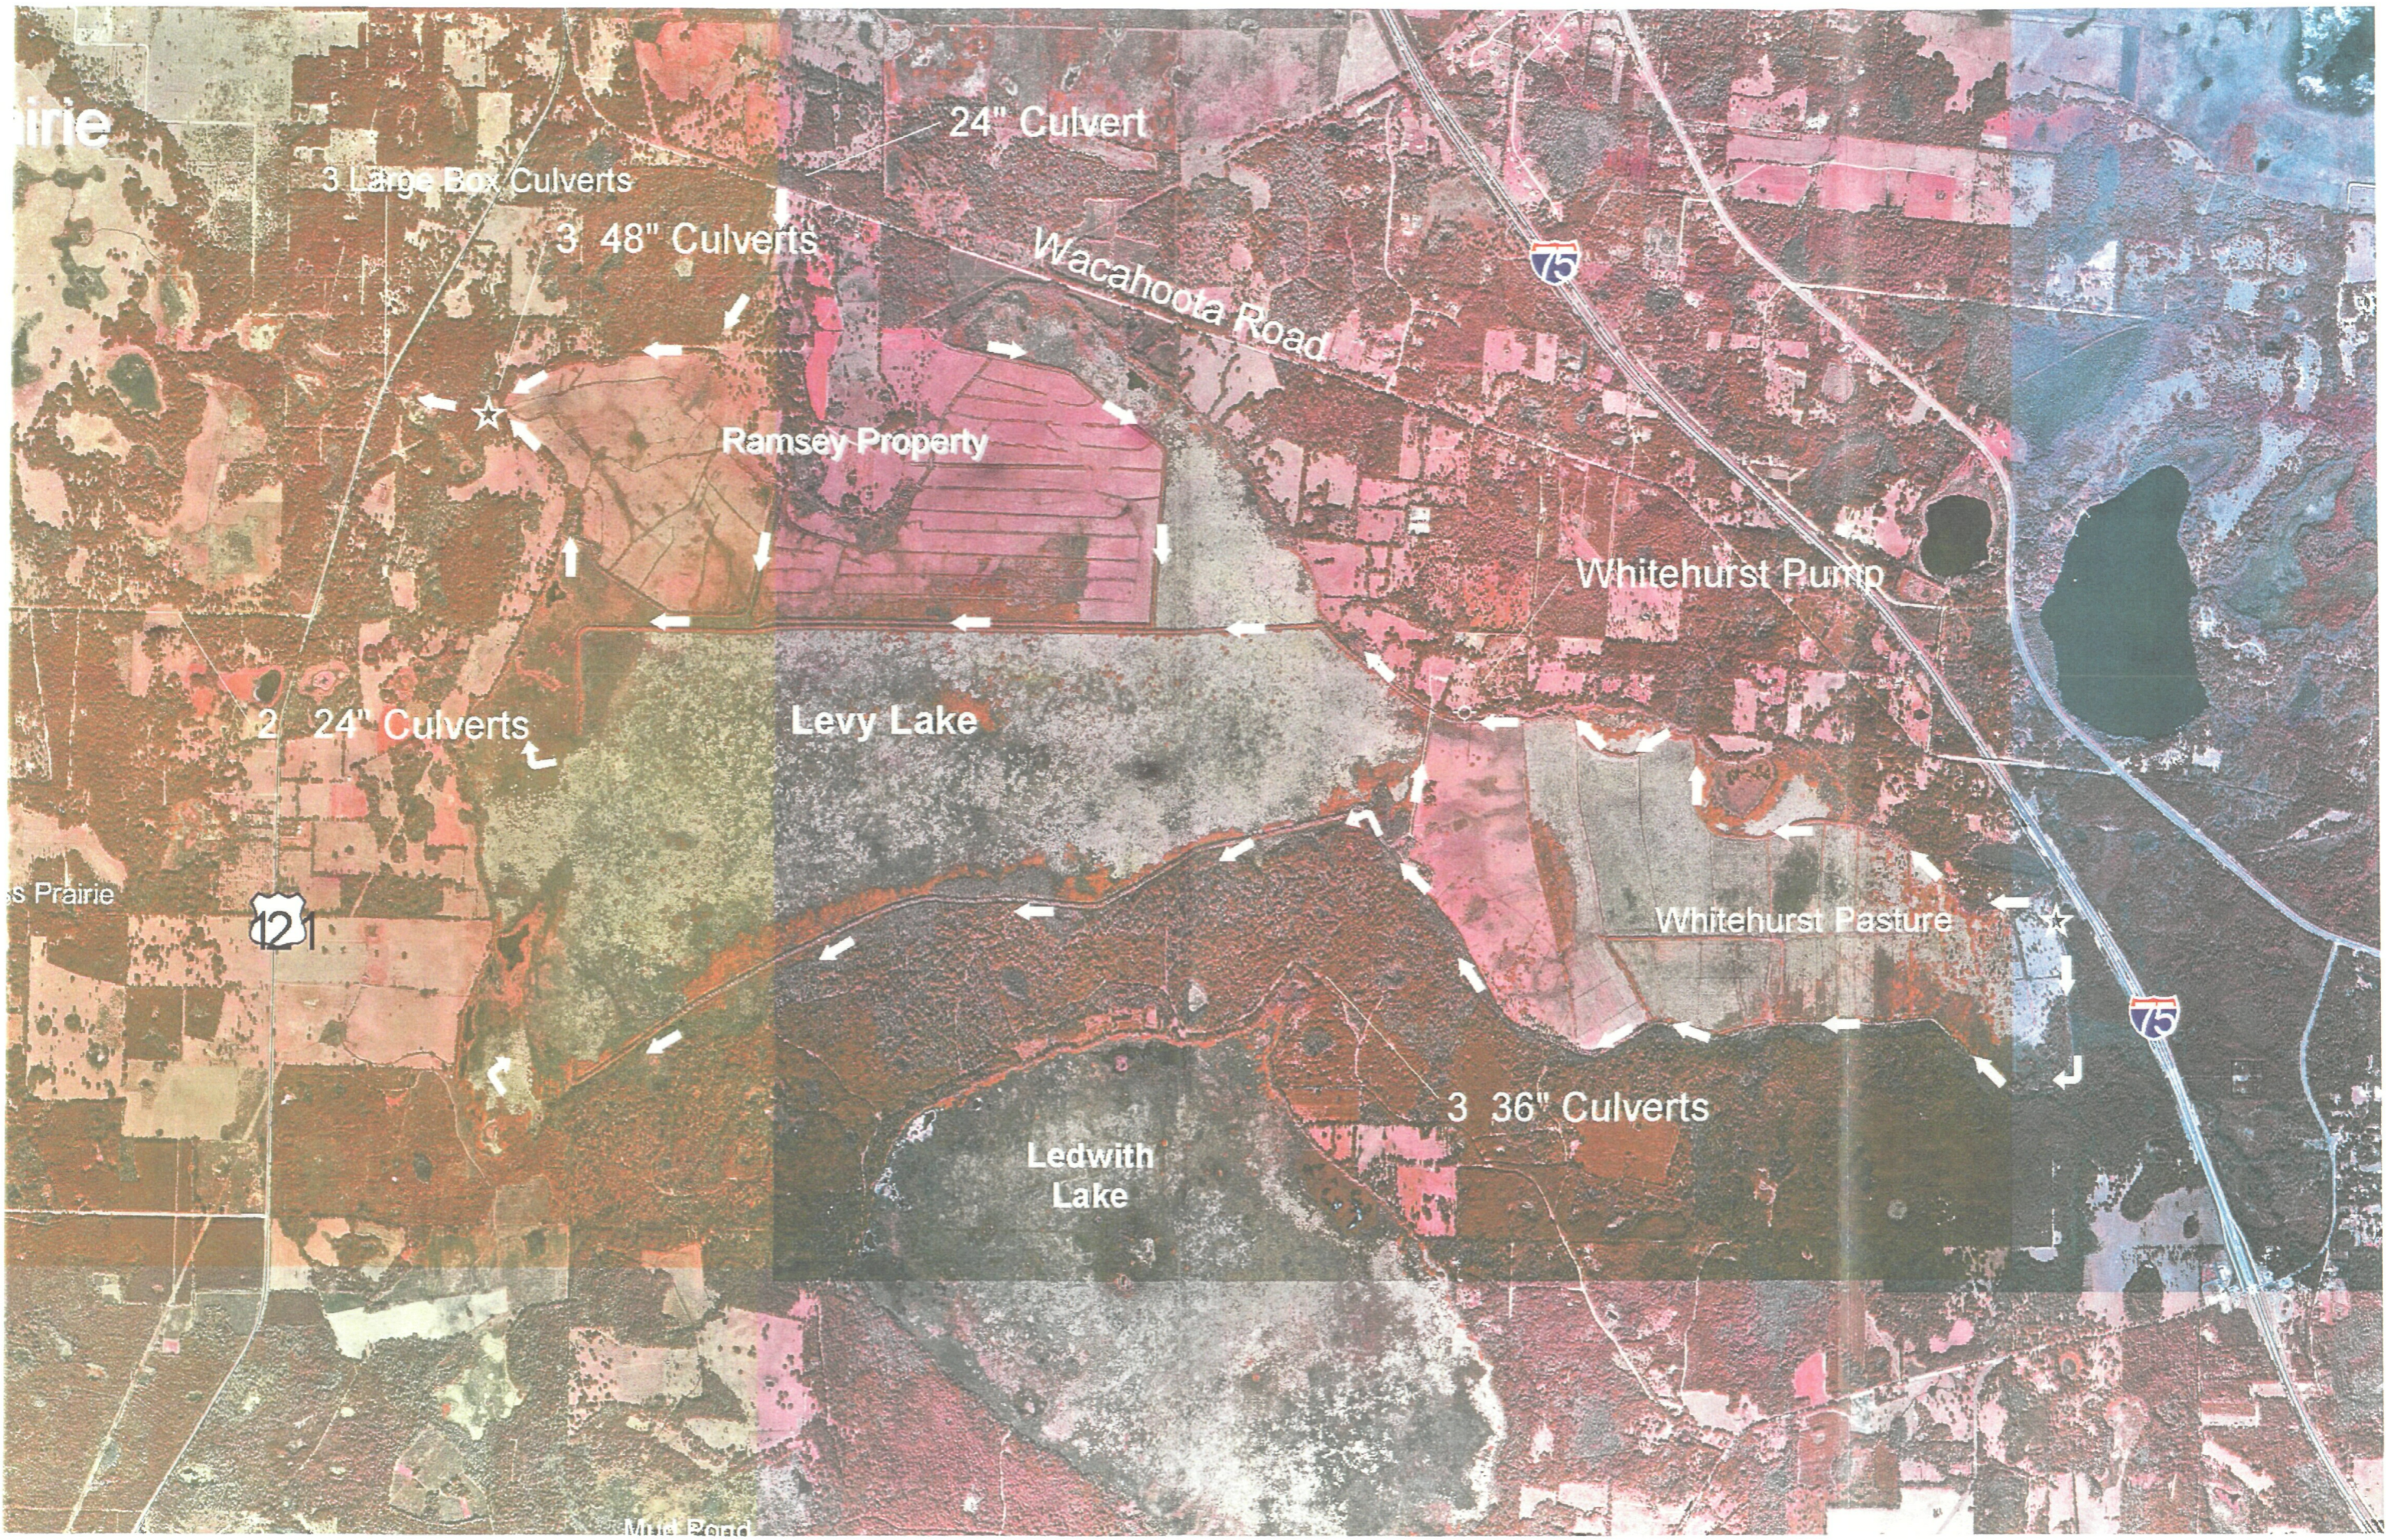
## **Appendix II-D Existing flow patterns along the Levy System**

Wetland and water level assessments were conducted in the field on April 27, July 25 and November 20, 2000 and the results are provided in field memorandum in Appendix II-C. A map showing the flow patterns along the Levy (dike/ditch) system around Whitehurst Pasture and Levy Lake under the field conditions is provided in Appendix II-D.
