**SPECIAL PUBLICATION SJ2008-SP7**

**SUBMERGED SPRINGS SITE DOCUMENTATION:  
AUGUST AND SEPTEMBER 2007**

# **Submerged Springs Site Documentation: August and September 2007**

## **St. Johns River Water Management District**

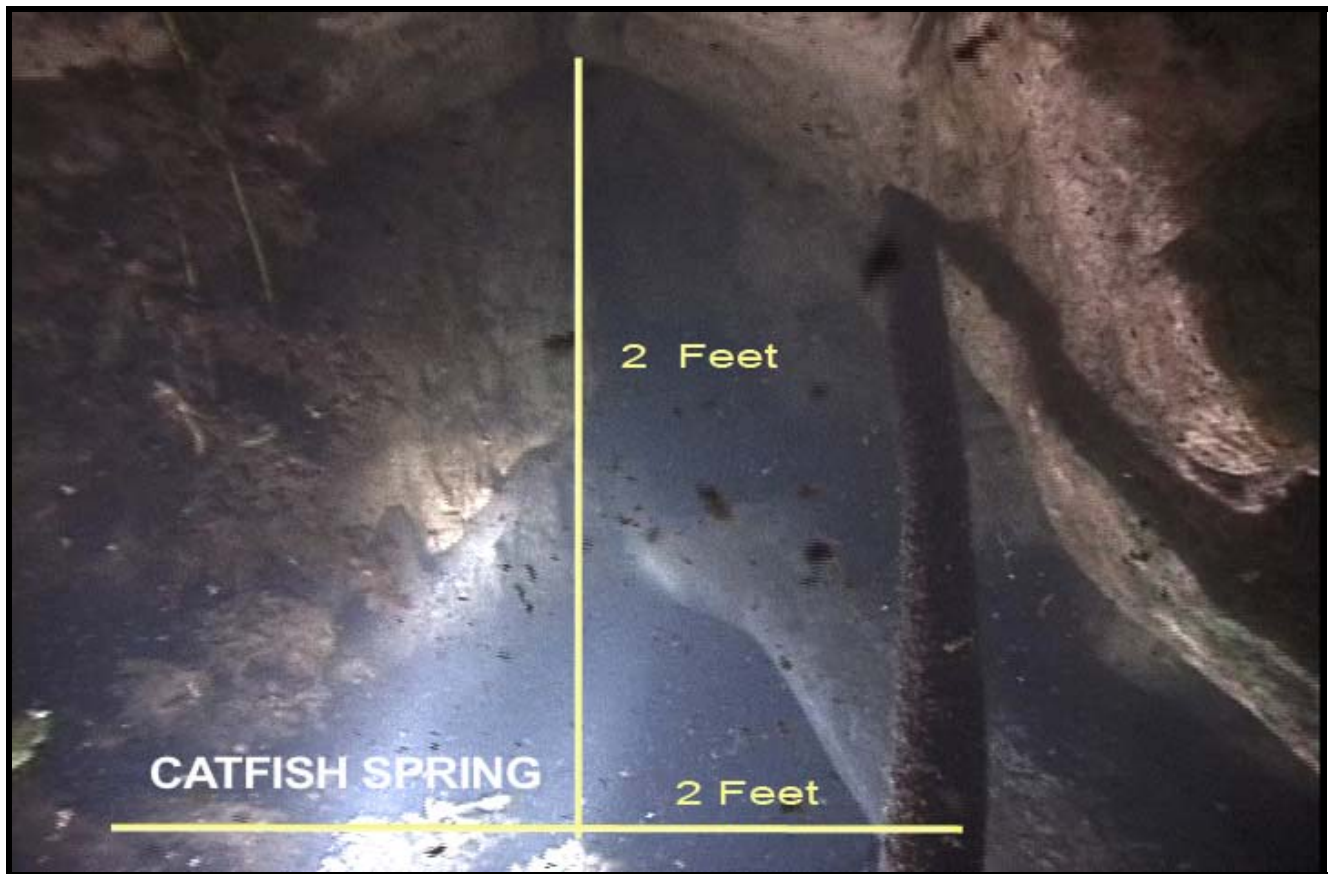
Figure 4. Underwater video still of Catfish Spring, Marion County, Florida.

This spring lies in an area of heavy aquatic vegetation about 132 meters south of Bright Angel Spring and about 485 meters west-northwest of Blue Spring. No boil was visible on the surface during the August 29 visit. The spring has one vent discharging from bedrock, too small for a diver to enter. The vent was at about 18 to 20 feet of depth. Discharge from this vent was very weak.

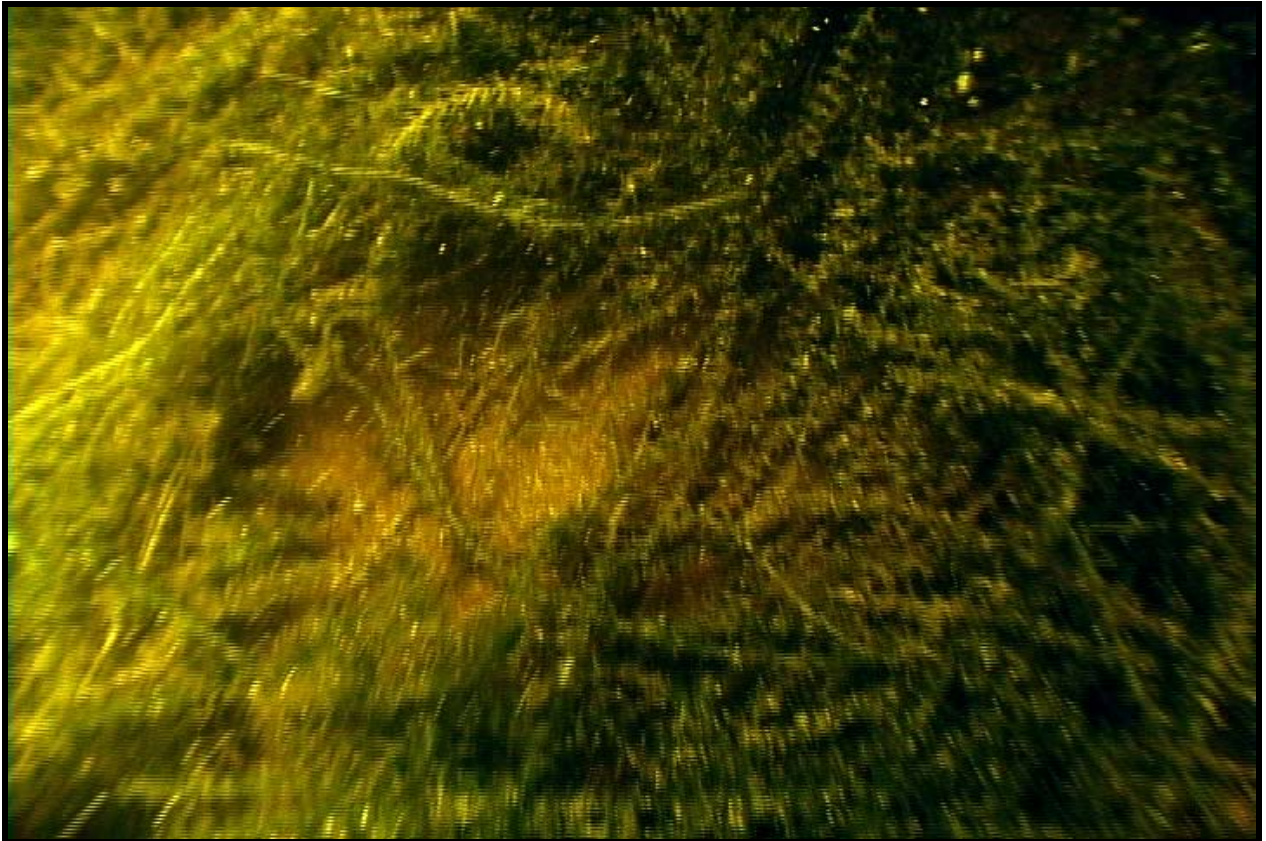
Figure 6. Underwater video still of Trench Seep, Marion County, Florida. This view is typical of bottom conditions in the cool water areas.

This seep area is located in an area of heavy aquatic vegetation northwest of Bamboo Spring. The clear, cooler water that identifies the seep area was located in channels between areas of thick aquatic vegetation. No actual vents were visible during the August 29, 2007 visit. This seep apparently discharges through vegetated soft sediments. The seep area is at about 10 feet deep.

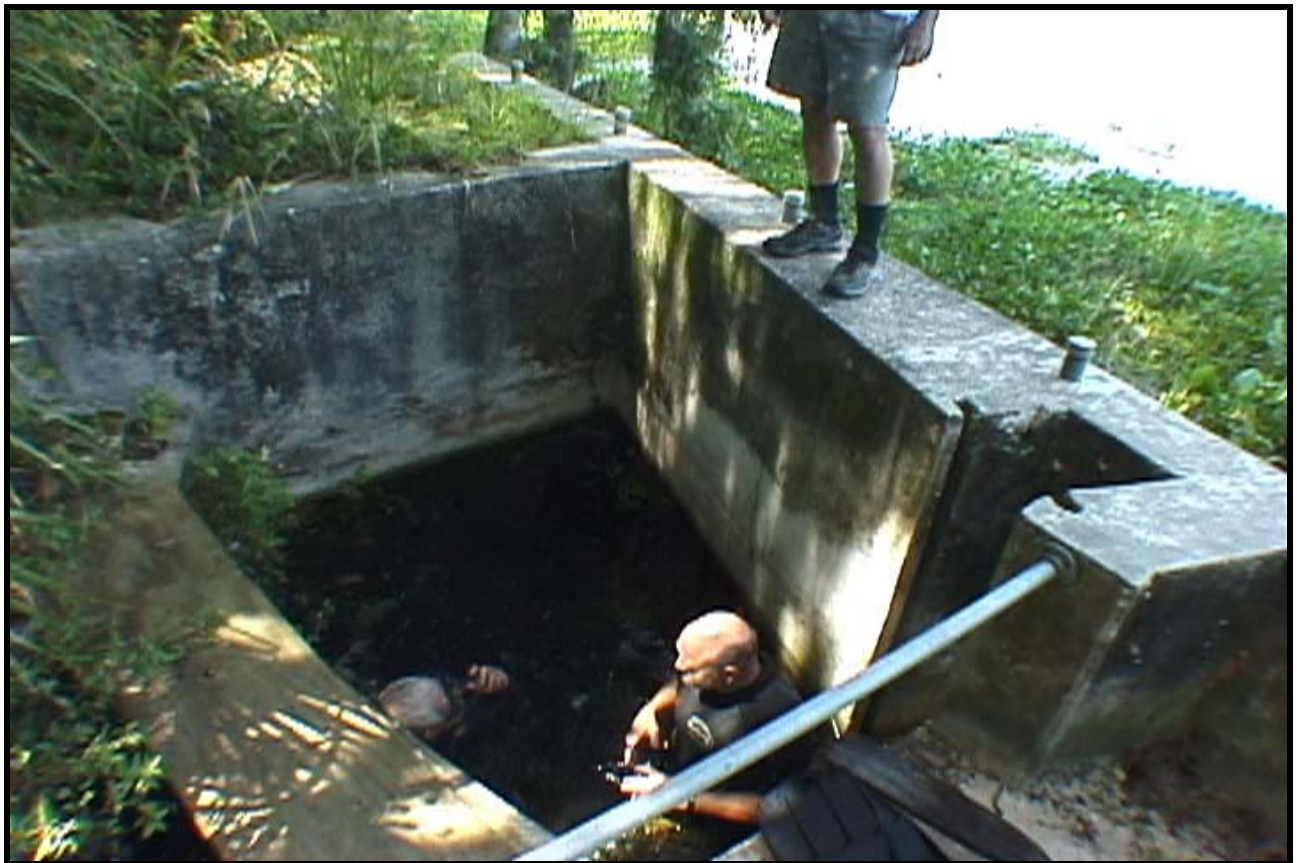
Figure 7. Video still of Sim's Spring, Marion County, Florida. The apparent vent is under the concrete wall on the left. The vertical slot behind the diver on the right is a discharge control structure.

Sim's Spring is identified by its surrounding man-made concrete structure, which apparently contained the spring and functioned as a control structure. A walkway leads up the shore slope to a small building that appears to have been a pump house. The pool within the concrete structure was searched, and although bedrock could be seen, there was no apparent discharge. Water depth was about 4 feet deep during the August 29, 2007 visit.

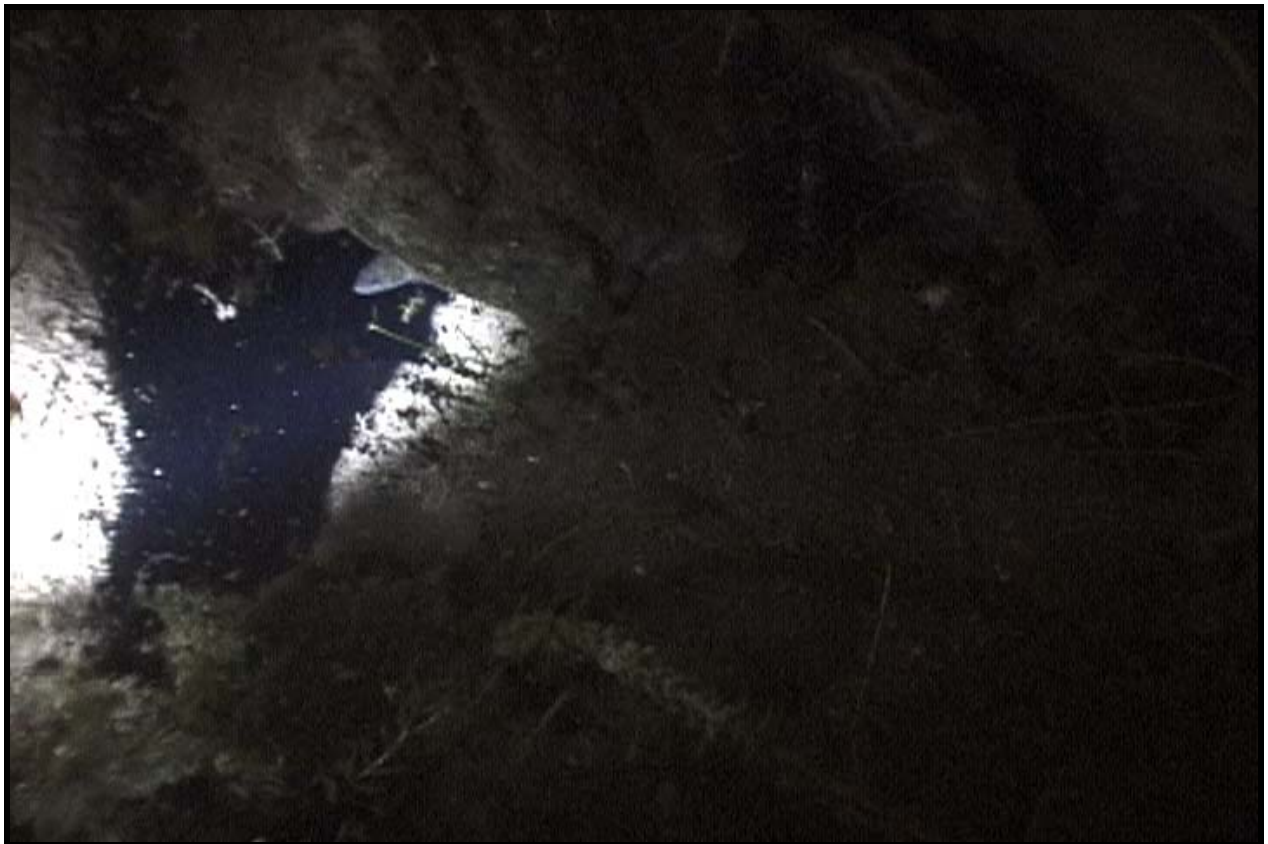
Figure 9. Underwater video still of Fish Hook Spring #2, Marion County, Florida. Shown is one of several vents discharging through a jumble of loose rock and timbers

This spring lies in an area of heavy aquatic vegetation along the south shore of the reservoir, and about 91 meters west of Fish Hook Spring #1. No boil was visible on the surface during the August 29 visit. This spring has a vent area of about 10 feet in diameter discharging from bedrock through a jumble of loose rock and timbers. The vent is about 8 feet deep. Discharge from this vent was weak.

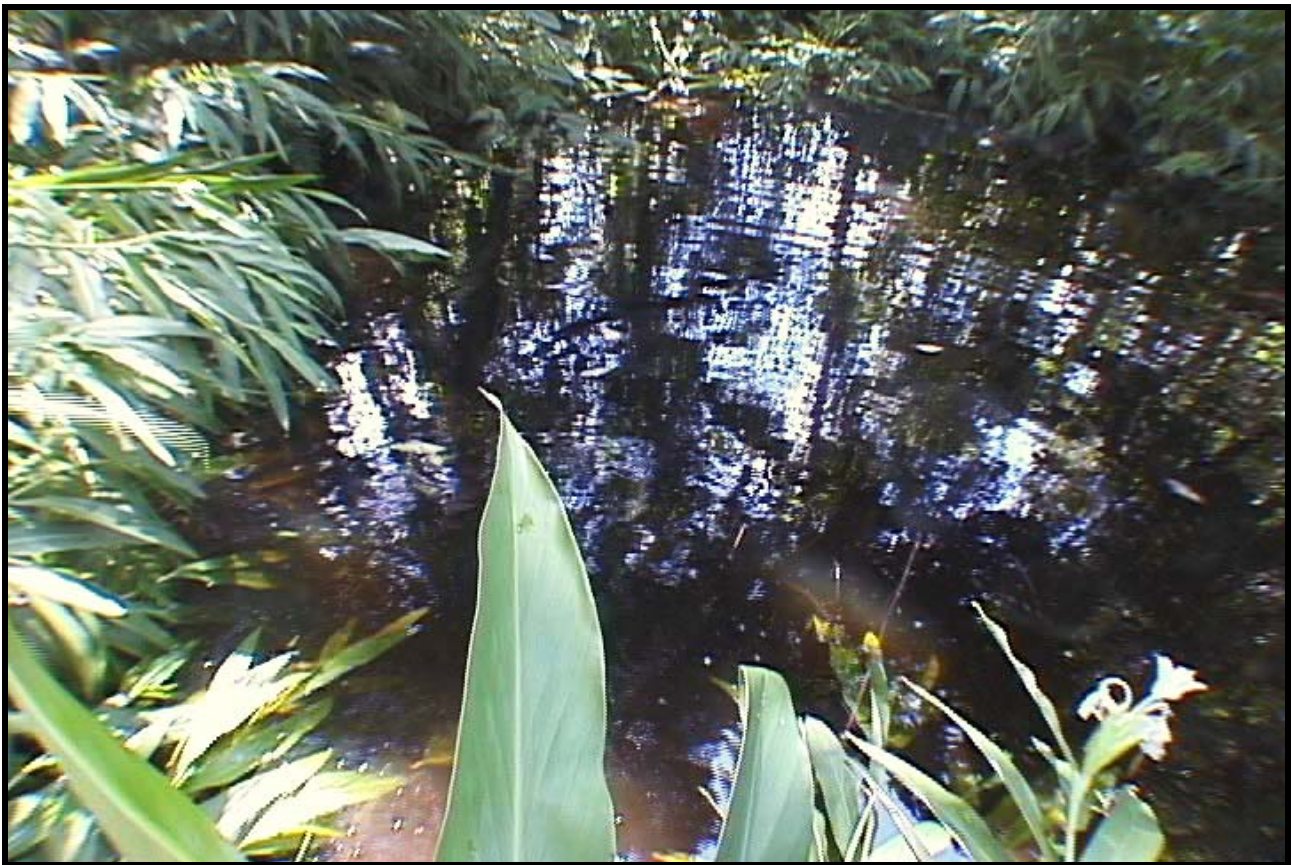
Figure 10. Video still of Lake Harris Site 1 Spring Pool, Lake County, Florida.

The Site 1 Spring Pool and Outfall is located along the southern shoreline of Lake Harris. The assumed spring pool is several hundred feet from the lake, in a mature forested wetland (bayhead). The circular pool was about six feet across and six feet deep and contained cool and slightly tannic water, but no vents were found. Discharge from the pool appears to flow down a small heavily vegetated channel excavated during the construction of a small causeway through the wetland. No discharge was apparent from the pool on September 12, 2007. However, farther downstream, water was flowing fairly vigorously from the bayhead into the littoral zone of the lake. This suggests that the site may be an area of general groundwater seepage, or that undetected vents are hidden in the vegetation of the drainageway.

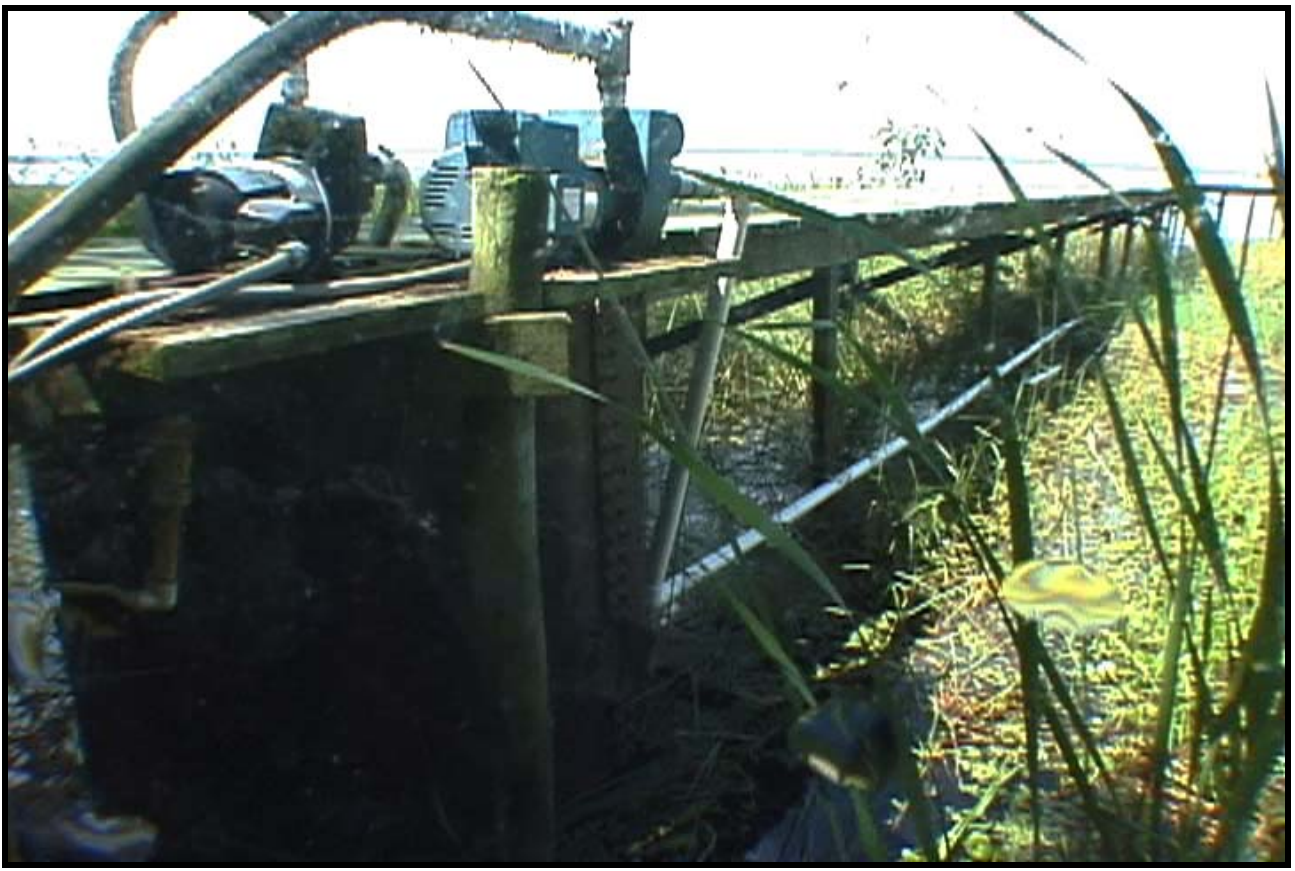
Figure 11. Video still of Lake Harris Dock Spring, Lake County, Florida. Spring is encased in large diameter steel casing below pumps on right side of picture.

Dock Spring is located along the southern shoreline of Lake Harris, within the littoral zone. The cool water of the spring discharges into a metal casement, about four feet in diameter and five feet tall, that has been placed over the spring. The pipe, which is attached to a dock, acts as a reservoir for a small watering system. The water surface in Lake Harris was low at the time of the visit, and the pipe was just at the waterline. Nonetheless, the water level in the pipe was about three feet above the water level in the lake.

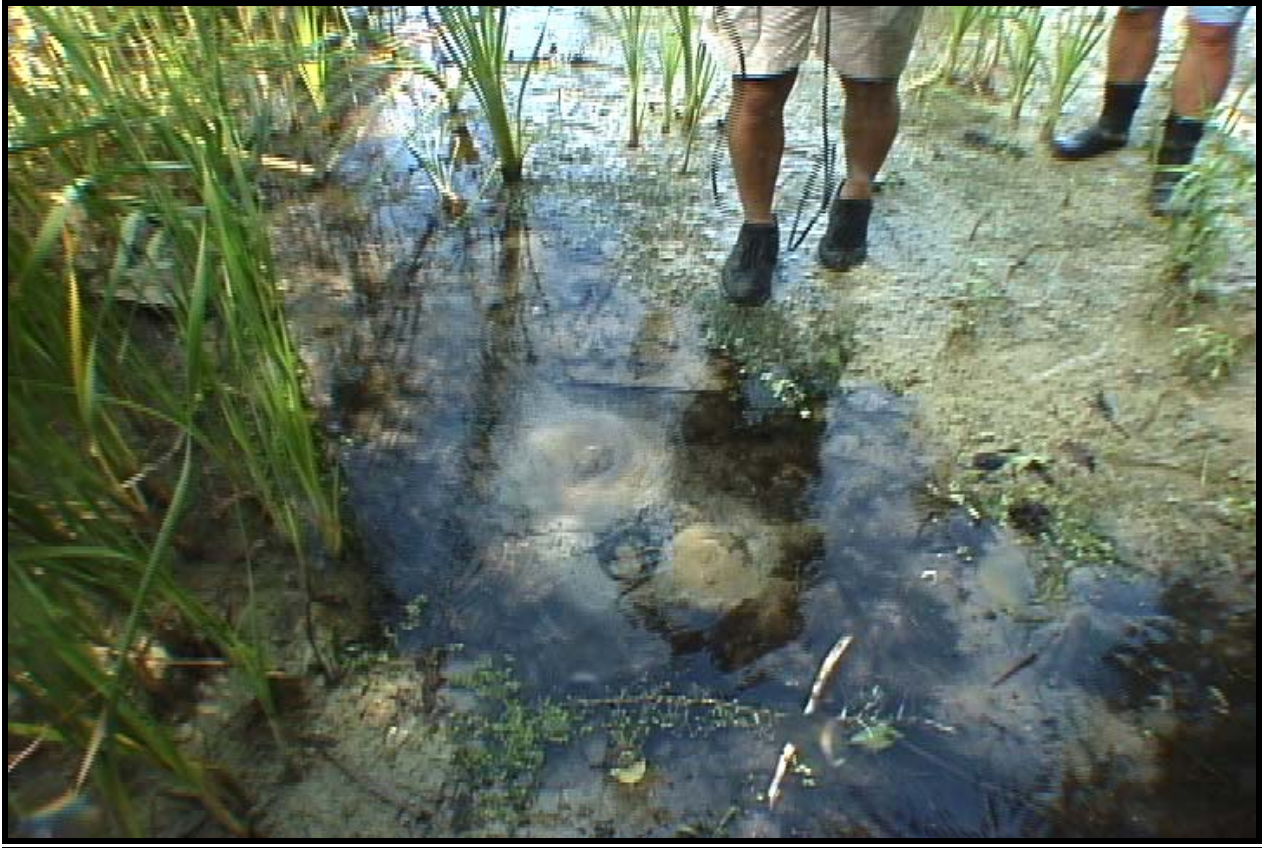
Figure 12. Video still of Lake Harris Twin Sand Boils Spring, Lake County, Florida.

Twin Sand Boils Spring is located in the littoral zone of the southern shoreline of Lake Harris. This feature consists of two small sand boils, each several inches in diameter and about a foot apart, in an area of very shallow water (less than 0.5 feet) and somewhat sparse emergent vegetation. The cool temperature of the discharge relative to the warm lake water suggests a groundwater source.

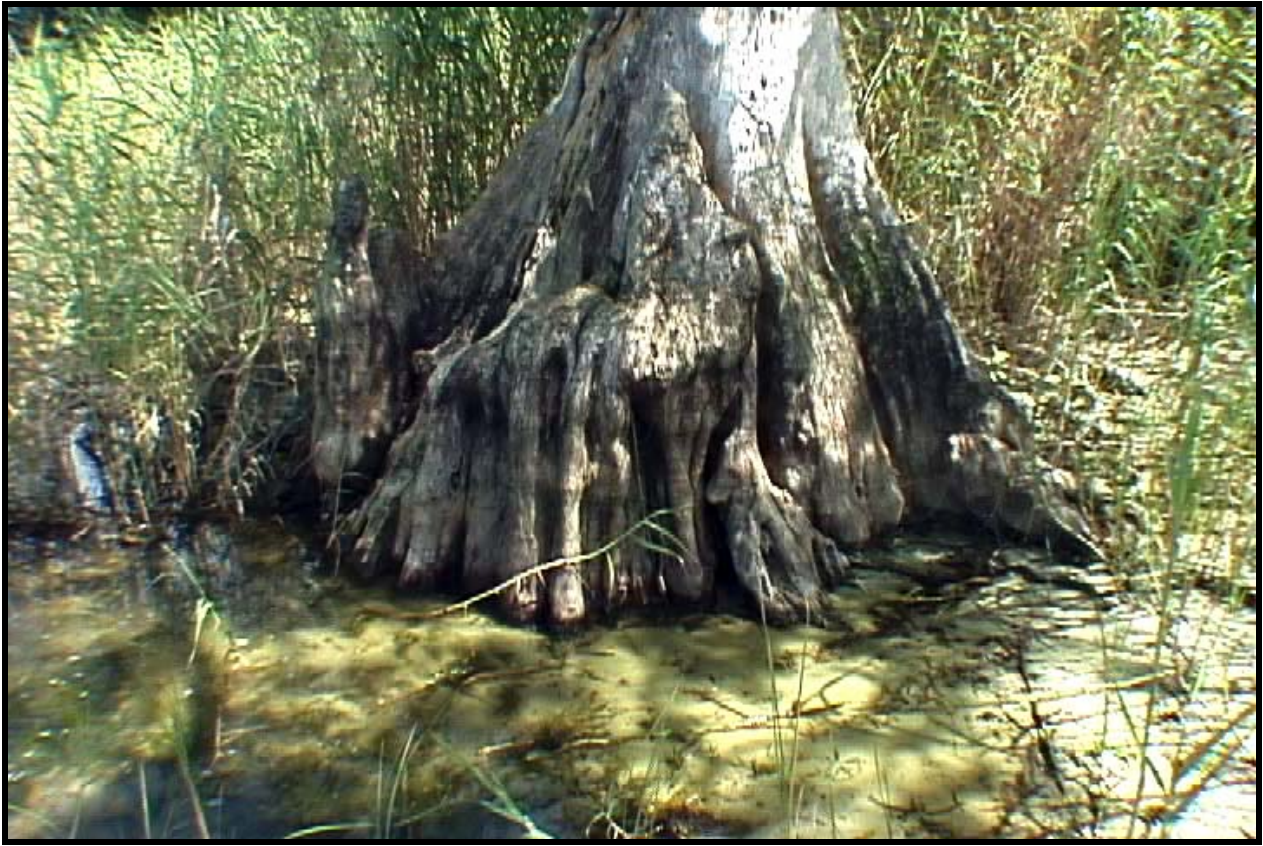
Figure 13. Video still of Lake Harris Cypress Tree Seep, Lake County, Florida.

Cypress Tree Seep is located in the littoral zone of the southern shoreline of Lake Harris. This feature is an area of notably cool water, no more than several inches deep, and about ten feet in diameter. No vent was found, but the relatively cool temperature of the seep area, when compared with the surrounding warm water of the lake, indicates discharge of groundwater. The shallow water in and around the seep supports emergent vegetation, and the feature is named after a nearby cypress tree.

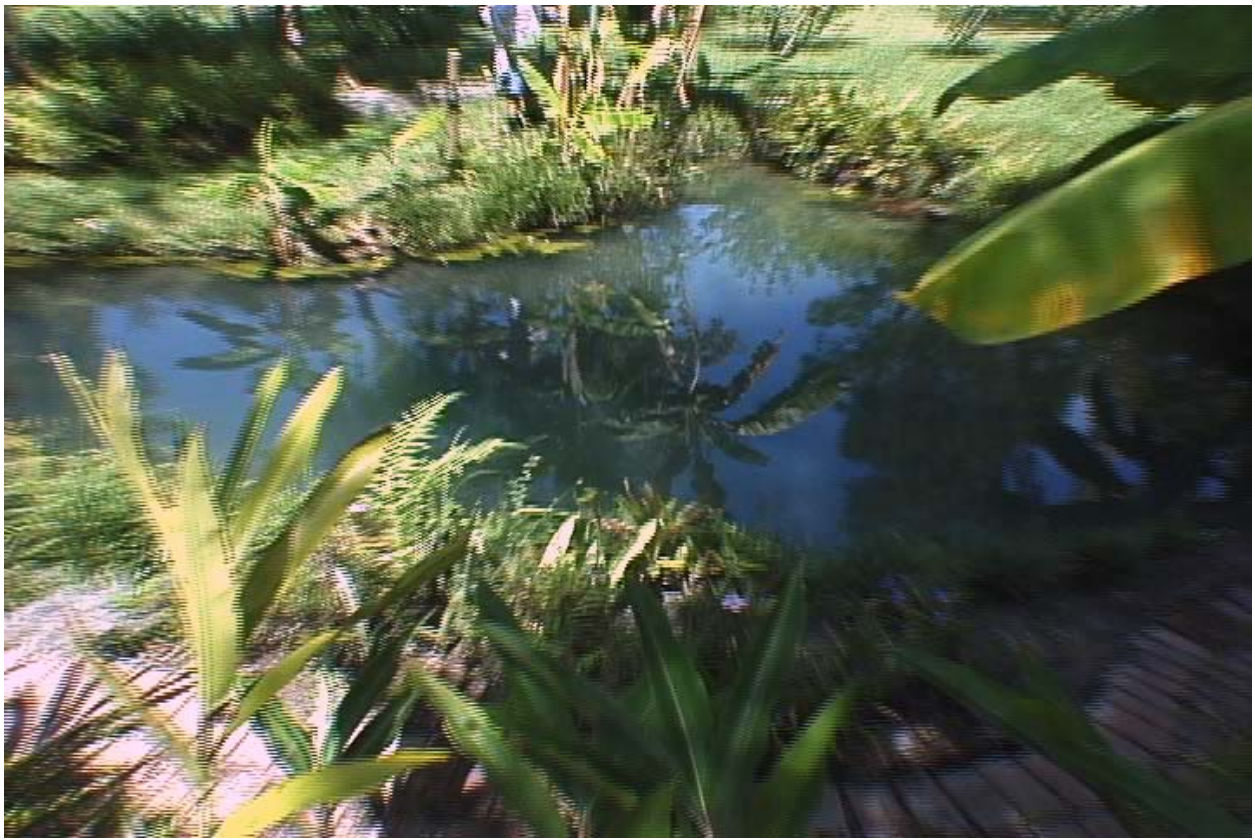
Figure 14. Video still of Sandy's Spring pool, Lake County, Florida.

Sandy's Spring is located at the head of a small run about 200 feet from the southern shoreline of Lake Harris. The spring run discharges into the littoral zone of the lake after flowing through a small culvert under Lakeshore Drive. The spring vent is located in a roughly circular pool, which is about ten feet in diameter, and about six feet deep. Groundwater gently discharges from a linear vent about two feet long at the deepest part of the spring pool. The vent was partially covered by soft sediments. The spring pool and run are maintained by the owner and are free of aquatic vegetation.

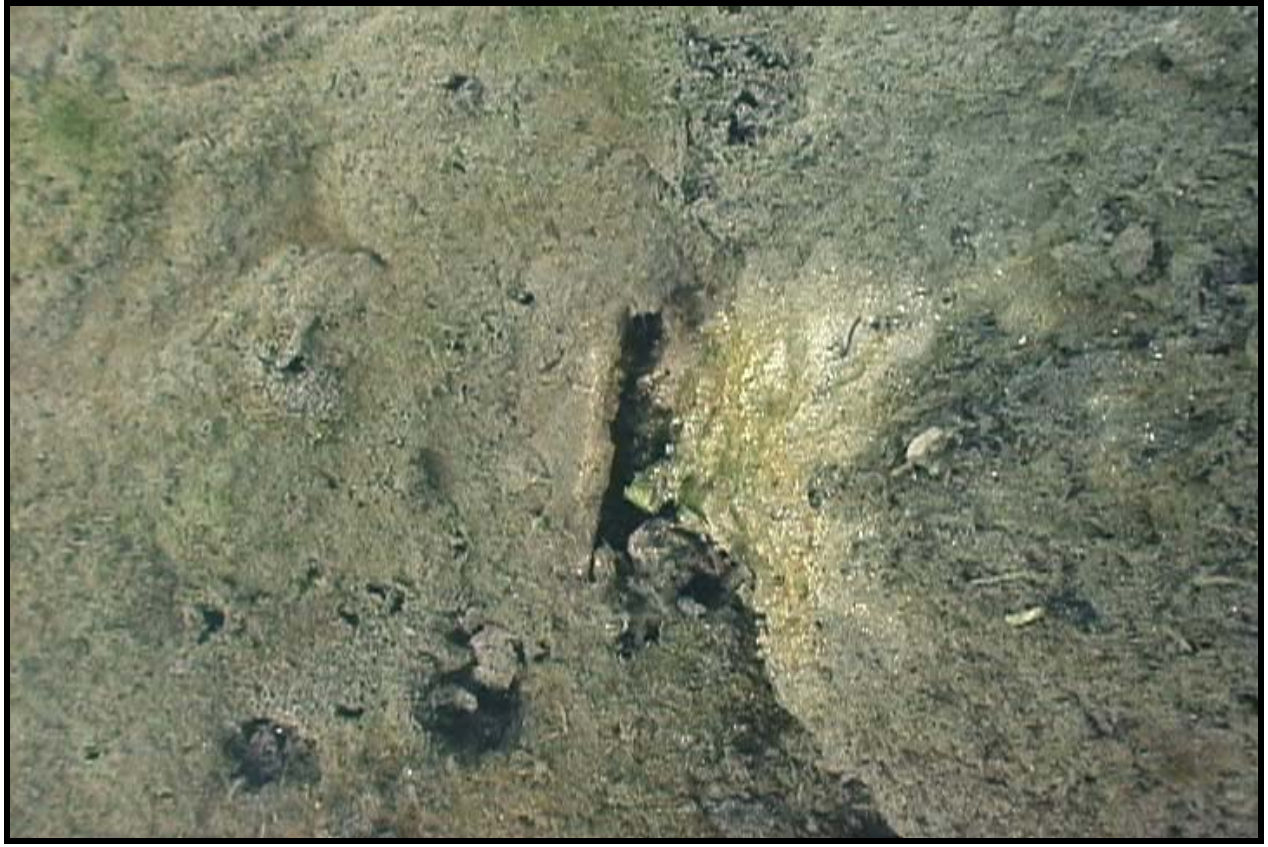
Figure 15. Underwater video still of Sandy's Spring, Lake County, Florida. The vent at the deepest part of the pool is shown.

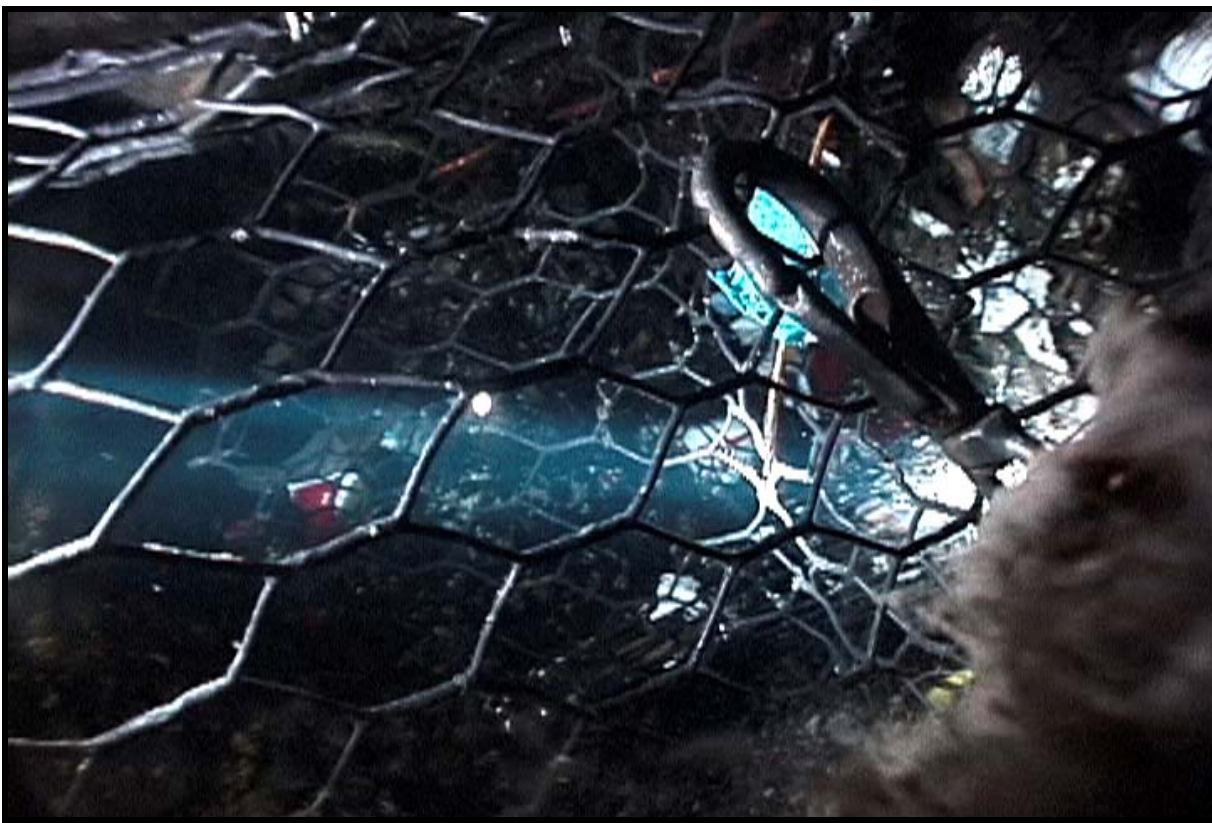
Figure 16. Underwater video still of Shands Bridge Spring, St. Johns County, Florida. Beam of light is shining down through the crab trap to the debris choked vent below.

Shands Bridge Spring is located in depression in the approximate middle of the St. John's River, downstream of Shands Bridge. No boil or slick was visible during this visit. The general location of the site was located using a depth finder, and then divers found the vent by following water temperature, bottom topography and debris. The spring vent was located beneath a derelict wire crab trap, and discharged up through the trap, at about 28 feet deep. A thick layer of soft organic sediments containing considerable man-made debris surrounded the vent (and crab trap) at the bottom of the depression. The vent could only be viewed by looking down through the upper end of the crab trap, and even then, the vent below was obscured by debris and sediment.

A water sample was collected by divers placing the end of an intake tube through the top of the crab trap and into the clear water directly above the vent.

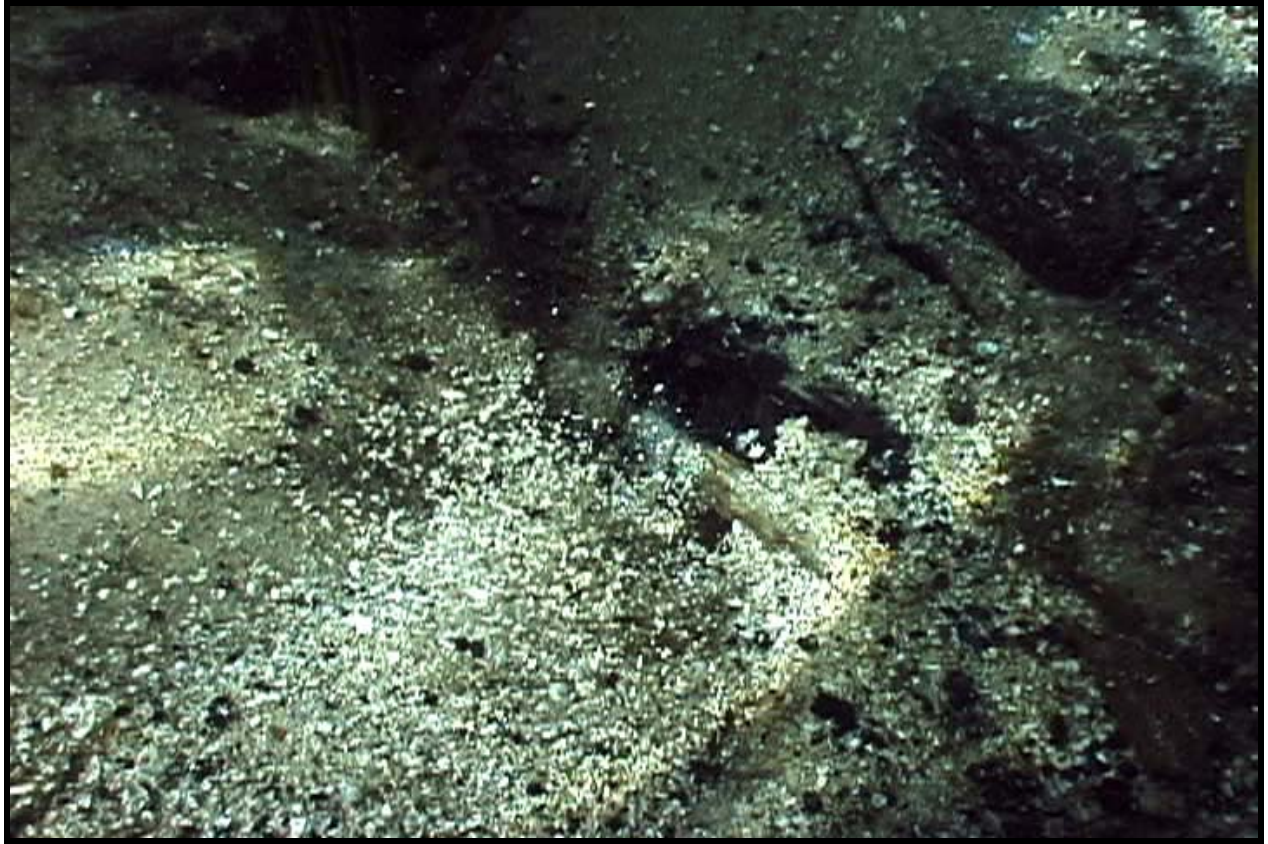
Figure 18. Underwater video still of Gang of 5 Vent #2, Silver Springs Group Channel and Boat House Vents, Marion County, Florida.

The Gang of Five Vent Group lies within a boat channel about 100 meters northeast of the boat house area, and about 60 meters south of a tourist boat dock located on one of the park's islands. All of these vents are approximately 10 feet deep. All discharge directly from bedrock, with varying amounts of loose rock, shells, sand, and dead wood (branches) in them. Vent #5 was the smallest, and the most difficult to collect water samples from.

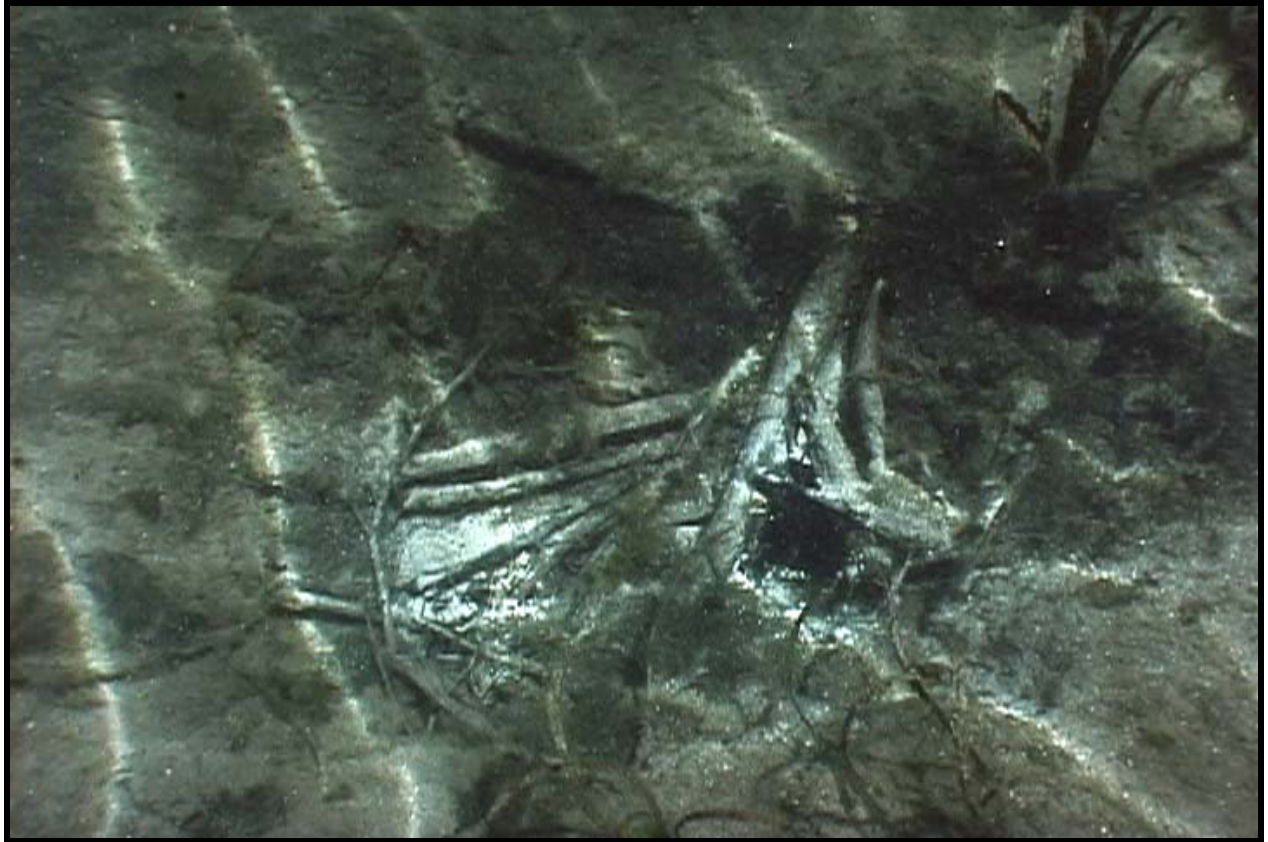
Figure 19. Underwater video still of Gang of 5 Vent #3, Silver Springs Group Channel and Boat House Vents, Marion County, Florida.

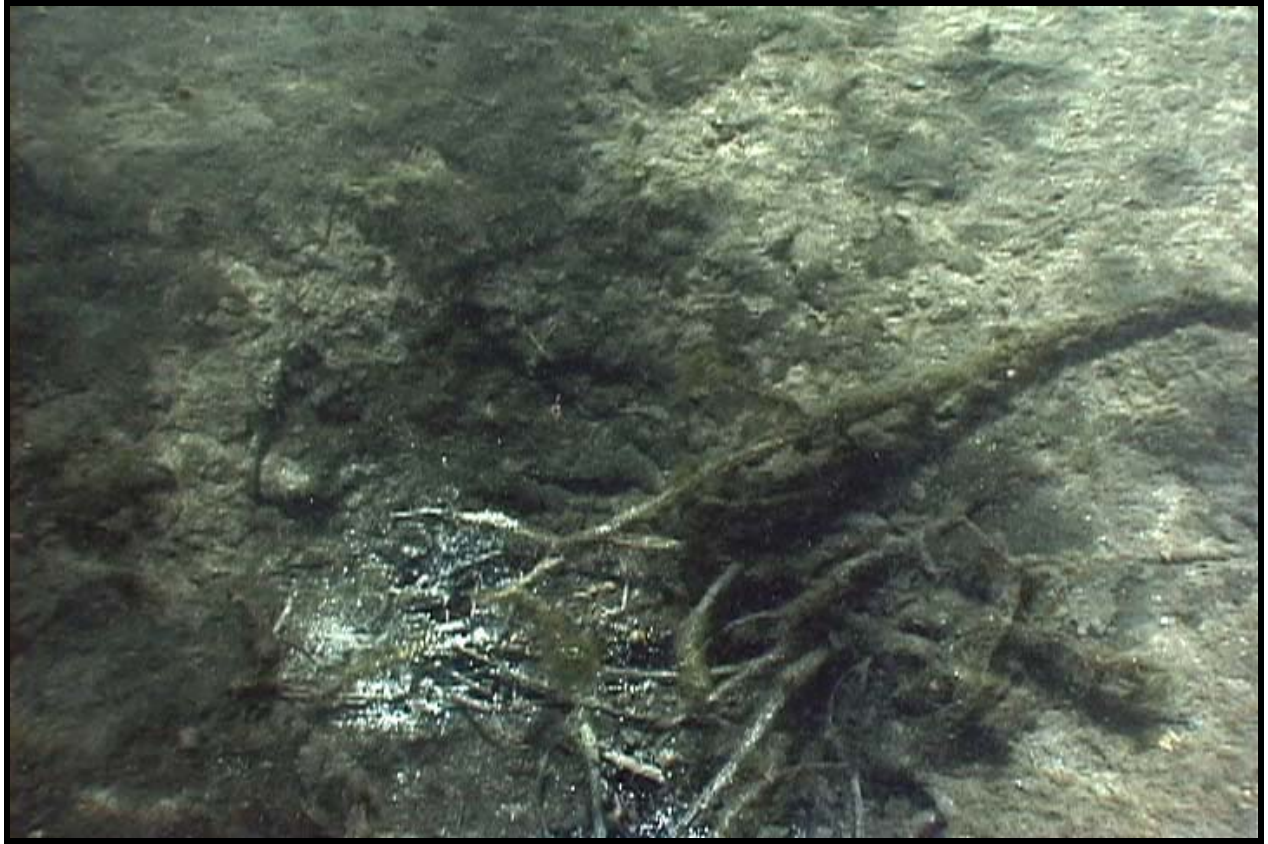
Figure 20. Underwater video still of Gang of 5 Vent #4, Silver Springs Group Channel and Boat House Vents, Marion County, Florida.

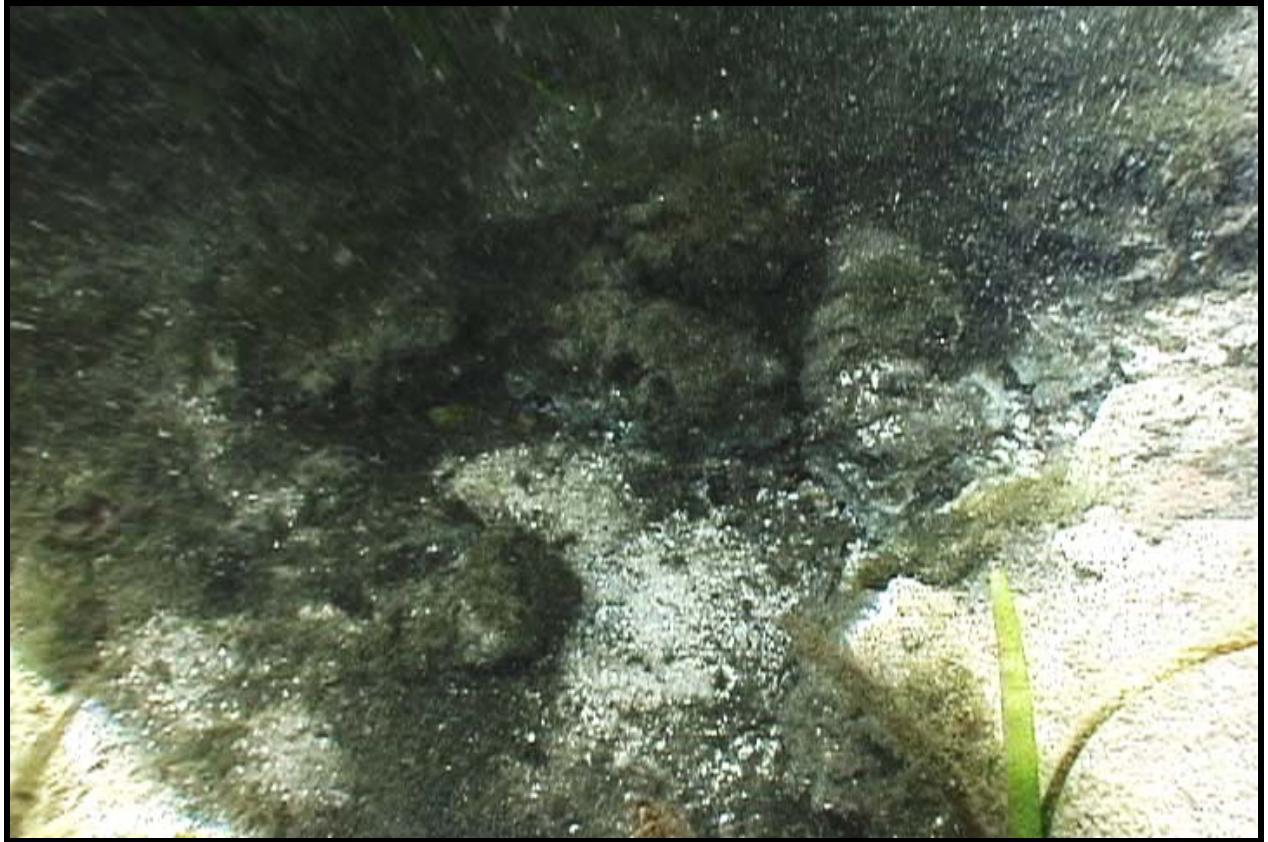
Figure 21. Underwater video still of Gang of 5 Vent #5, Silver Springs Group Channel and Boat House Vents, Marion County, Florida.

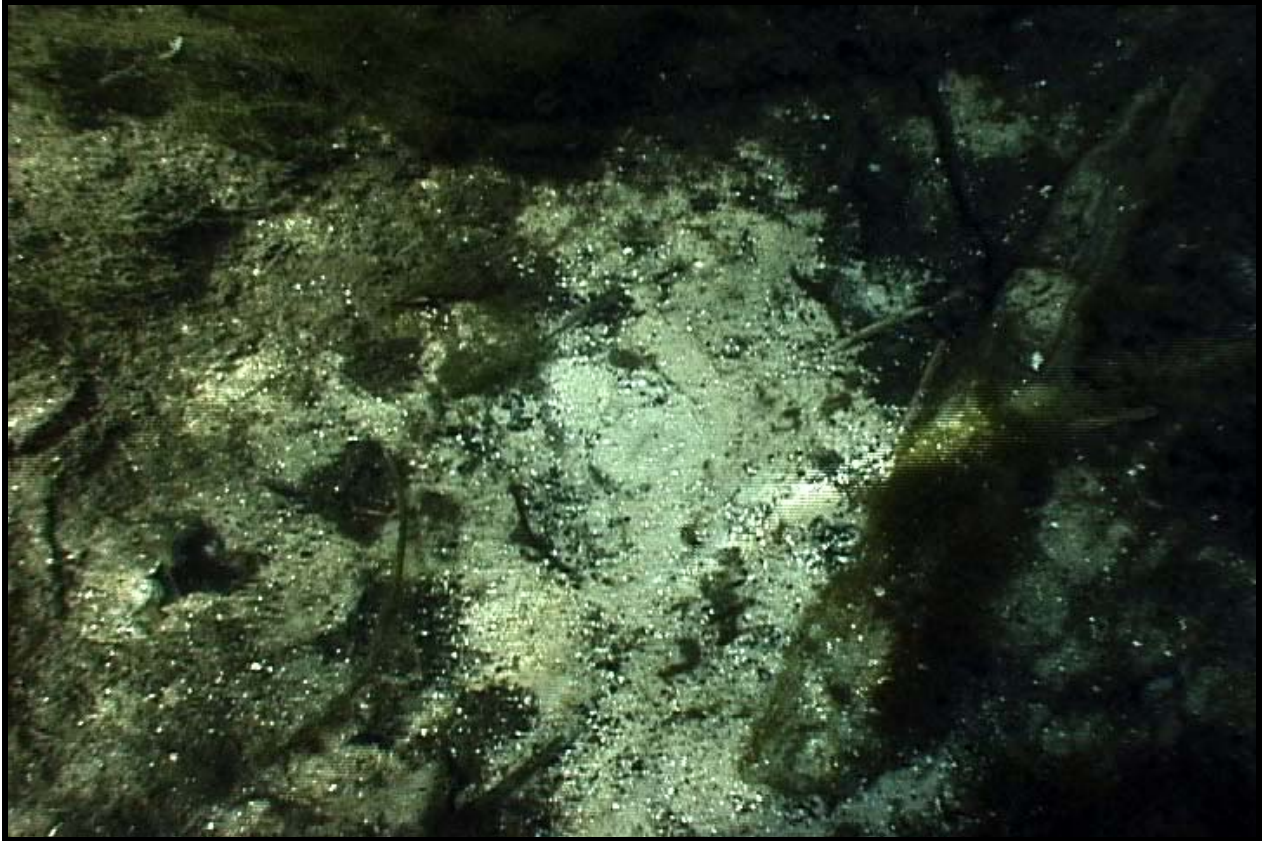
Figure 22. Underwater video still of Sandboil Vent, Silver Springs Group Channel and Boat House Vents, Marion County, Florida.

This spring is a small sand boil located on the bottom of the channel, about 225 meters downstream of the boat house. It discharges through sand and soft bottom sediments about 10 feet deep.

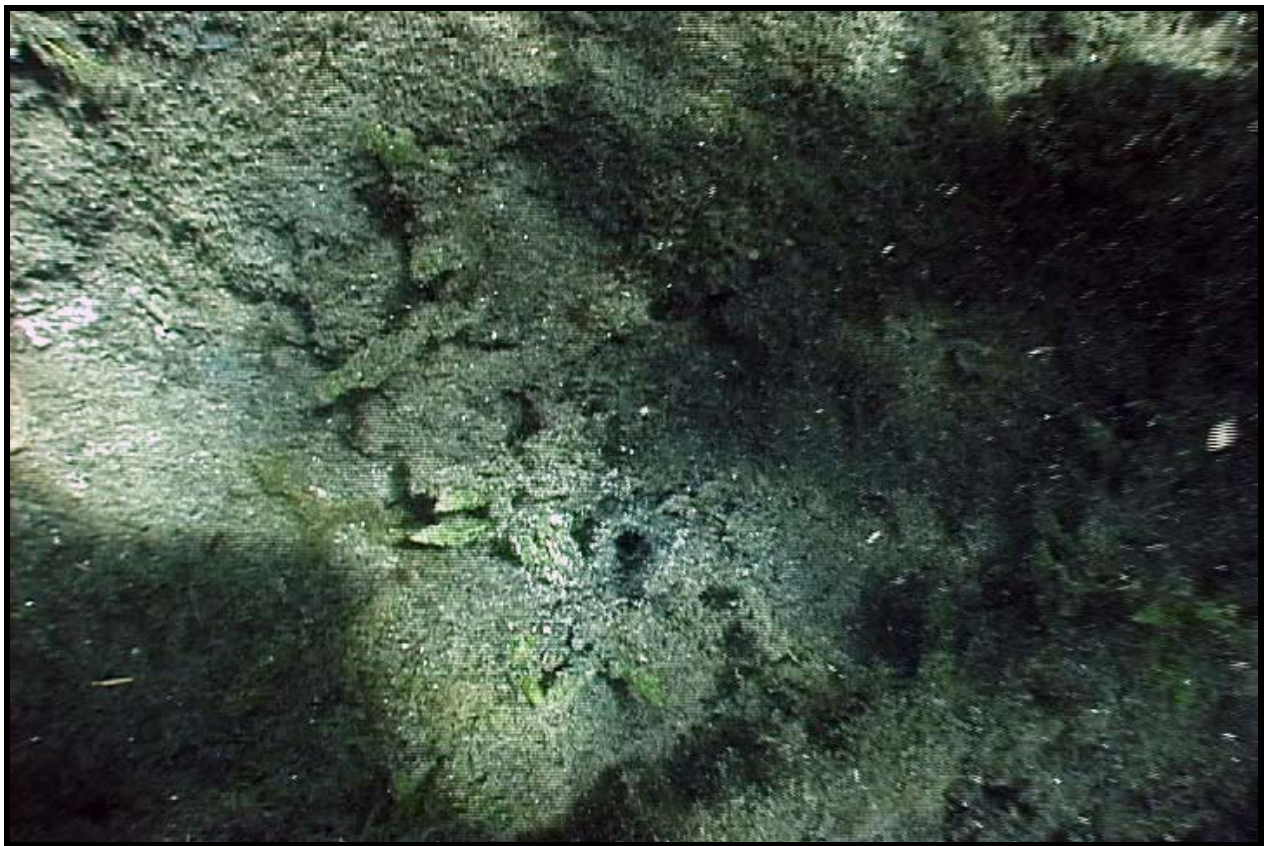
Figure 23. Underwater video still of Silver Springs Landing Vent #1, Silver Springs Group Channel and Boat House Vents, Marion County, Florida.

These vents form a group, or cluster, in a deeper portion of the channel about 750 meters downstream of the boat house. They are located in front of a park re-creation of an old time Florida river trading post and river boats. They all discharge through sand, soft bottom sediments and heavy detritus at about 13 feet of depth. Vent #1 is the most northern of the vents, Vent #2 is mid-channel, and Vent #3 lies closest to the south bank. Vent #3 has the most aquatic vegetation around it.

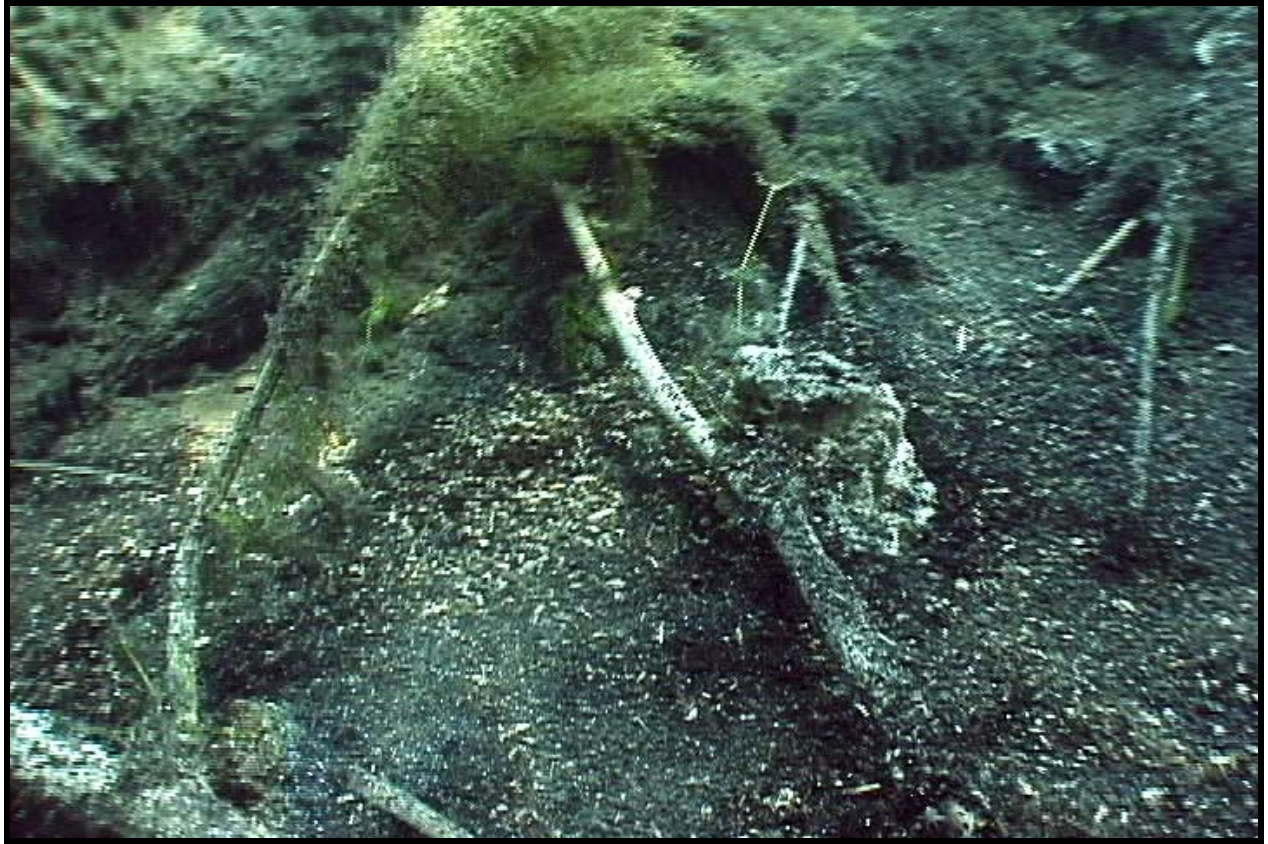
Figure 24. Underwater video still of Silver Springs Landing Vent #2, Silver Springs Group Channel and Boat House Vents, Marion County, Florida.

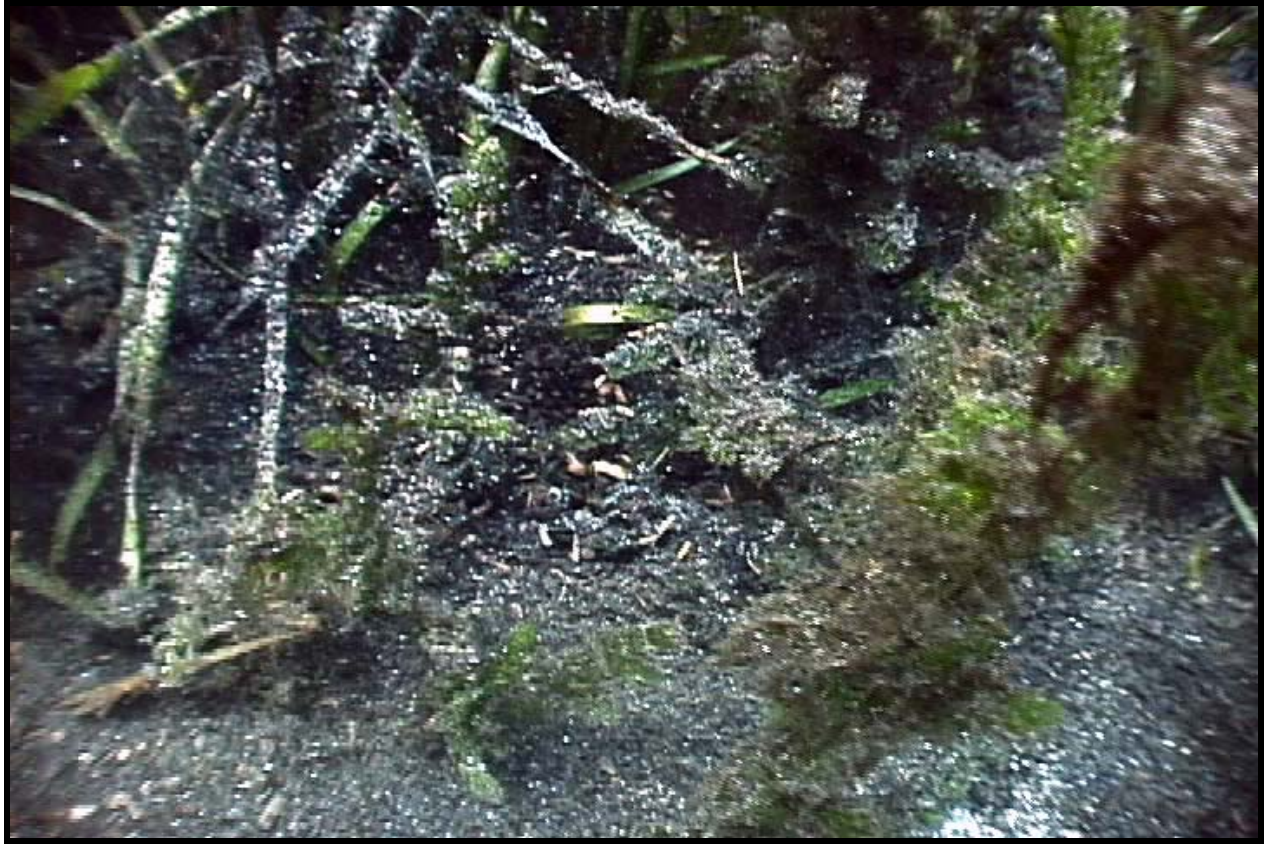
Figure 25. Underwater video still of Silver Springs Landing Vent #3, Silver Springs Group Channel and Boat House Vents, Marion County, Florida.
