**SPECIAL PUBLICATION SJ2008-SP7**

**SUBMERGED SPRINGS SITE DOCUMENTATION:  
AUGUST AND SEPTEMBER 2007**

# **Submerged Springs Site Documentation: August and September 2007**

## **St. Johns River Water Management District**

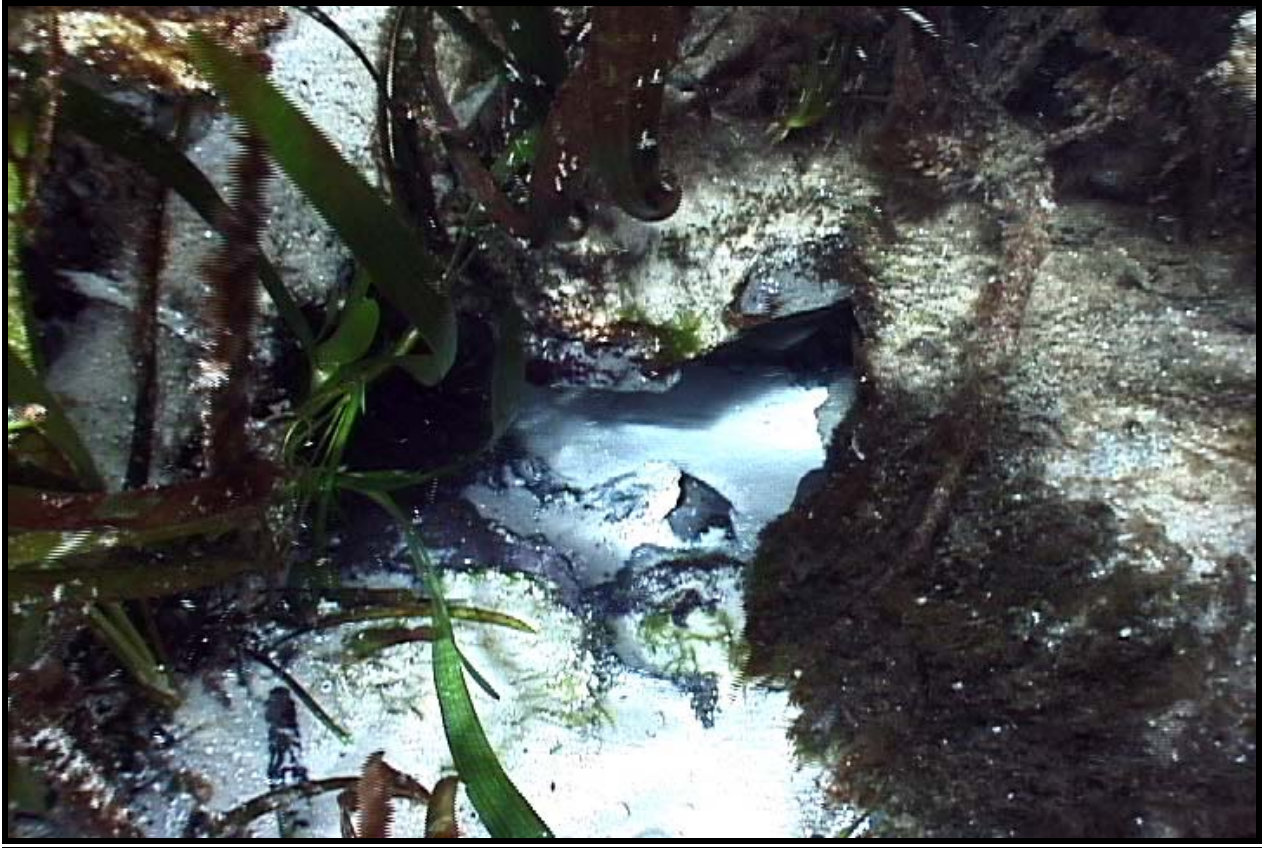
Figure 26. Underwater video still of South Boat House/Christmas Boat Vent, Silver Springs Group Channel and Boat House Vents, Marion County, Florida.

This vent has two openings in the rocky bottom in front of the eastern side of the south (main) boathouse. Flow was vigorous from both openings. Aquatic vegetation surrounds the vent, which is 8 feet deep. The name references a glass-bottomed boat berthed nearby that has been outfitted with Christmas lighting.

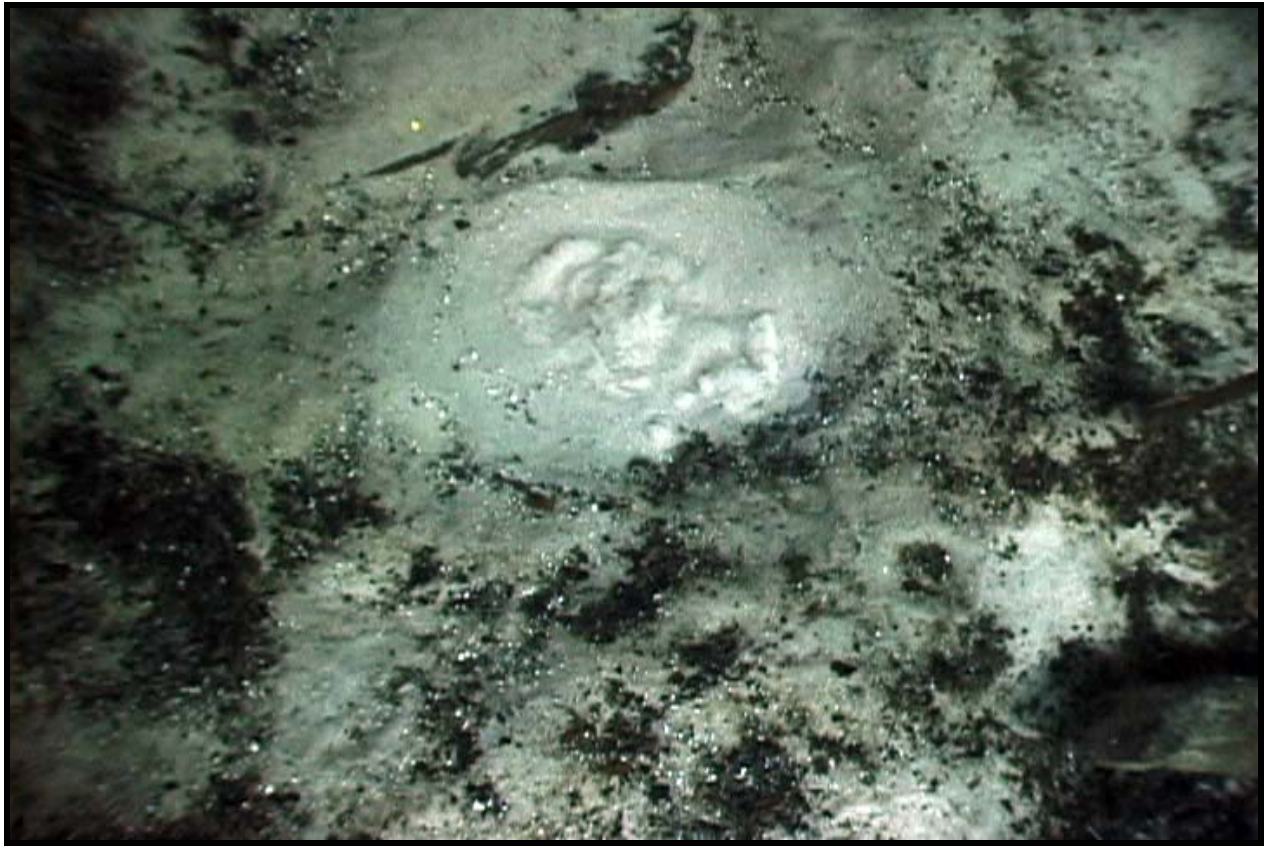
Figure 27. Underwater video still of South Boat House Vent #2, Silver Springs Group Channel and Boat House Vents, Marion County, Florida.

This vent is located under the roof of the south (main) boathouse in 8 feet of water, just southwest of the Christmas boat vent. The spring discharges from a bedrock vent obscured by sand, and is littered with debris.

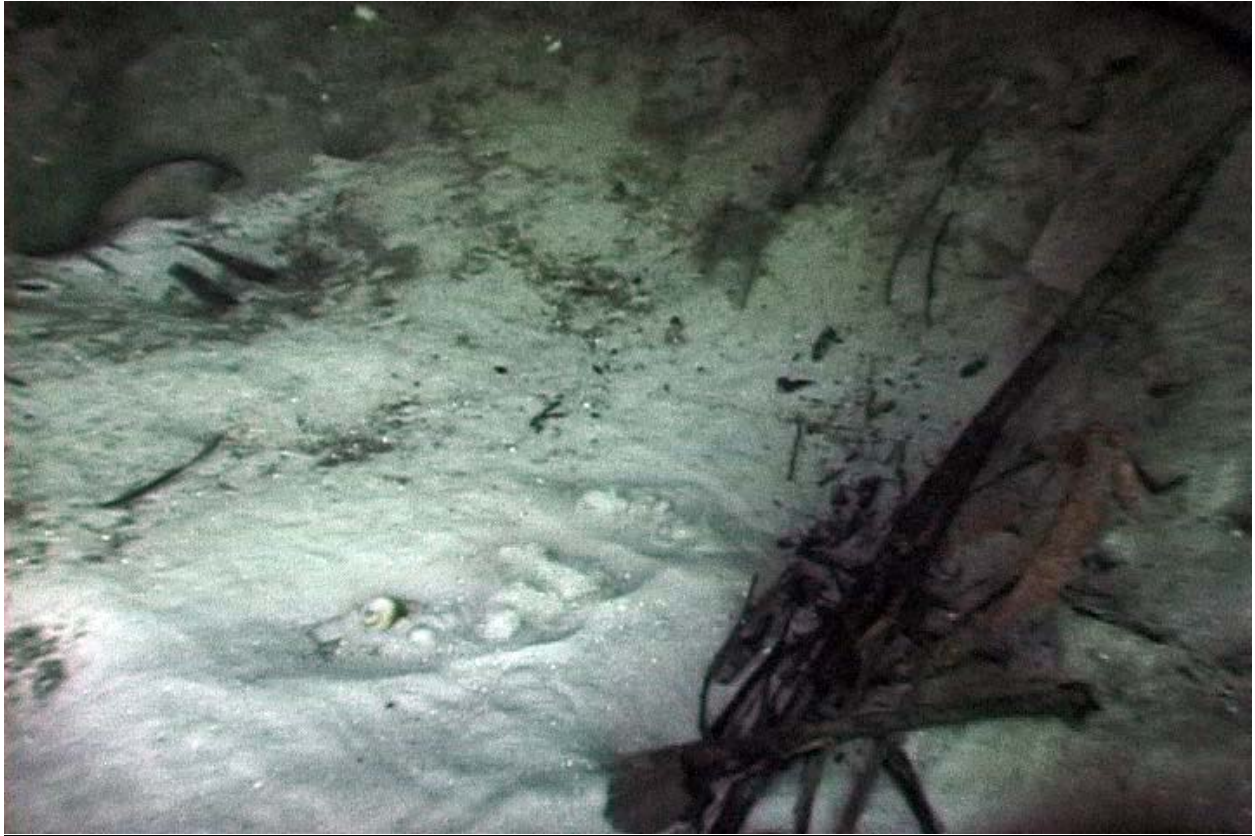
Figure 28. Underwater video still of South Boat House Vent #3, Silver Springs Group Channel and Boat House Vents, Marion County, Florida.

This vent is located under the roof of the south (main) boathouse in 8 feet of water, just west of Vent #2. The vent discharges from bedrock mantled by sand, and is littered with debris.

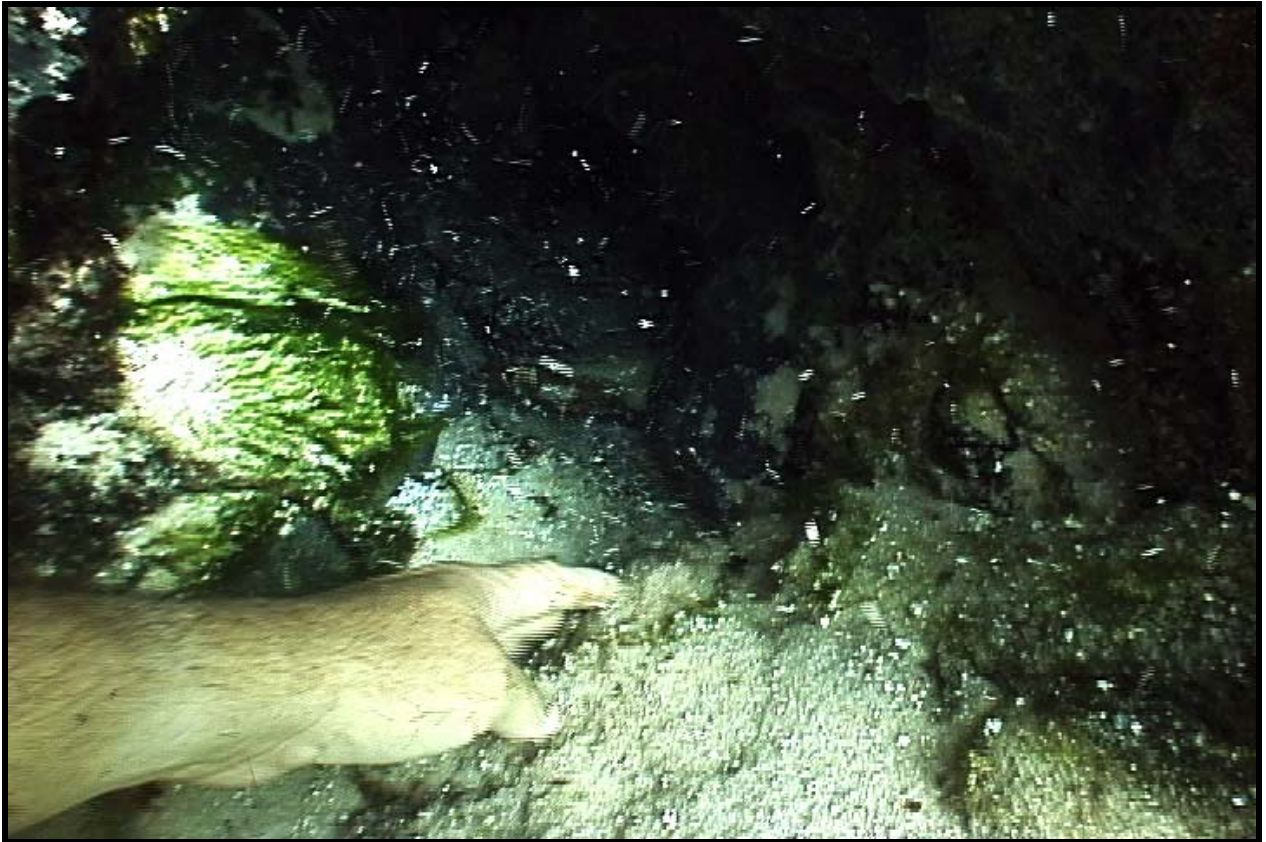
This vent has multiple openings in the rocky bottom in front of (south of) the north boathouse. Flow was vigorous from all openings. Aquatic vegetation surrounds the vent openings, which are 8 feet deep. The name makes reference to a piece of man-made litter that was found during the investigation

Figure 29. Underwater video still of North Boat House/Rubber Mask Vent, Silver Springs Group Channel and Boat House Vents, Marion County, Florida.

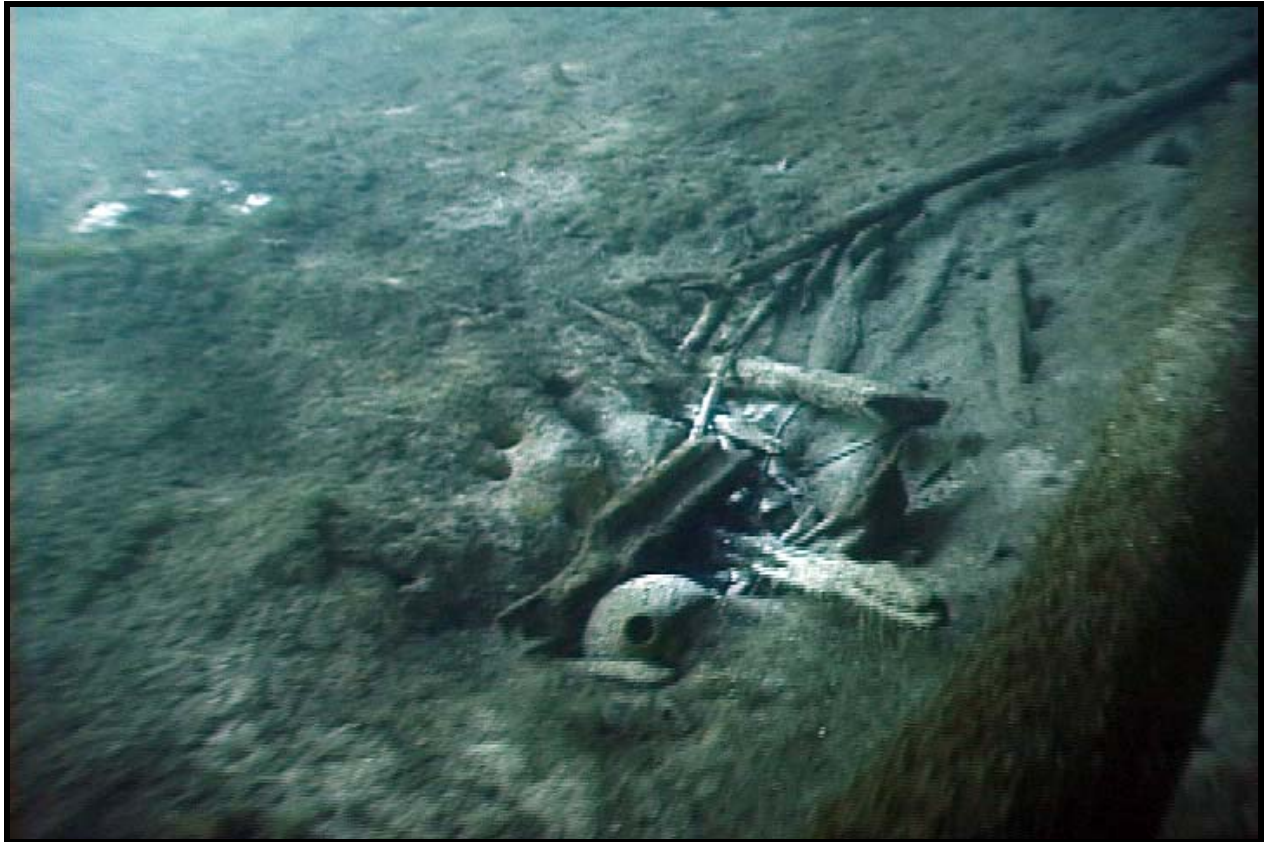
This vent is located under the roof of the north boathouse in 8 feet of water. The vent discharges from bedrock mantled with sand and debris. The name makes reference to an old river boat berthed above it.

Figure 30. Underwater video still of North Boat House/Silver Queen IV Vent, Silver Springs Group Channel and Boat House Vents, Marion County, Florida.

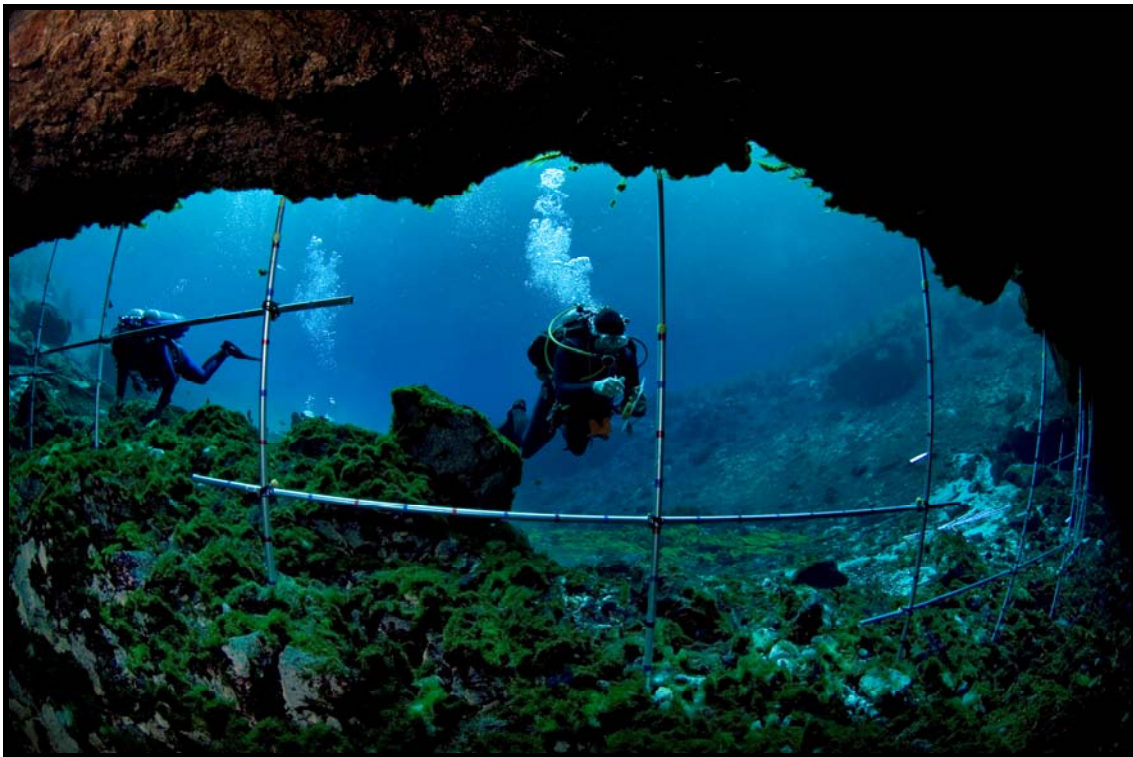
This is the largest and most upstream of the spring vents. It discharges horizontally into a large basin just east of the glass-bottom boat loading area. The vent is a horizontal, oval-shaped opening 2 to 6 feet high and about 65 feet wide at the base of a limestone wall. The bottom of the vent's mouth is composed largely of breakdown boulders and rubble. The depth of water measured in front of the vent opening is about 34 feet. Water from at least two distinct sources (Mammoth East and Mammoth West) discharge from the cave opening. These sources differ in temperature and chemistry. The spring basin measures about 300 feet north to south and 200 feet east to west.

Figure 31. Mammoth Spring, Silver Springs Group, Marion County, Florida. Viewed from inside the cavern looking out. Discharge measurement supports are in place.

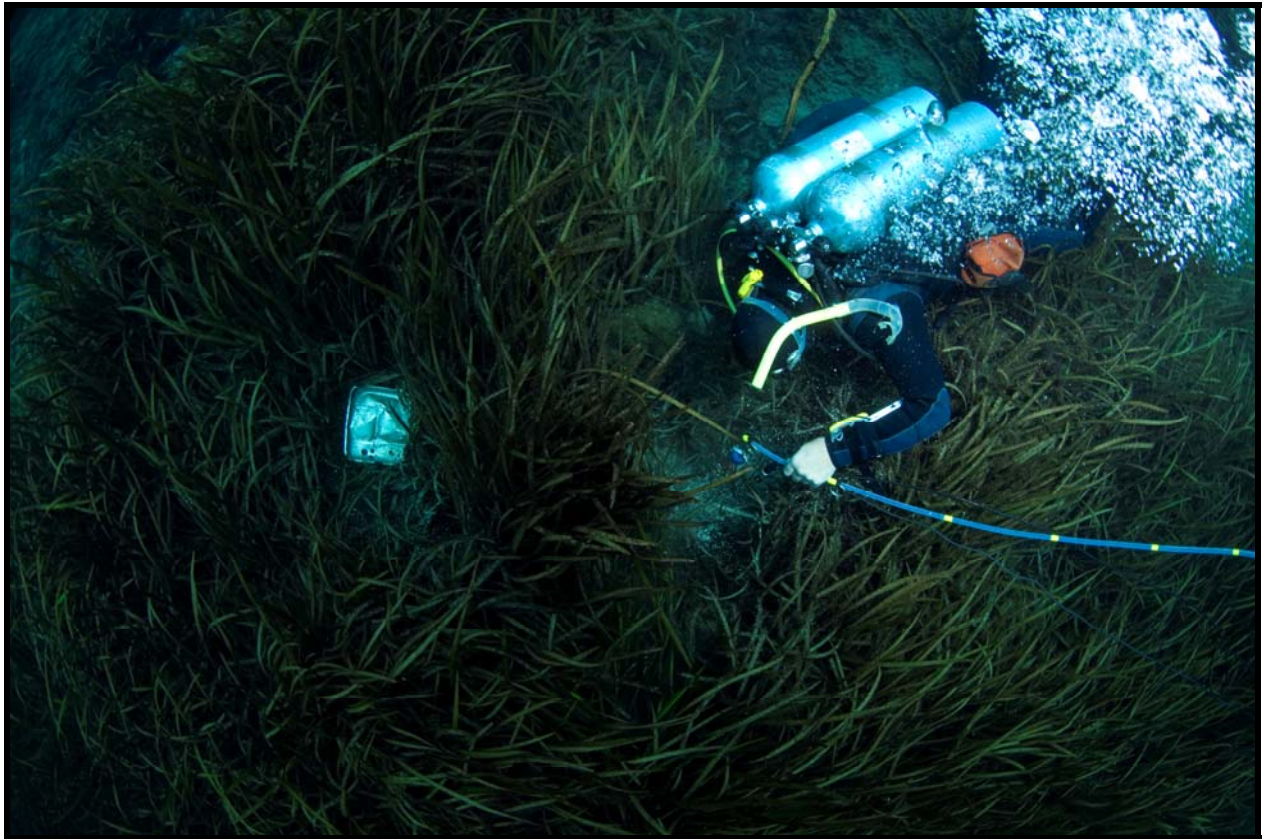
Oscar Spring is a group of spring vents in a shallow depression on the north side of the center of the river channel, about 140 feet northeast of Jacob's Well Spring. There are three small vents in the depression, one of which discharges from a marl ledge, and a line of vents about 8 feet long about ten feet to the southwest of the marl ledge. The deepest part of the depression is about 17 feet deep.

Figure 33. Underwater photograph of Oscar Spring, Silver Springs Group, Marion County, Florida.

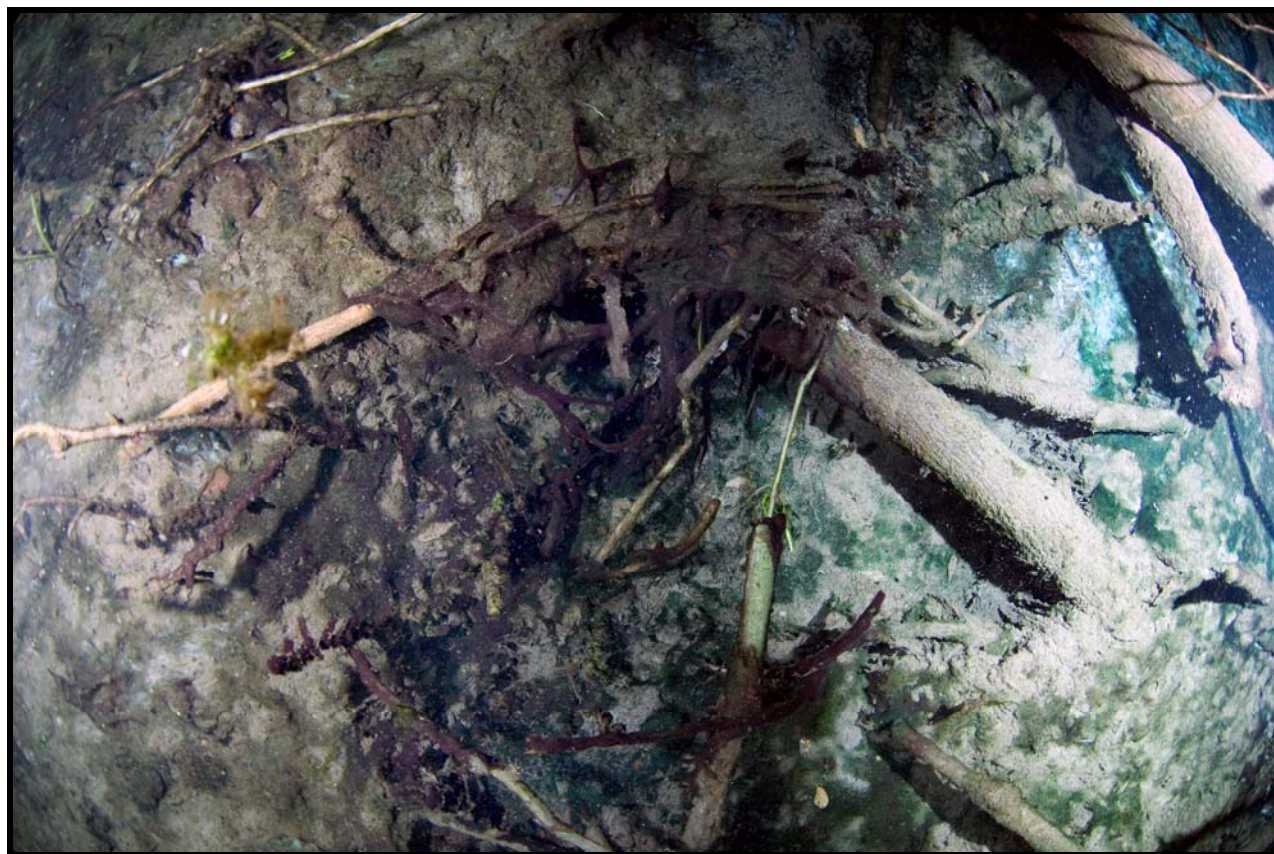
Two additional vents were discovered during this study east of the vent line, in a shallow swampy extension of the cove. The nearest of these, named Lost River Spring, is about 70 feet to the east, and is about two feet in diameter and about 8 feet deep. The second vent, named Log Spring, is 110 feet to the east of the vent line, and is about 3 feet in diameter and 5 feet deep. The vents of both of these springs gently discharge through detrital sediments and are beneath fallen tree limbs.

Figure 35. Underwater photograph of Lost River Spring, Silver Springs Group, Marion County, Florida.

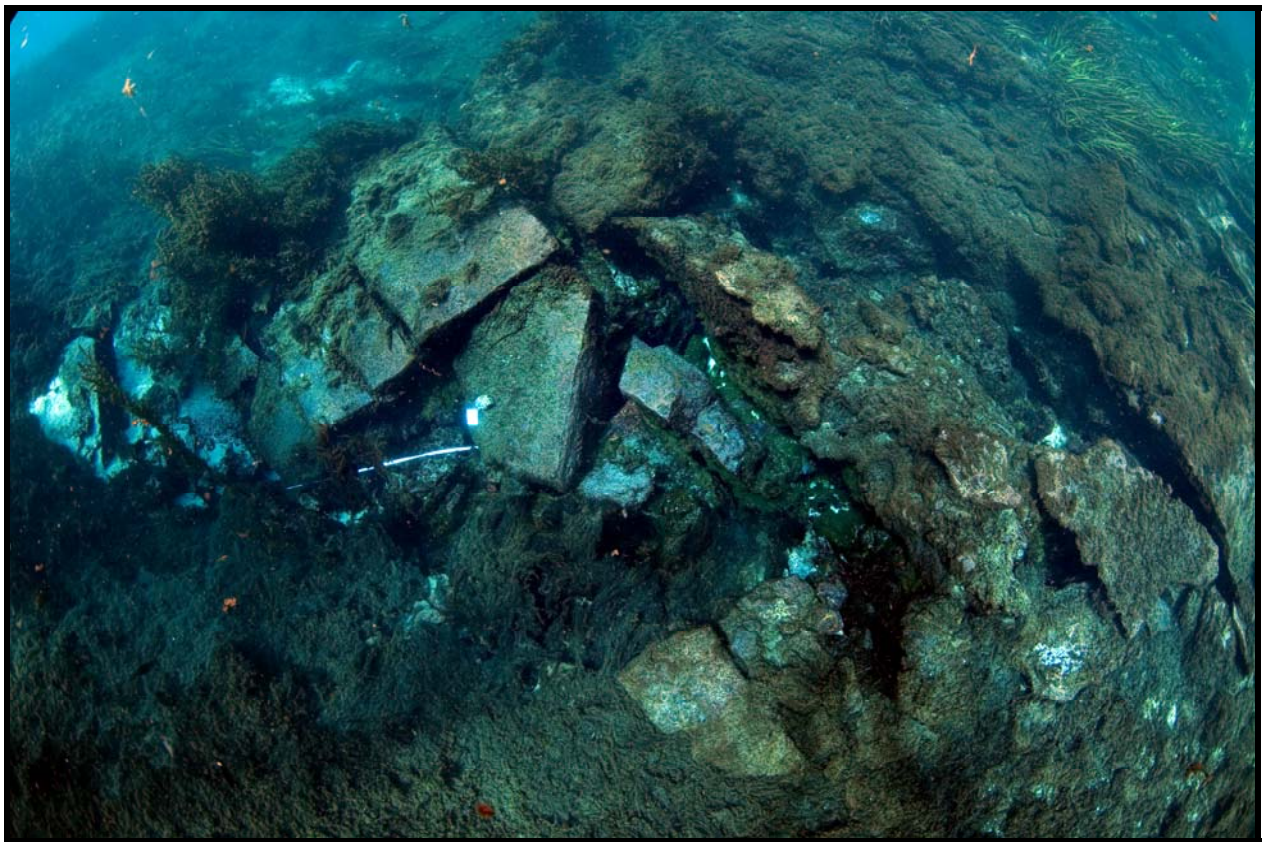
Catfish Hotel Spring is located in the main channel approximately 100 feet southeast of Second Fisherman's Paradise Spring. This spring has a deep basin that is bordered on the east by a limestone ledge. West of this ledge is a large and complex area of angular boulders and slabs. Discharge was strong from the numerous vents scattered among the boulders and ledges. Void spaces below the rocks extend down past depths of 25 feet. The physical structure and complexity of this spring did not lend itself to the application of the underwater discharge measurement methods used at the other springs.

Figure 39. Underwater photograph of Catfish Hotel Spring, Silver Springs Group, Marion County, Florida.

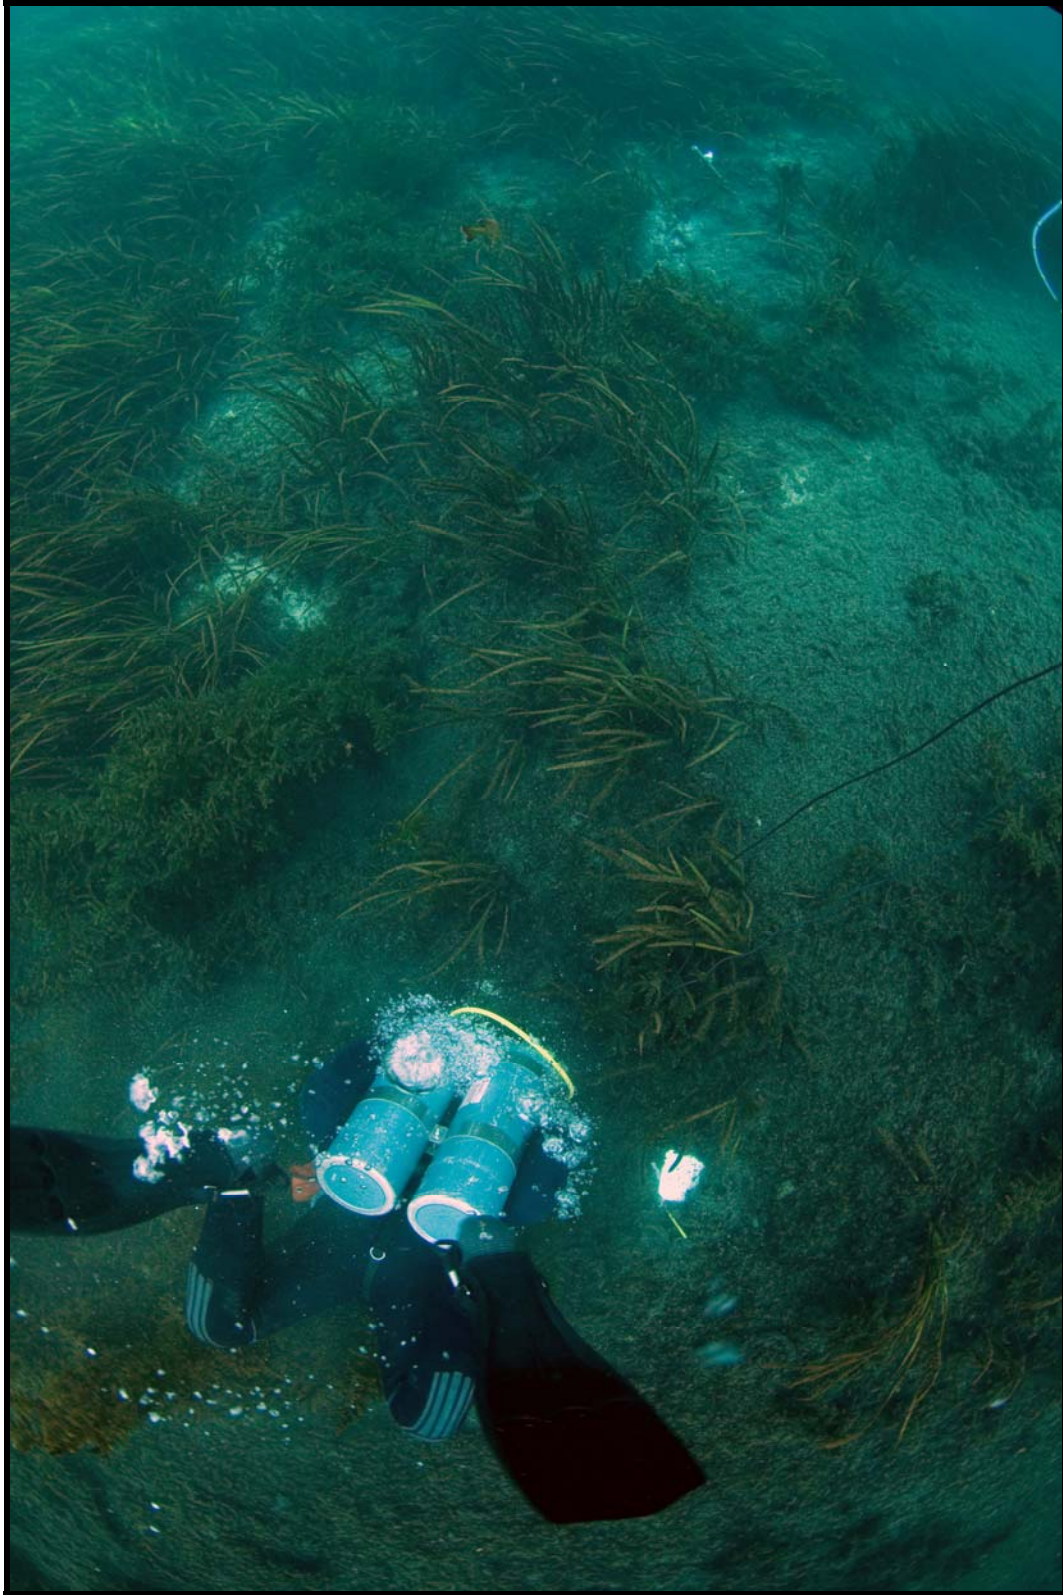
Figure 42. Underwater photograph of Catfish Convention Hall Spring, Silver Springs Group, Marion County, Florida. Vents that comprise this spring lie in front of the diver.

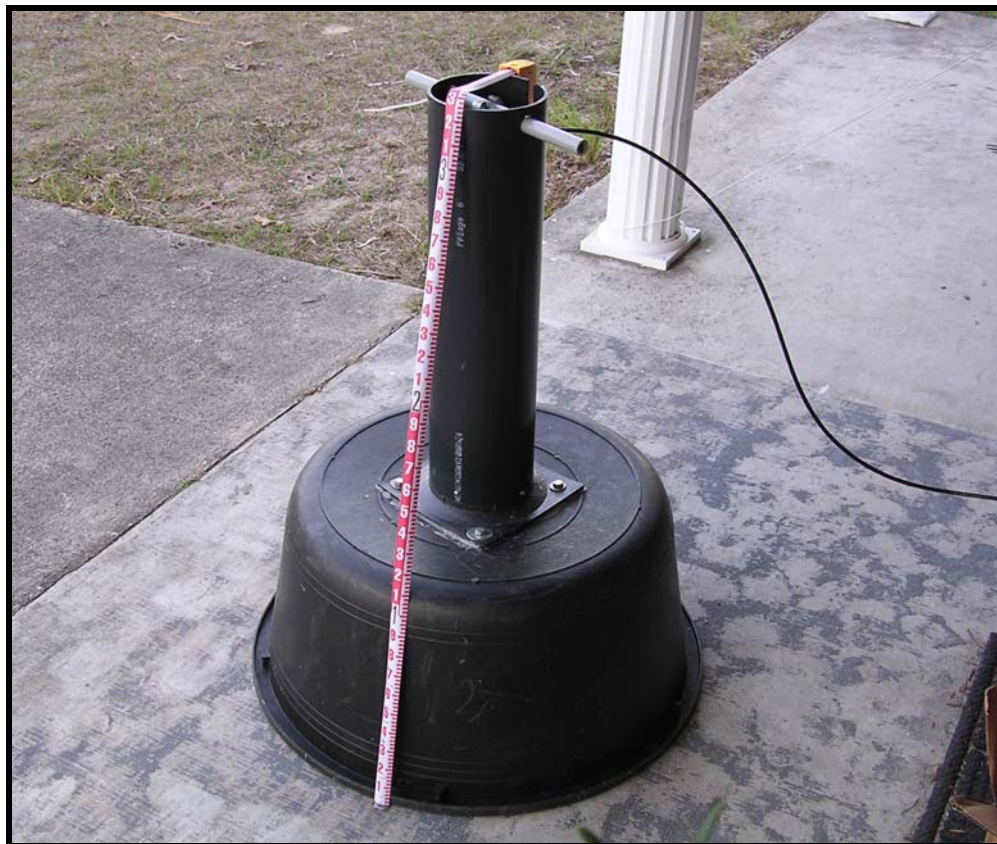
Figure 2. Vent Discharge Capture Device (VDCD). Sensor is attached to and centered on the gray PVC tube at the top of the 0.5 foot diameter pipe.

Once in place, the installation is checked for leakage around its bottom circumference. The condition of nearby vents is monitored for changes in flow, or the formation of new vents. A few minutes are allowed to let debris clear and for conditions to stabilize. The sensor is monitored for debris accumulation and cleaned off as needed.

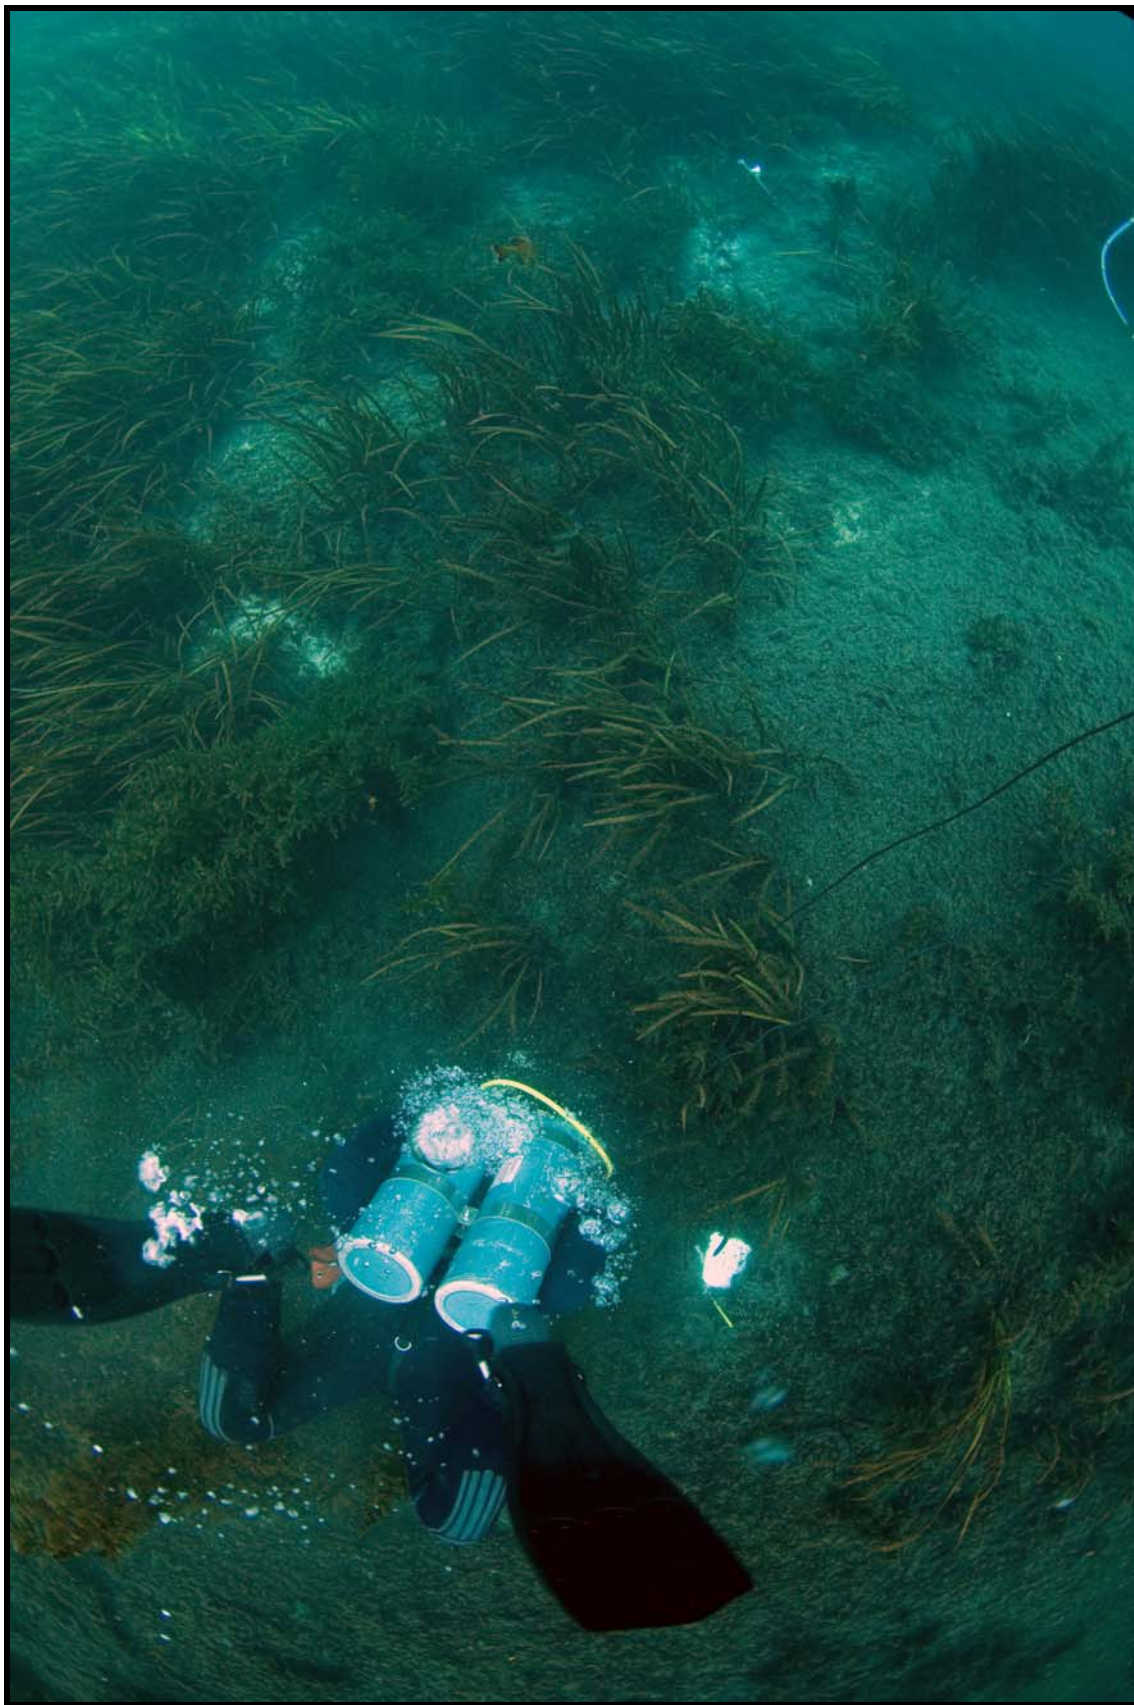
Figure 2. Underwater photograph of Catfish Convention Hall Spring, Silver Springs Group, Marion County, Florida. Vents that comprise this spring lie in front of the diver.

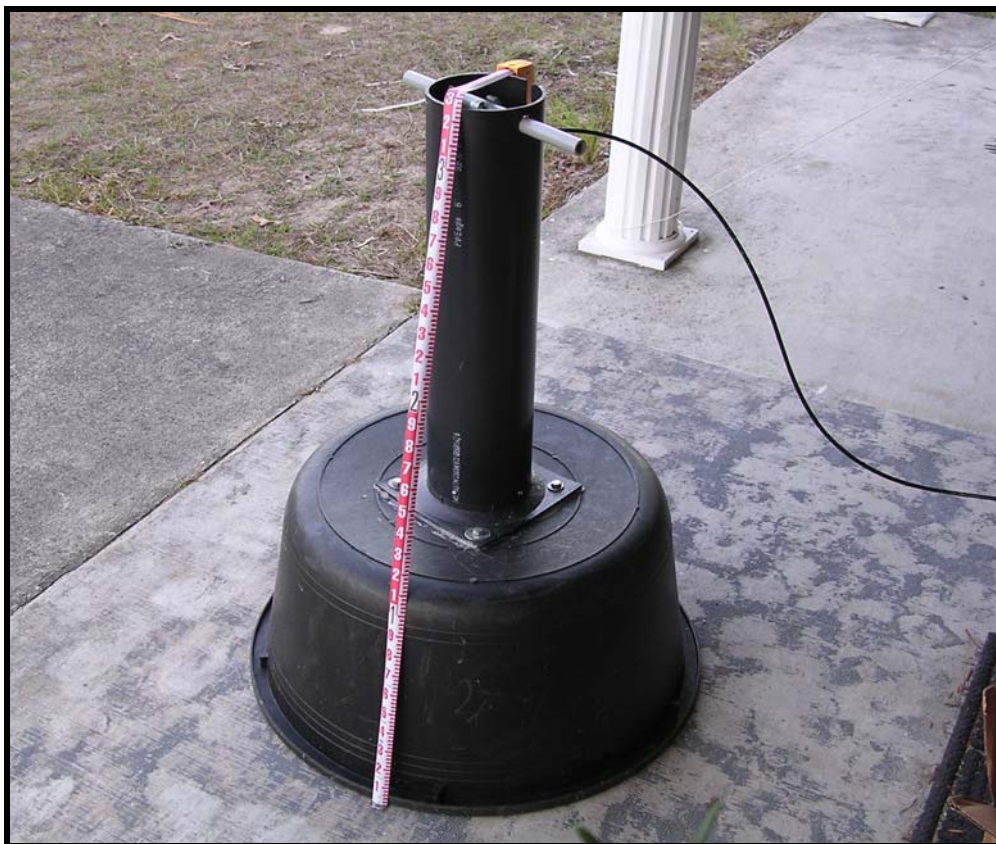
Figure 4. Vent Discharge Capture Device (VDCD). Sensor is attached to and centered on the gray PVC tube at the top of the 0.5 foot diameter pipe.

This spring consists of small, scattered vents discharging through a mixed bottom of either detritus, sediments, a thick algal layer, sand or pebbles. See Figure 3. Direct measurements of the vent cross-sections at this site were not practical. To accomplish measurements of these vents, a device was designed and employed to capture and concentrate the vent discharge for effective measurement. This device is referred to herein as the Vent Discharge Capture Device (VDCD). See Figure 4.

Once in place, the installation is checked for leakage around its bottom circumference. The condition of nearby vents is monitored for changes in flow, or the formation of new vents. A few minutes are allowed to let debris clear and for conditions to stabilize. The sensor is monitored for debris accumulation and cleaned off as needed.

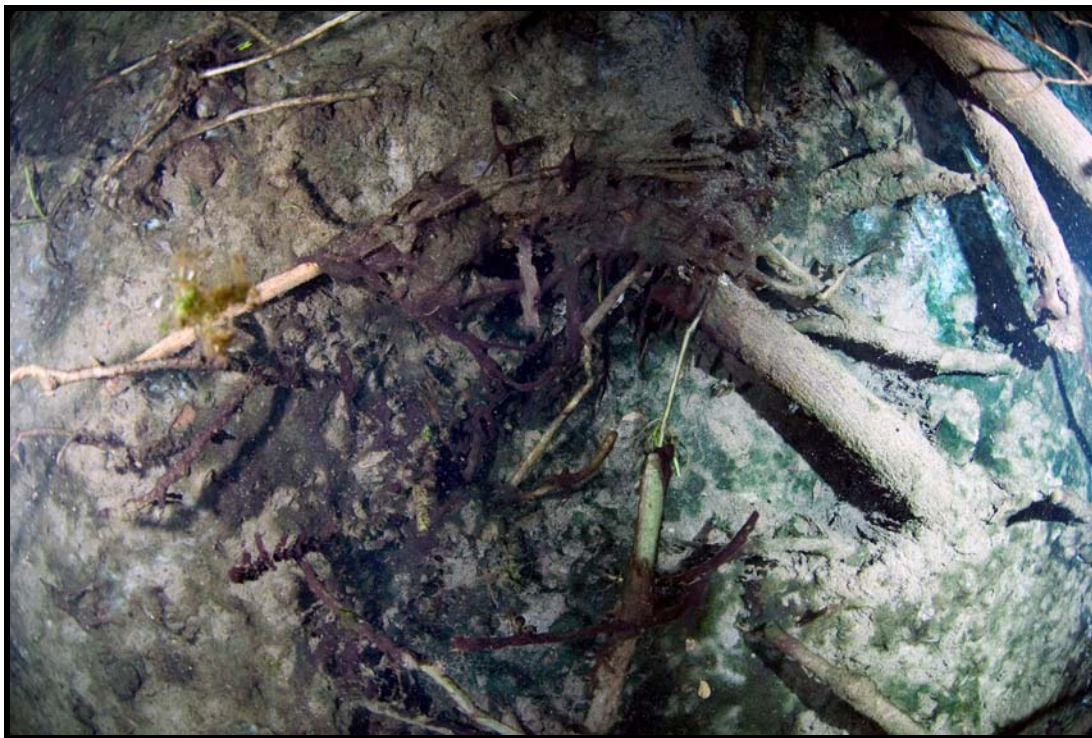
Figure 2. Underwater photograph of Lost River Spring, Silver Springs Group, Marion County, Florida.

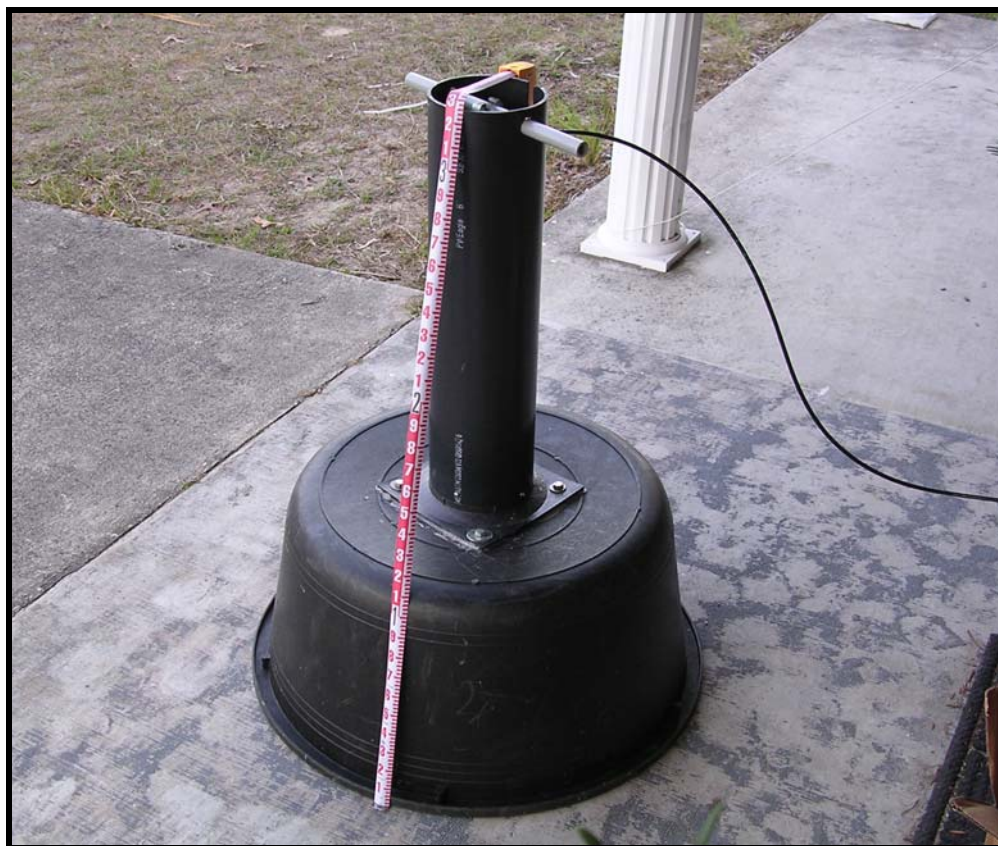
Figure 3. Vent Discharge Capture Device (VDCD). Sensor is attached to and centered on the gray PVC tube at the top of the 0.5 foot diameter pipe.

Once in place, the installation is checked for leakage around its bottom circumference. The condition of nearby vents is monitored for changes in flow, or the formation of new vents. A few minutes are allowed to let debris clear and for conditions to stabilize. The sensor is monitored for debris accumulation and cleaned off as needed.
