Abandoned Artesian Well Plugging Program

2000

St. Johns River Water Management District

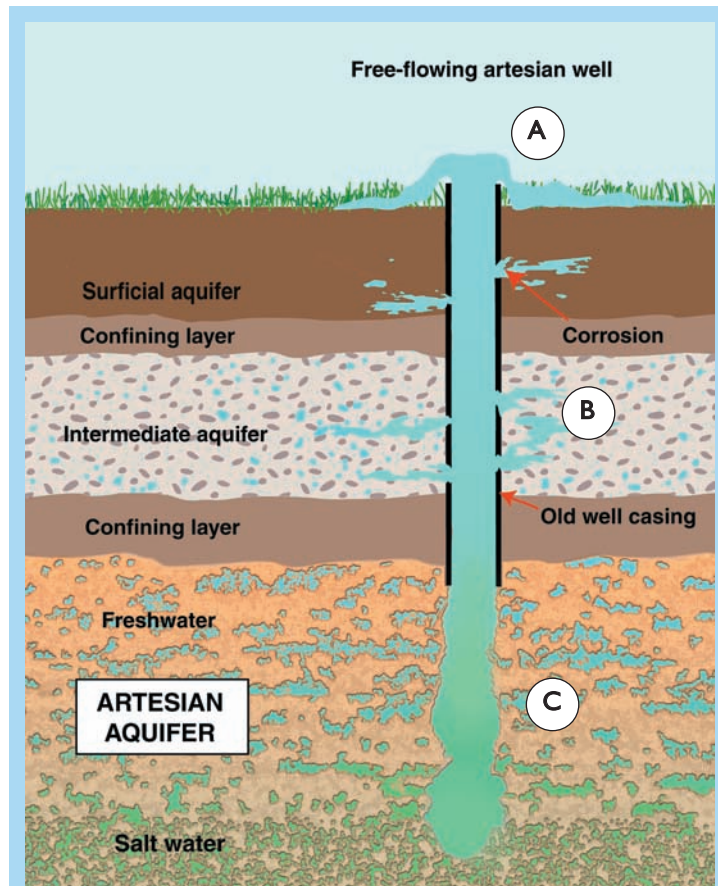
Figure 1. This well schematic illustrates several problems which may be associated with abandoned artesian wells, including (A) uncontrolled (continuous) flow at the surface, (B) leakage below the surface into the surficial and intermediate aquifers, and (C) intra-aquifer flow in the artesian aquifer where water of lesser quality moves upward and contaminates the freshwater in the upper portion of the same aquifer.

An artesian well is a well that has been drilled into a rock formation that contains water confined under pressure (an artesian aquifer; Figure 1). An abandoned artesian well is one that has no present or future beneficial use. It also may:

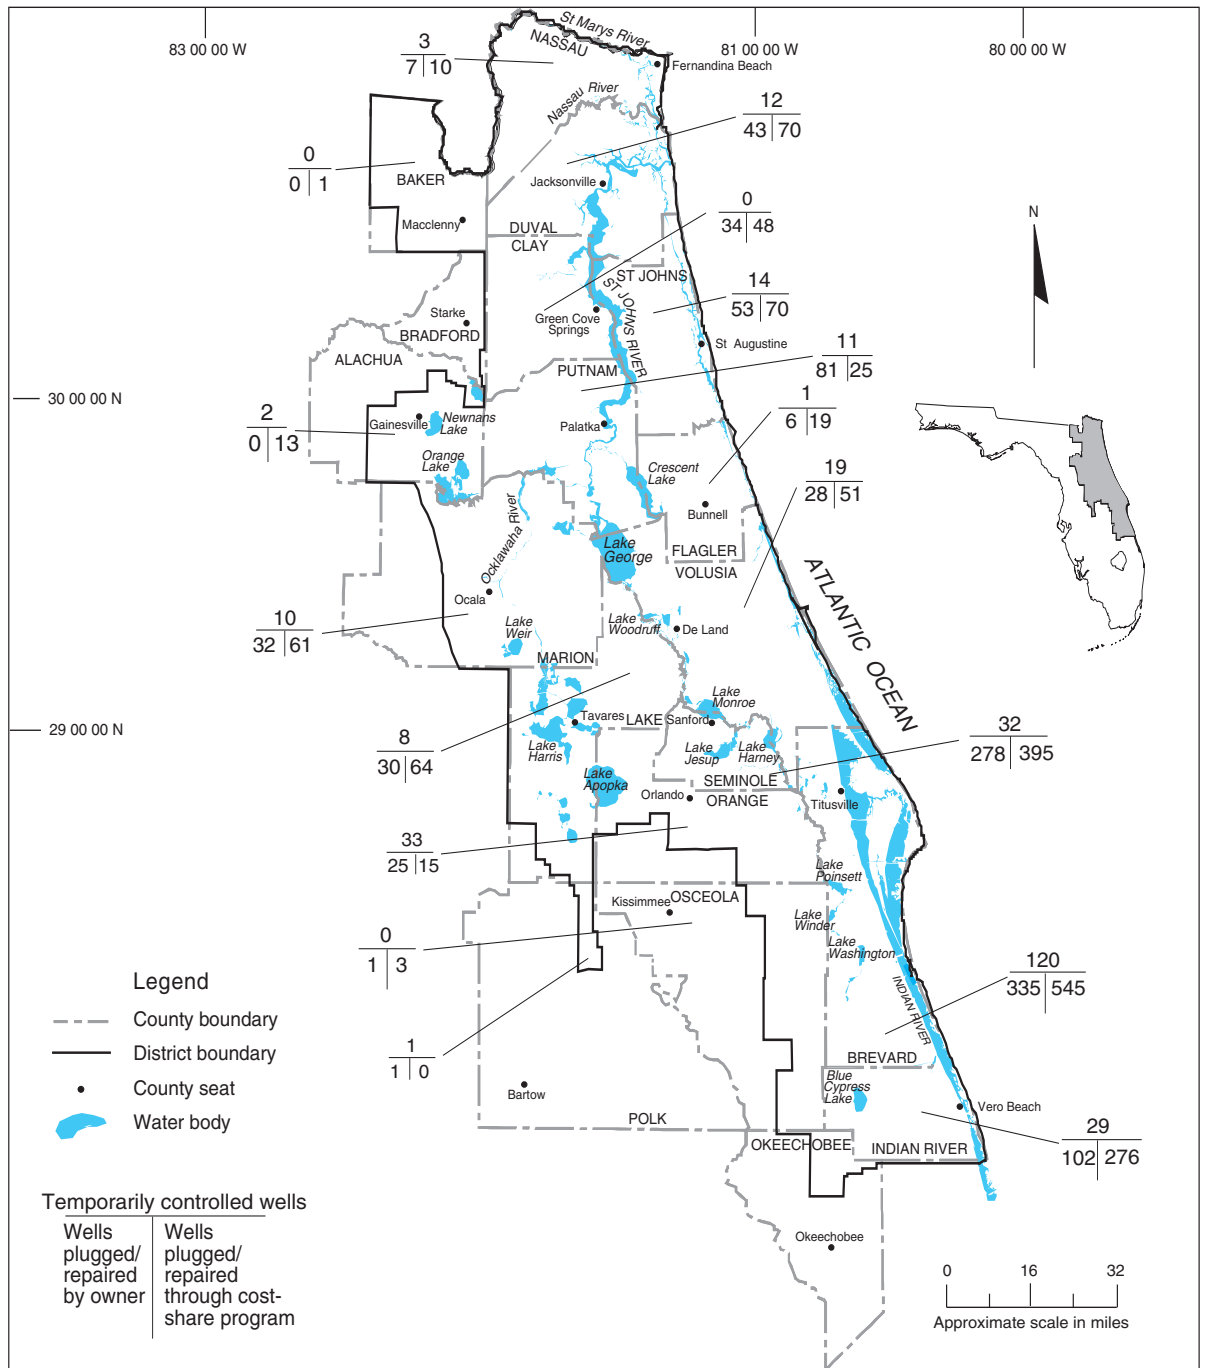
Figure 2. Distribution of temporarily controlled and plugged or repaired abandoned artesian wells in the St. Johns River Water Management District as of September 30, 2000

As of September 30, 2000, the cumulative number of artesian wells identified under the abandoned artesian well plugging program was 3,018 (Figure 2). Of this total, 295 are undergoing investigation to be permanently plugged, 1,667 have been permanently plugged or repaired through the SJRWMD cost-share program, and 1,056 have been plugged or repaired by the well owners. A summary of the wells which are on the SJRWMD inventory of wells under investigation to be permanently abandoned is presented in Table 3. These wells have been temporarily controlled whenever possible.
